Historic Preservation Commission

AMENDED AGENDA

Existing Conditions Survey Report

Knutson Building

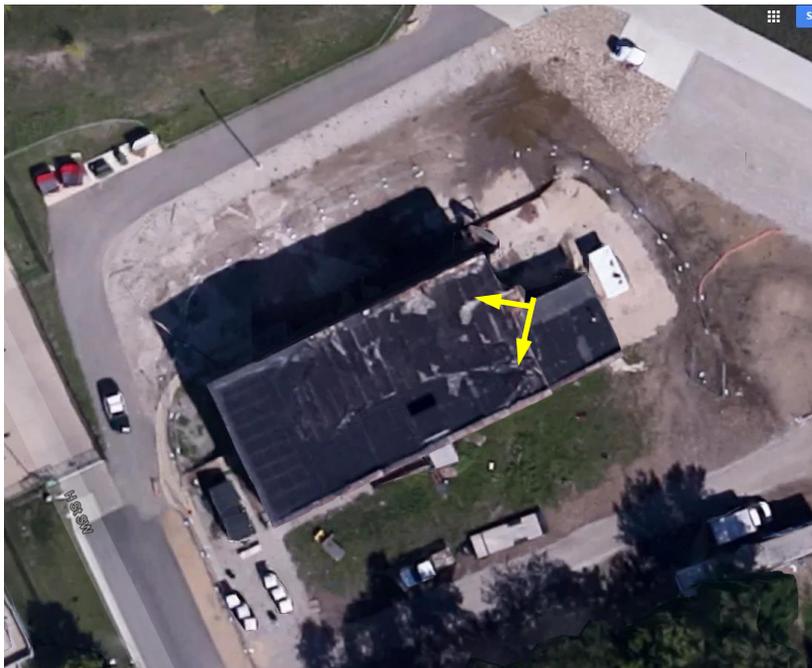
Figure 3 – Aerial view of Knutson Building roof. The arrows point to an area of the roof that collapsed after this view was taken. Google Maps © 2015.

Observations from the 2nd floor made apparent a roof collapse of the rear bay of the building, reportedly collapsed this summer. (Figure 3.) The team declined any opportunity to go up on top of the roof to make observations based on this state of collapse. (Figure 4.)

1. Make repairs to the collapsed roof. Clear away collapsed structure. Install new roof structure in line with the adjacent roof.
2. Provide new sub-roofing and new roofing membrane over all of the roof. This is intended to be temporary until full rehabilitation is feasible.
3. Provide parapet cap flashing to prevent further deterioration of the parapet walls.

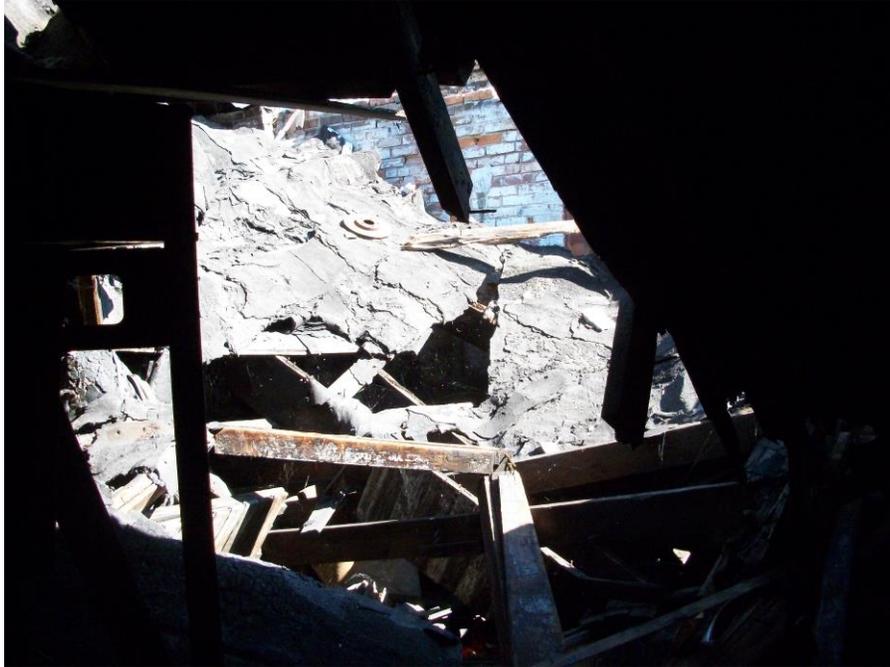
Figure 4 – Interior view of collapsed roof at the 3rd floor.

Roof framing was observed from the second floor. A significant portion of the rear bay roof had collapsed, reportedly this past summer. Significant water damage was observed around the collapse as well as other areas throughout the roof.

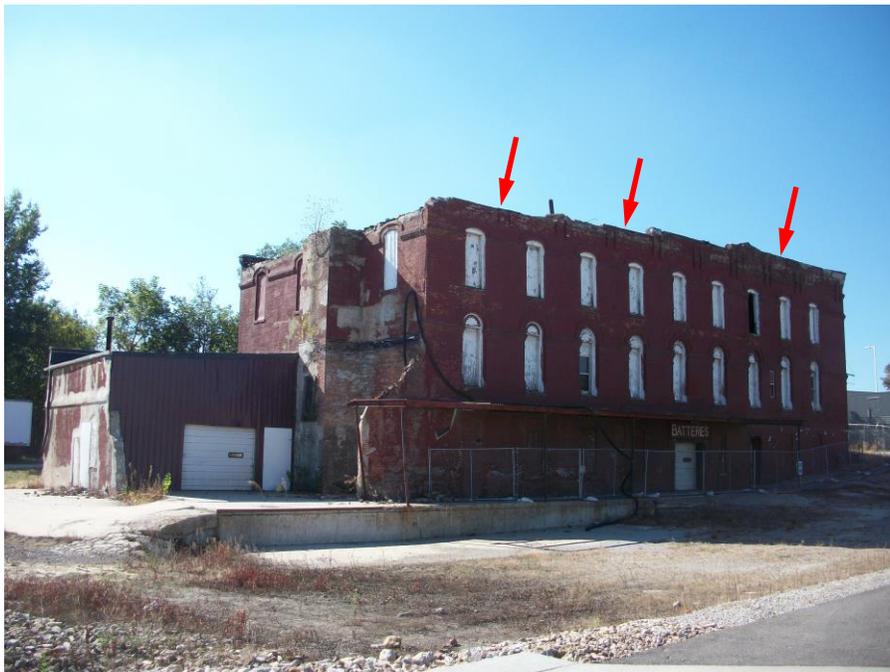
- The parapet walls along the length of the building had been significantly shortened towards the back of the building. Water infiltration at the parapet cap many years ago likely deteriorated the parapet, resulting in the removal of that top of the wall by previous building owners. This parapet may not need to be reconstructed in order to make repairs to the roof, however, the cap should be covered with cap flashing to prevent further deterioration.

Historic photos indicate a parapet wall of a consistent height at the front and sides of the building. The rear of the building did not have a parapet and allowed for rain run-off. The parapets at the sides were likely as high as 5 or 6 feet tall. Water infiltration over the years probably facilitated mortar deterioration and the wall was likely dismantled down to its current elevations. (Figure 5.)

Figure 5 – Exterior view showing stepped parapet along the side wall.

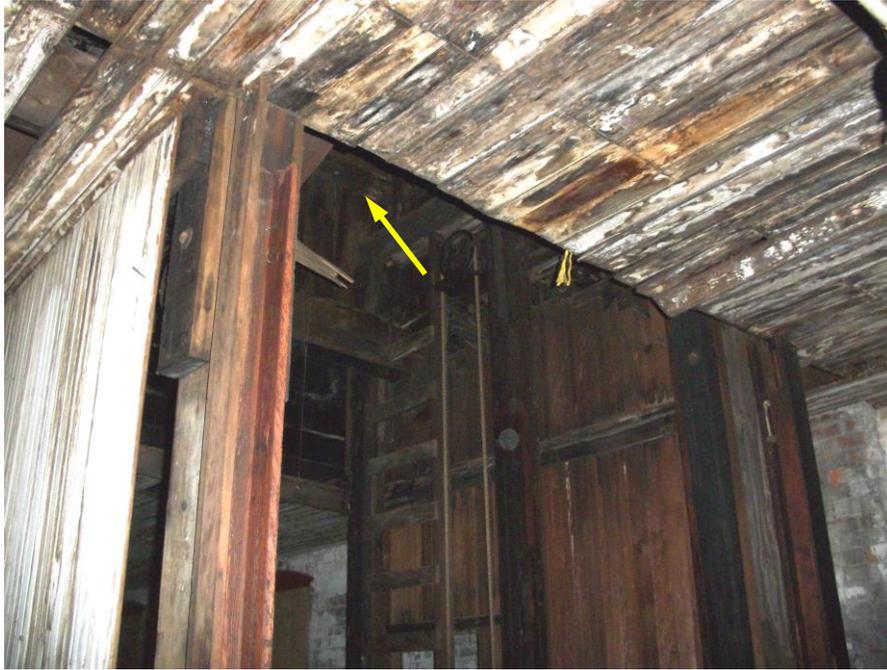
Charred wood roof structural members were observed adjacent to the freight elevator. It is not known when the fire may have occurred. (Figure 6.)

Figure 6 – Interior view of ceiling at the freight elevator at 3rd floor.

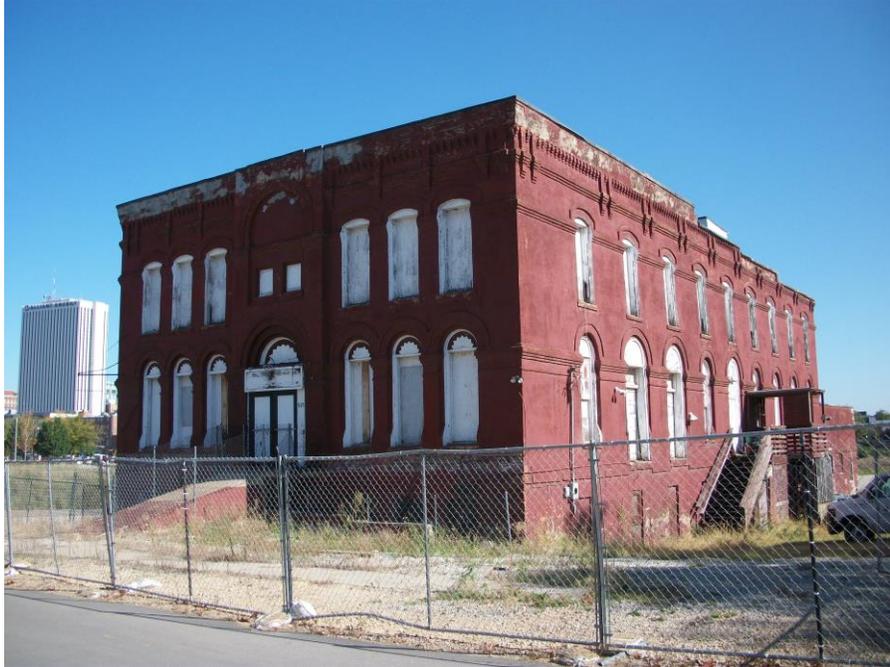
The exterior walls are generally load bearing masonry walls. No evidence of structural concerns were evident. (Figure 7.)

Figure 7 – Exterior view of the front entrance and side elevation.

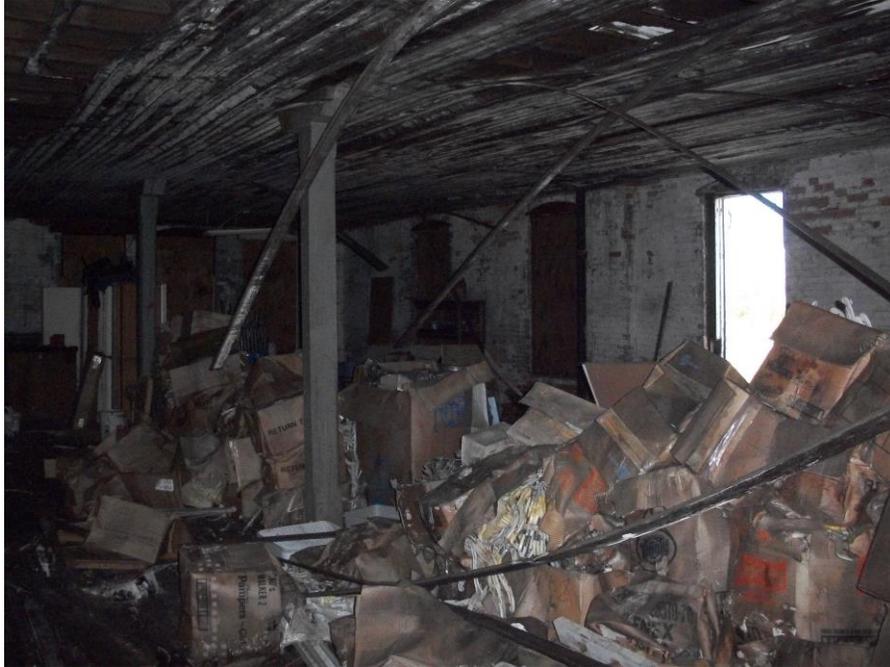
Debris was common throughout the 2nd floor. Much of this debris was also water damaged. (Figure 8.) The 1st floor had recently been used as a “haunted house” and much of this construction remains.

Figure 8 – Example of debris inside at the 3rd floor.

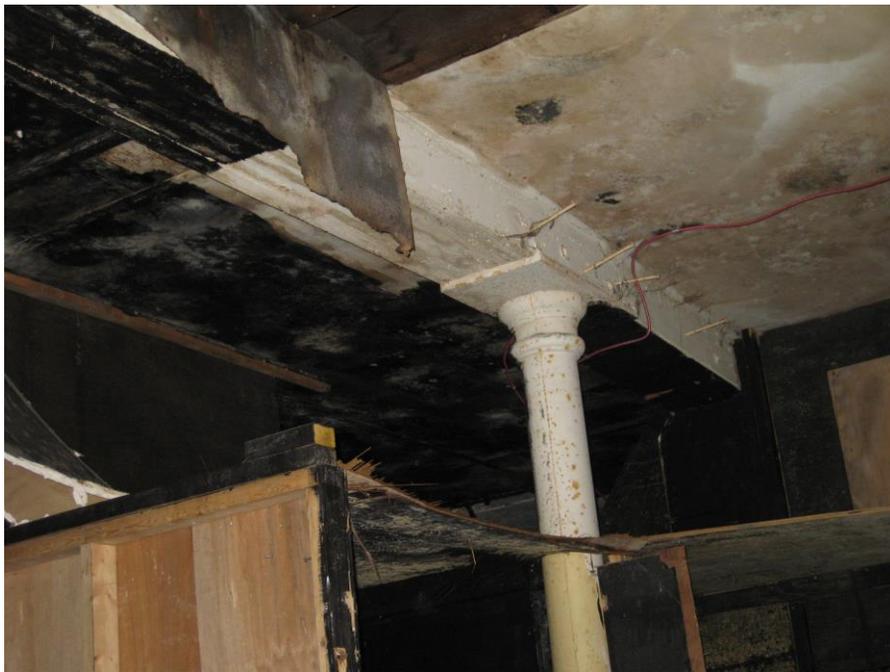
Significant character defining features were difficult to locate within the building. Steel or iron columns remain throughout the 1st floor, these should be retained. (Figure 9.)

Figure 9 – Example of iron column and wood ceiling beam at the 2nd floor.
