ENVIRONMENTAL ASSESSMENT REPORT

**City of Cedar Rapids
4264 Cottage Grove Parkway SE
Cedar Rapids, IA**

Project Report Dated: August 22, 2016

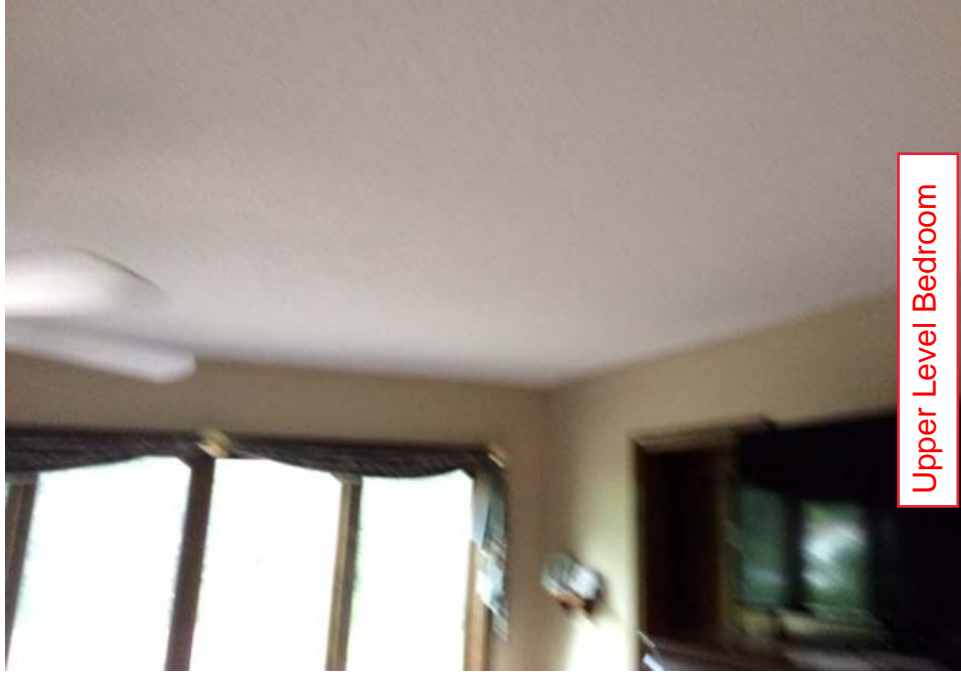
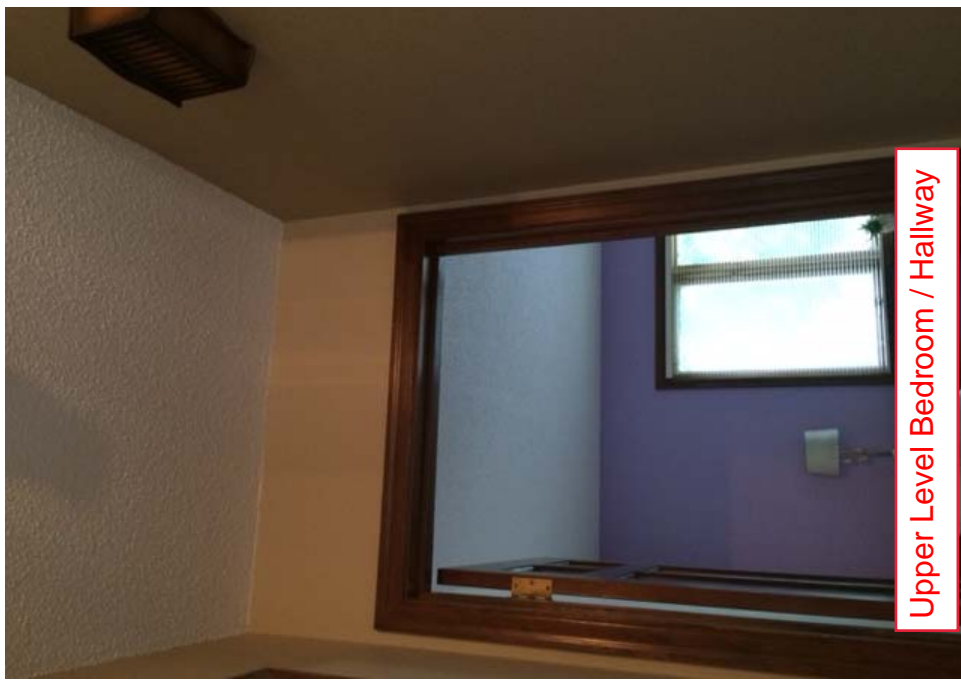
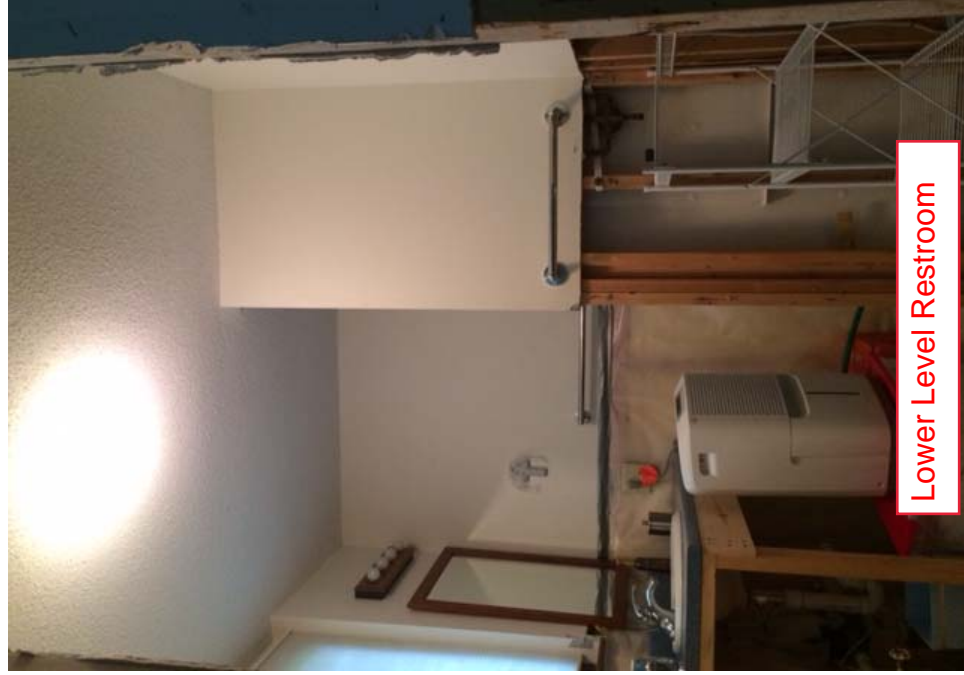
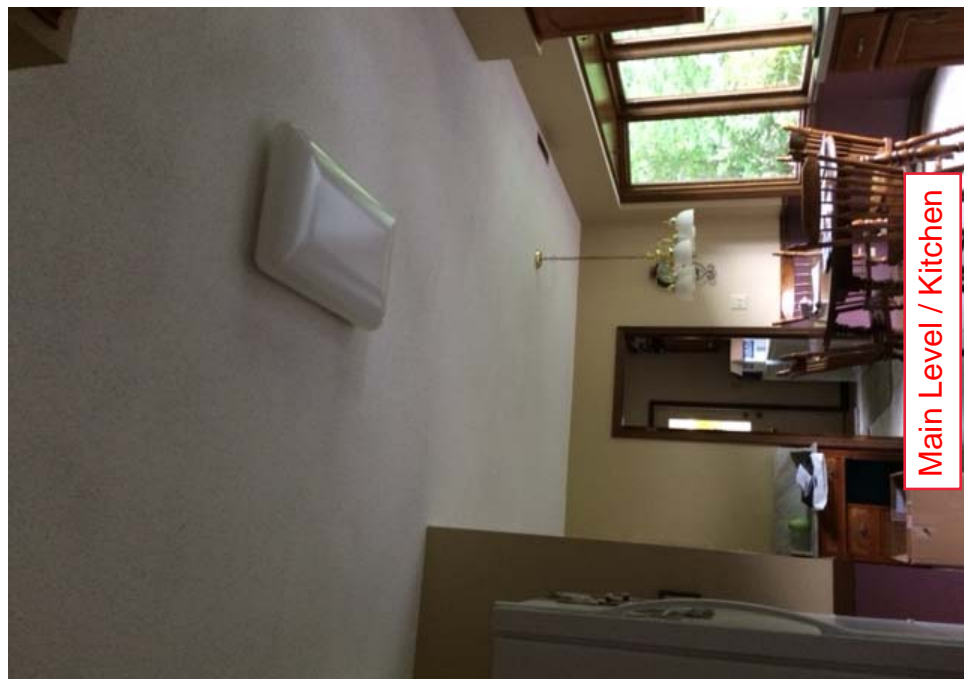
<u>Material</u>	<u>Description</u>	<u>Location</u>	<u>Quantity</u>
Spray-Applied Ceiling Texture	White	1 st Floor (living room, kitchen, laundry, dining room), Lower Level (bathroom), Upper Level (bedrooms, hallway)	1,350 SF
