Upper Seminole Well Field Road Repairs

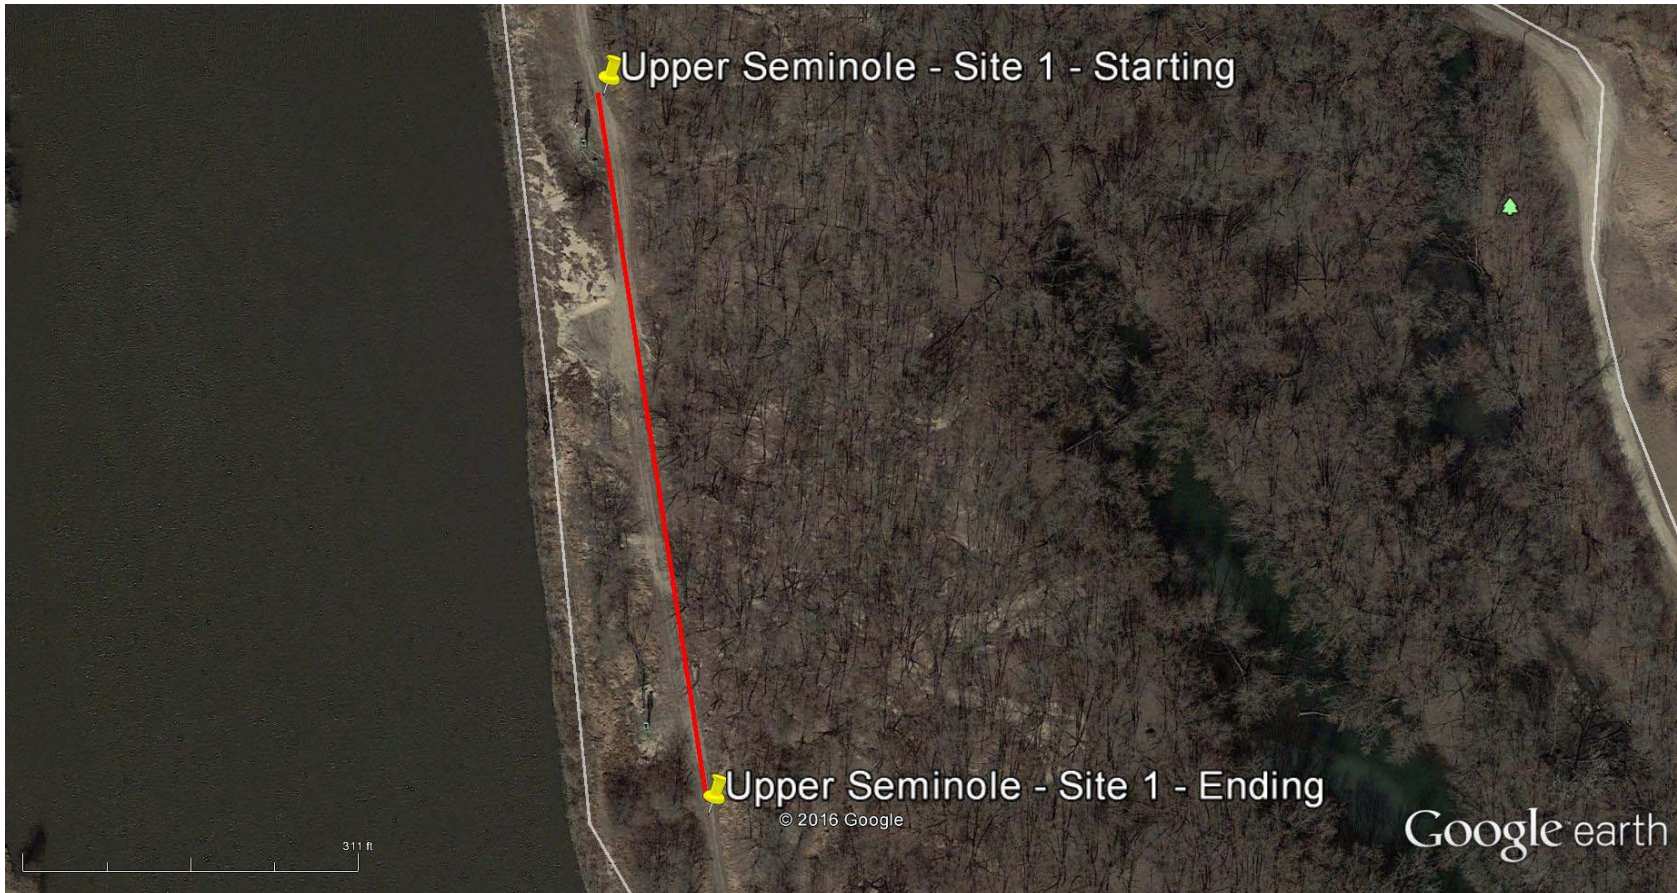
Site 1: Gravel Road in the Well Field
Damage: Water Division asserts that road stone was scoured during the flood and when sand was cleared from the roadway
Starting: 42.008385 -91.744812 Near Well #22
Ending: 42.006512 -91.744453 Near Well #21

Base Material: Possibly 2 inch Clean
Length: 675 feet
Width: 15 feet
Depth: 2 inch
Volume: 62.50 cubic yards
Amount: 87.50 tons (1.4 conversion rate)

Surface Material: Possibly 2 inch Minus
Length: 675 feet
Width: 15 feet
Depth: 2 inch
Volume: 62.50 cubic yards
Amount: 87.50 tons (1.4 conversion rate)

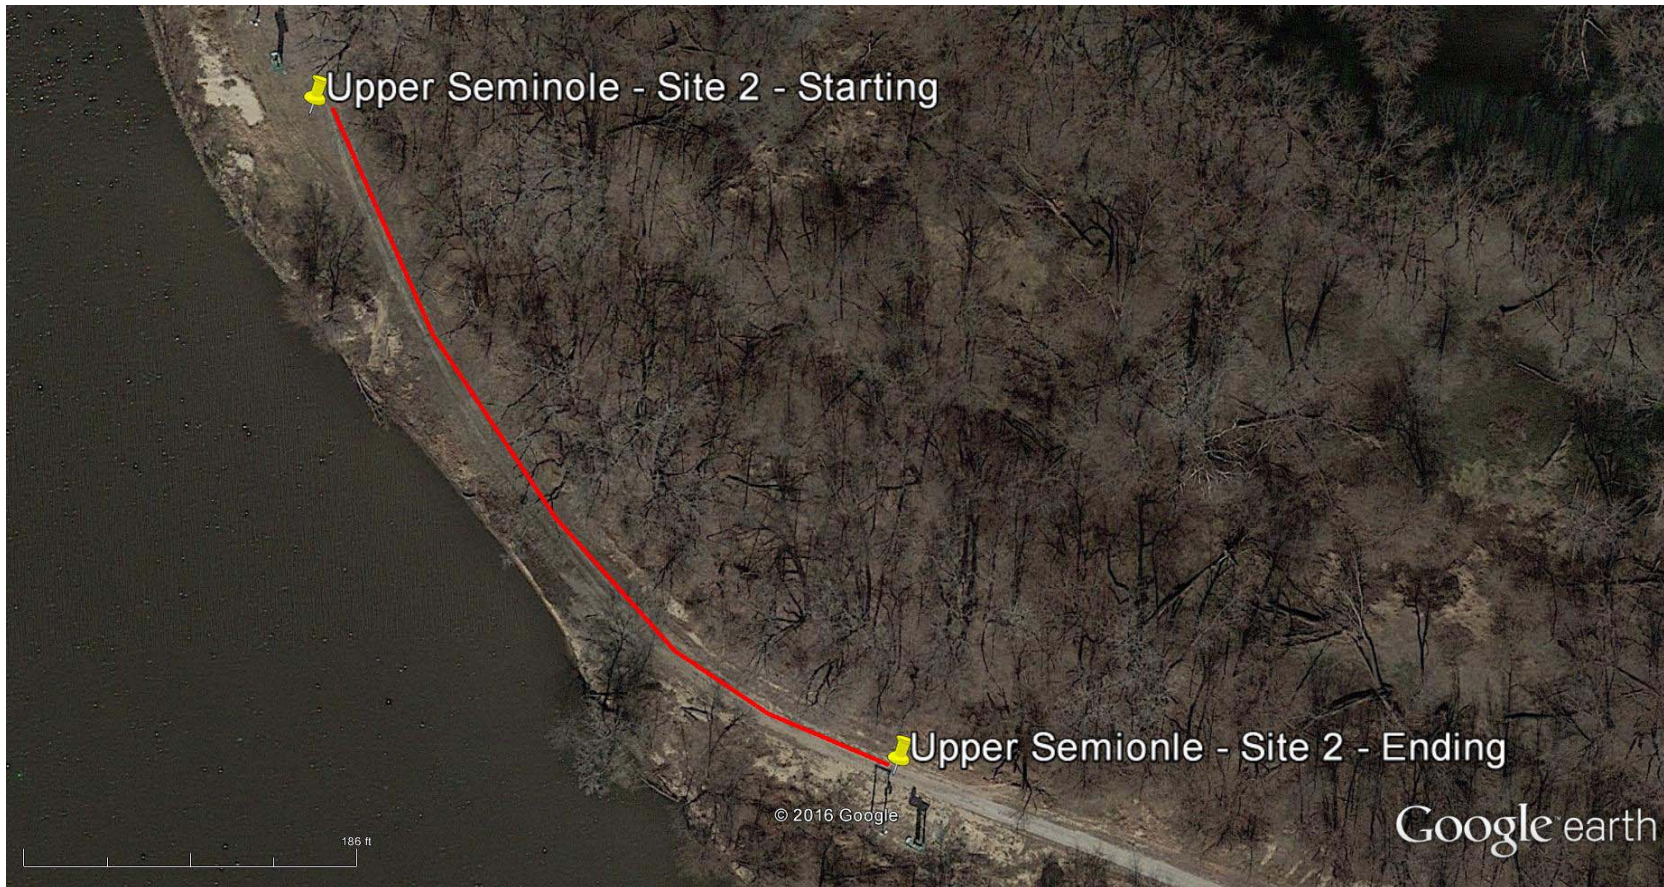
Site 2: Gravel Road in the Well Field

Damage: Water Division asserts that road stone was scoured during the flood and when sand was cleared from the roadway

Base Material: Possibly 2 inch Clean

Surface Material: Possibly 2 inch Minus

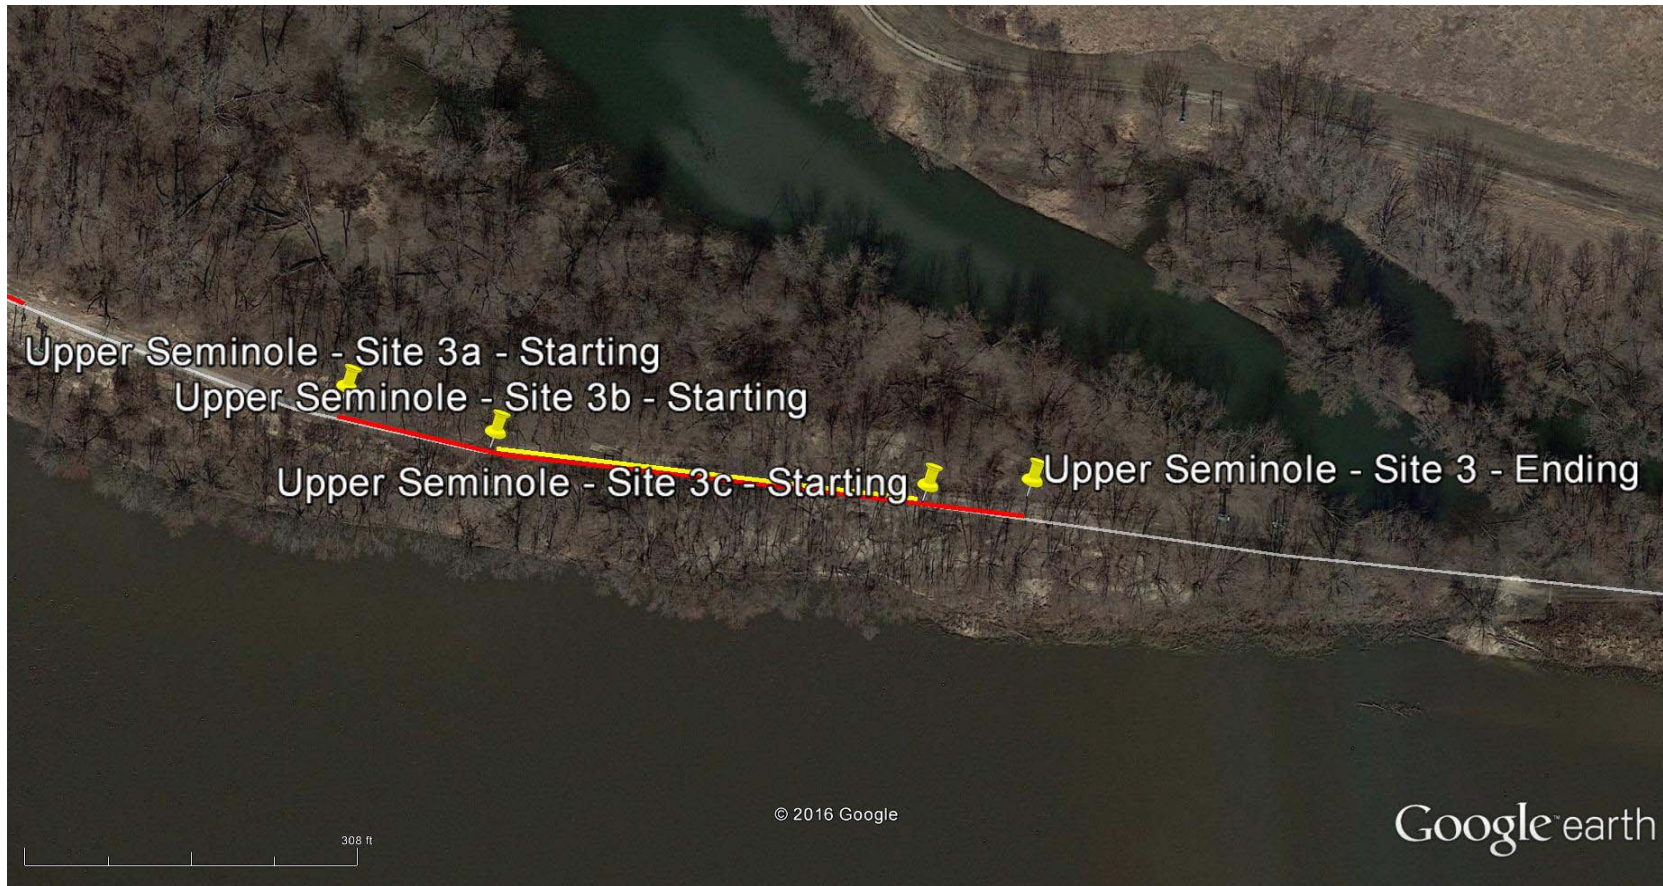
Site 3: Gravel Road in the Well Field
Damage: Water Division asserts that road stone was scoured during the flood

Base Material: Possibly 2 inch Clean
Length: 175 feet
Width: 15 feet
Depth: 2 inch
Volume: 16.20 cubic yards
Amount: 22.69 tons (1.4 conversion rate)

Surface Material: Possibly 2 inch Minus
Length: 175 feet
Width: 15 feet
Depth: 2 inch
Volume: 16.20 cubic yards
Amount: 22.69 tons (1.4 conversion rate)

Base Material: Possibly 4 inch Clean
Length: 400 feet
Width: 15 feet
Depth: 4 inch
Volume: 74.07 cubic yards
Amount: 103.70 tons (1.4 conversion rate)

Surface Material: Possibly 2 inch Minus
Length: 400 feet
Width: 15 feet
Depth: 2 inch
Volume: 37.04 cubic yards
Amount: 51.85 tons (1.4 conversion rate)

Base Material: Possibly 2 inch Clean
Length: 150 feet
Width: 15 feet
Depth: 2 inch
Volume: 13.89 cubic yards
Amount: 19.44 tons (1.4 conversion rate)

Surface Material: Possibly 2 inch Minus
Length: 150 feet
Width: 15 feet
Depth: 2 inch
Volume: 13.89 cubic yards
Amount: 19.44 tons (1.4 conversion rate)

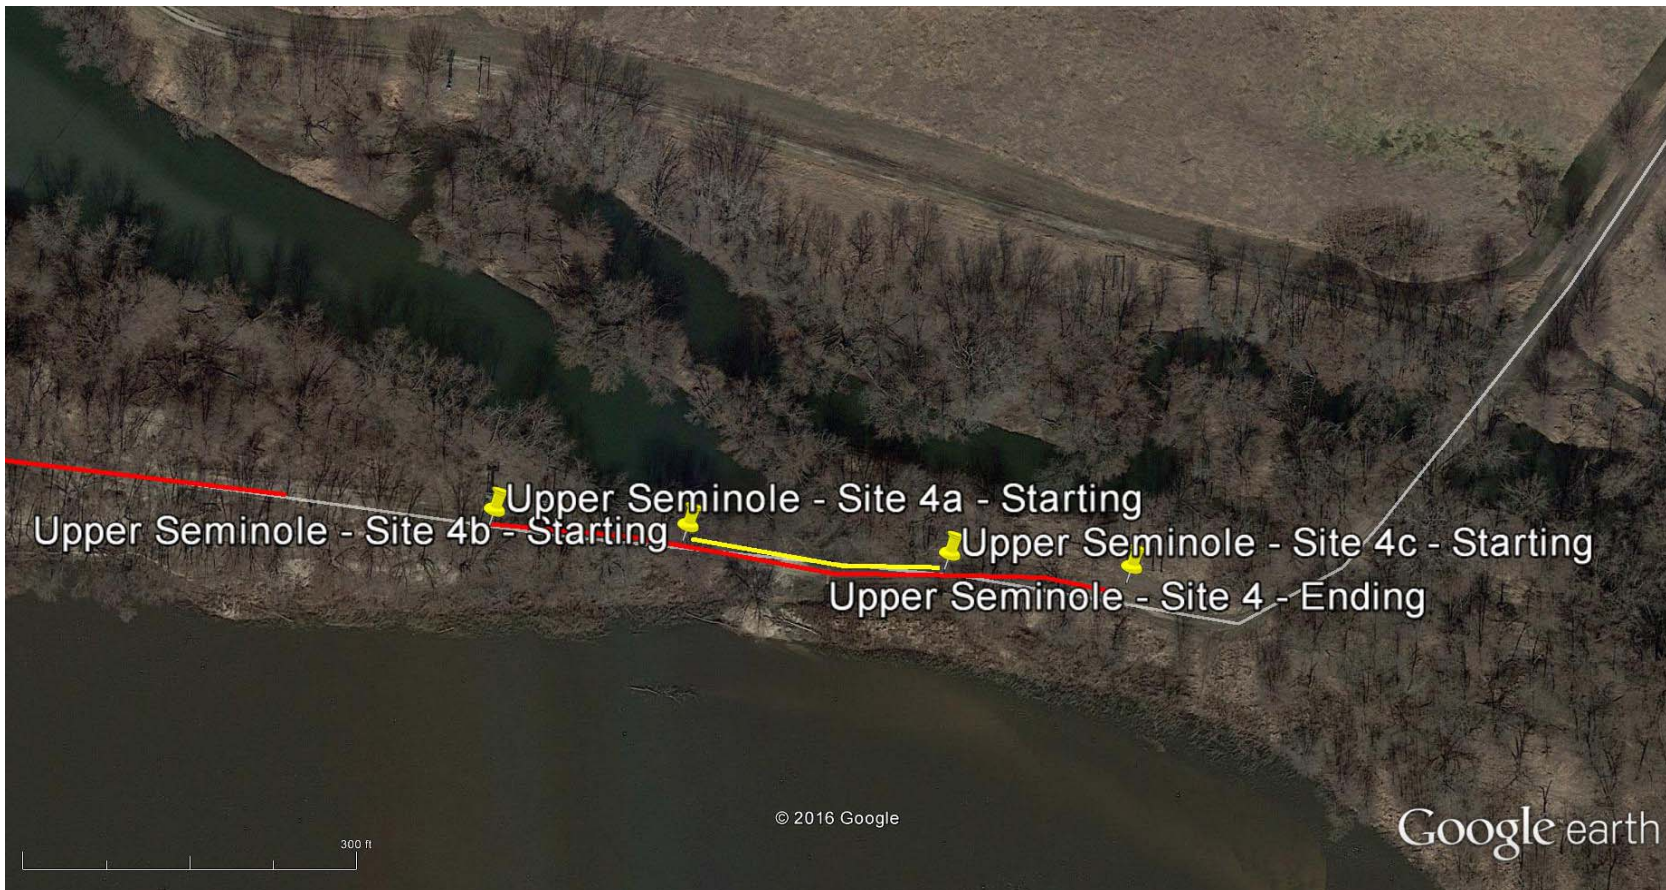
Site 4d: Pad Near Utility Poles #33 and #34

Site 4: Gravel Road in the Well Field
Damage: Water Division asserts that road stone was scoured during the flood

Base Material: Possibly 2 inch Clean

Surface Material: Possibly 2 inch Minus

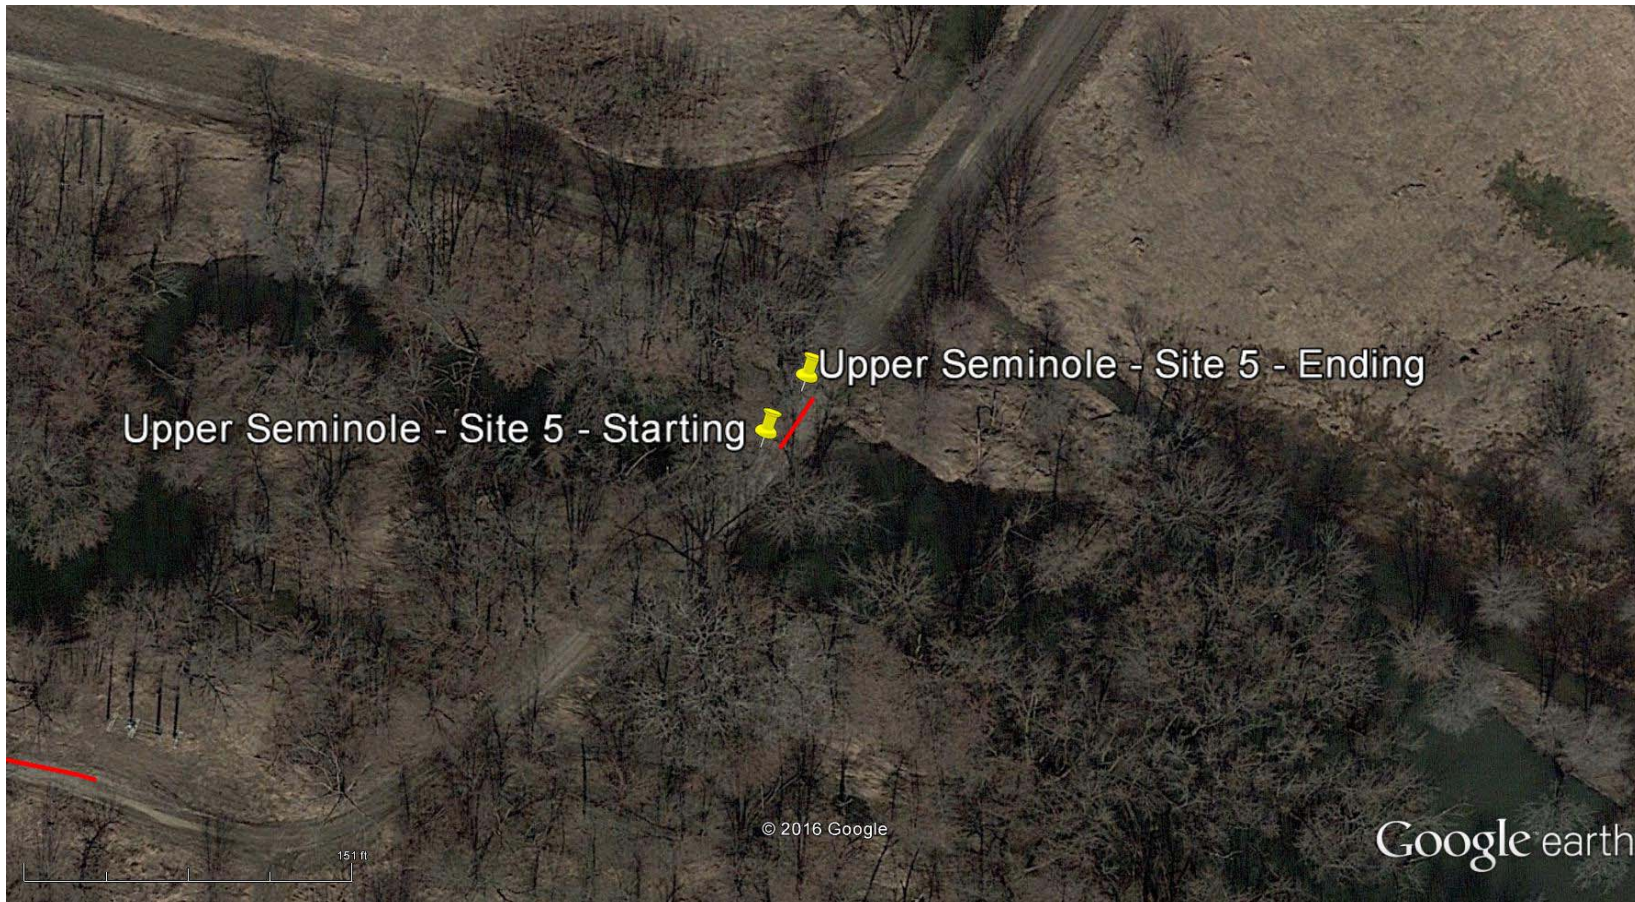
Site 5: Gravel Road in the Well Field
Damage: Water Division asserts that road stone was scoured during the flood
Starting: 42.003735 -91.735580
Ending: 42.003807 -91.735511

Base Material: Possibly 4 inch Clean
Length: 50 feet
Width: 15 feet
Depth: 4 inch
Volume: 9.26 cubic yards
Amount: 12.96 tons (1.4 conversion rate)

Surface Material: Possibly 2 inch Minus
Length: 50 feet
Width: 15 feet
Depth: 2 inch
Volume: 4.63 cubic yards
Amount: 6.48 tons (1.4 conversion rate)

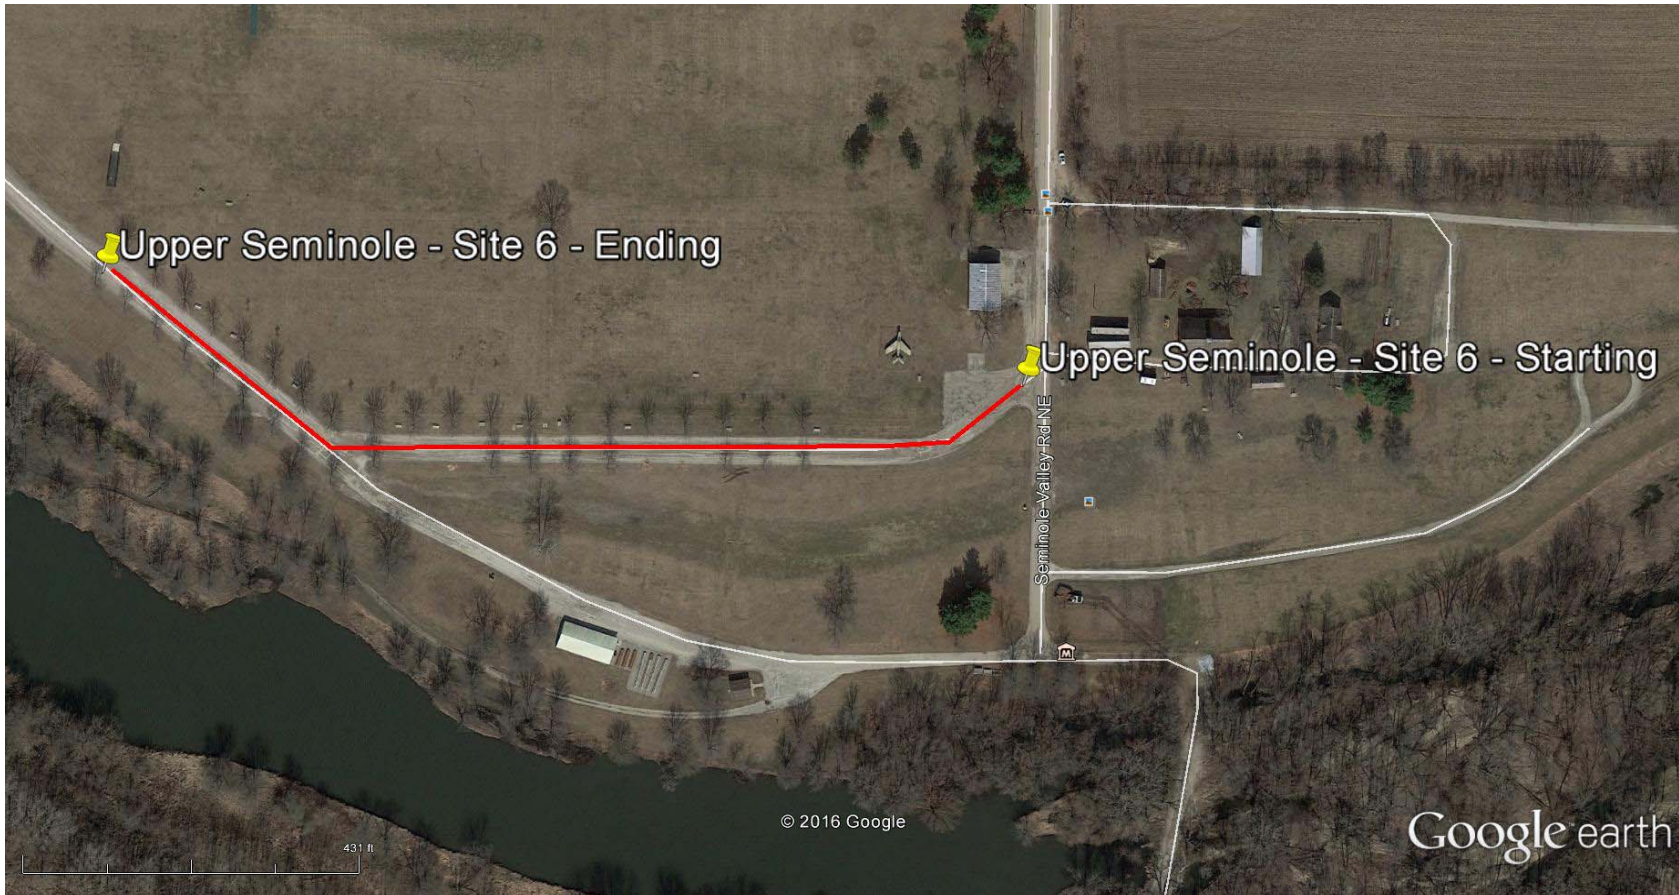
Site 6: Aged Asphalt / Chip and Seal Entrance Road to Well Field through Park Property
Damage: Water Division anticipates that this road will be heavily damaged due to gravel truck and other equipment traffic while completing well field road repairs
Starting: 42.003265 -91.728279
Ending: 42.00367 -91.732628
Length: 1320 feet (0.25 mile)
Width: 30 feet
Depth: Chip and Seal

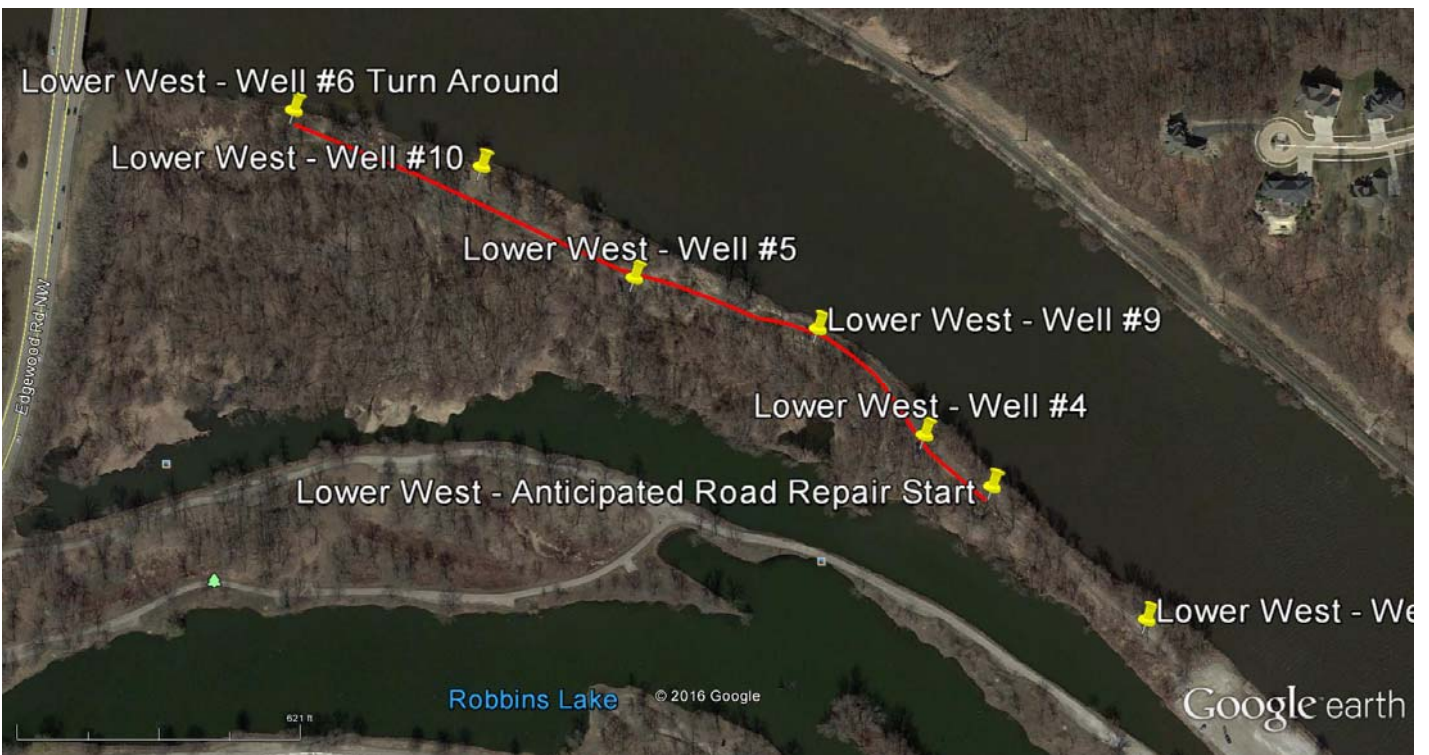
Site 1: Gravel Road in the Well Field

Damage: Water Division asserts that road stone was scoured during the flood and when sand was cleared from the roadway last fall, and the Water Division anticipates that this road will be heavily damaged due to gravel truck and other equipment traffic when the sand along the side of the roadway is removed

Base Material: Possibly 2 inch Clean

Base Material: Possibly 4 inch Clean

Surface Material: Possibly 2 inch Minus
