Limited Asbestos Survey Report

**Building 16 Roof Replacement Project
City Services Center
500 15th Avenue SW
Cedar Rapids, Iowa 52404**

July 19, 2016
Terracon Project No. F1166091

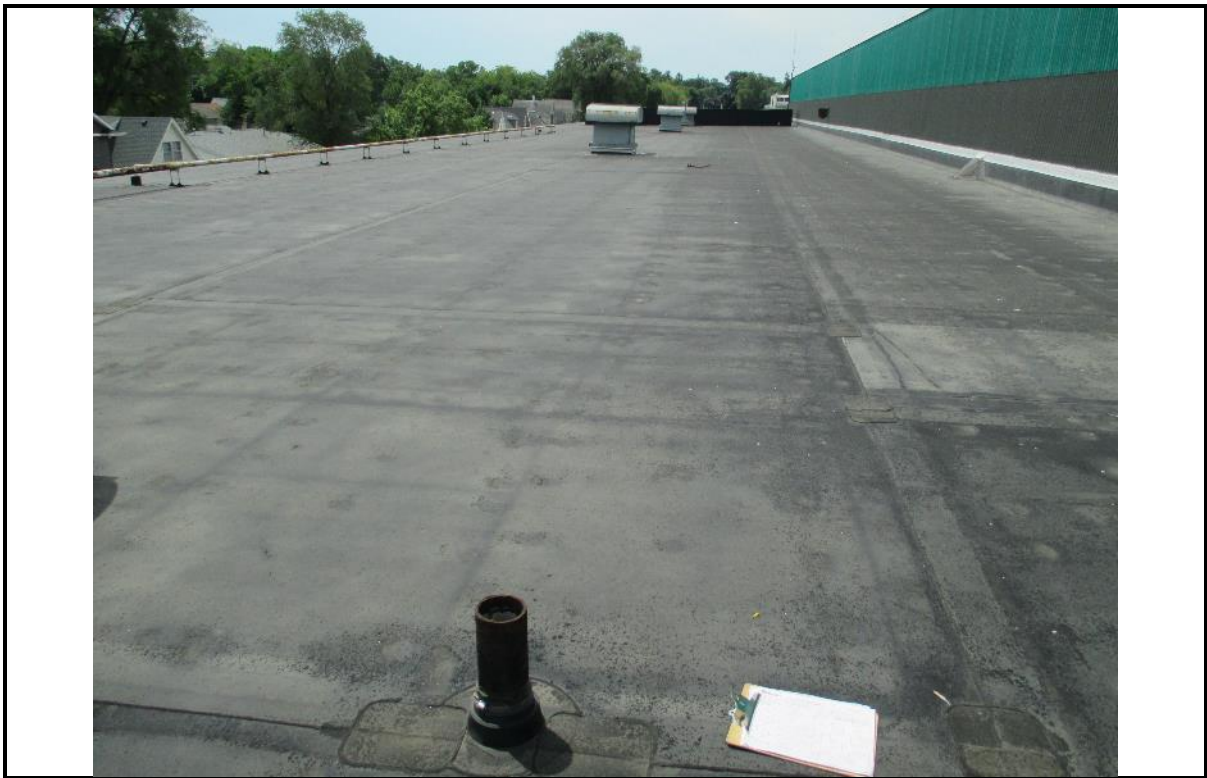
Asbestos-containing roofing flashing and bituminous coating were identified on the subject roof. These materials are considered Category I nonfriable ACM in damaged condition. Category I materials are unlikely to release fibers into the air and per USEPA guidance, hand methods (for removal) should not render roofing material friable. Based on our survey activities and understanding of the project, the ACMs on the roof drains are likely to be disturbed. ACMs on the vents may or may not be impacted as part of the project. If the ACMs are to be removed or disturbed, a State of Iowa licensed asbestos abatement firm should be retained to abate the materials. Abatement practices should not include the use of grinders or rotating blades with serrated edges or any other method that renders the material friable, unless the equipment is equipped with local exhaust ventilation and high efficiency particulate air filters. Additionally, the Category I ACM materials need not be disposed of as asbestos-containing waste material provided such Category I ACM remains nonfriable. However, Terracon recommends the landfill operator be notified that debris contains nonfriable asbestos-containing materials.

Photo 2: Picture of cast vent penetration with ACM flashing on lower roof, looking south.

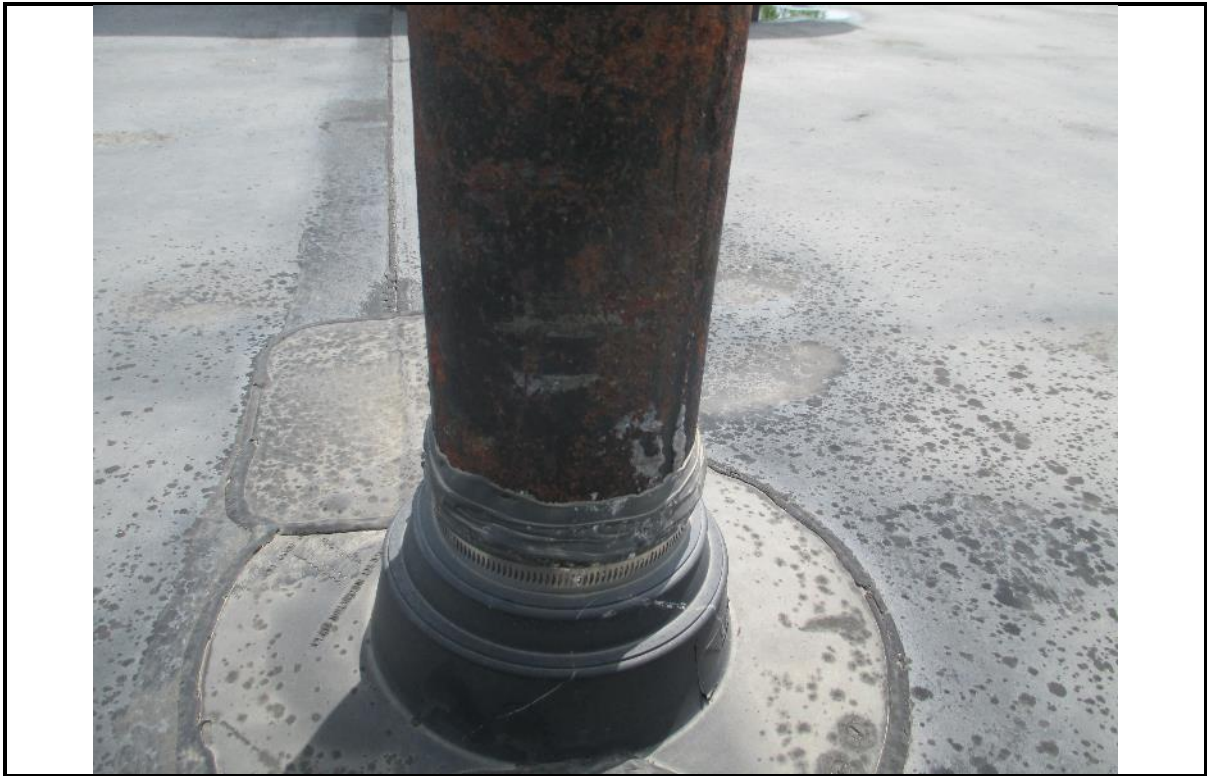
Photo 3: View of asbestos-containing flashing on cast vent on lower roof.

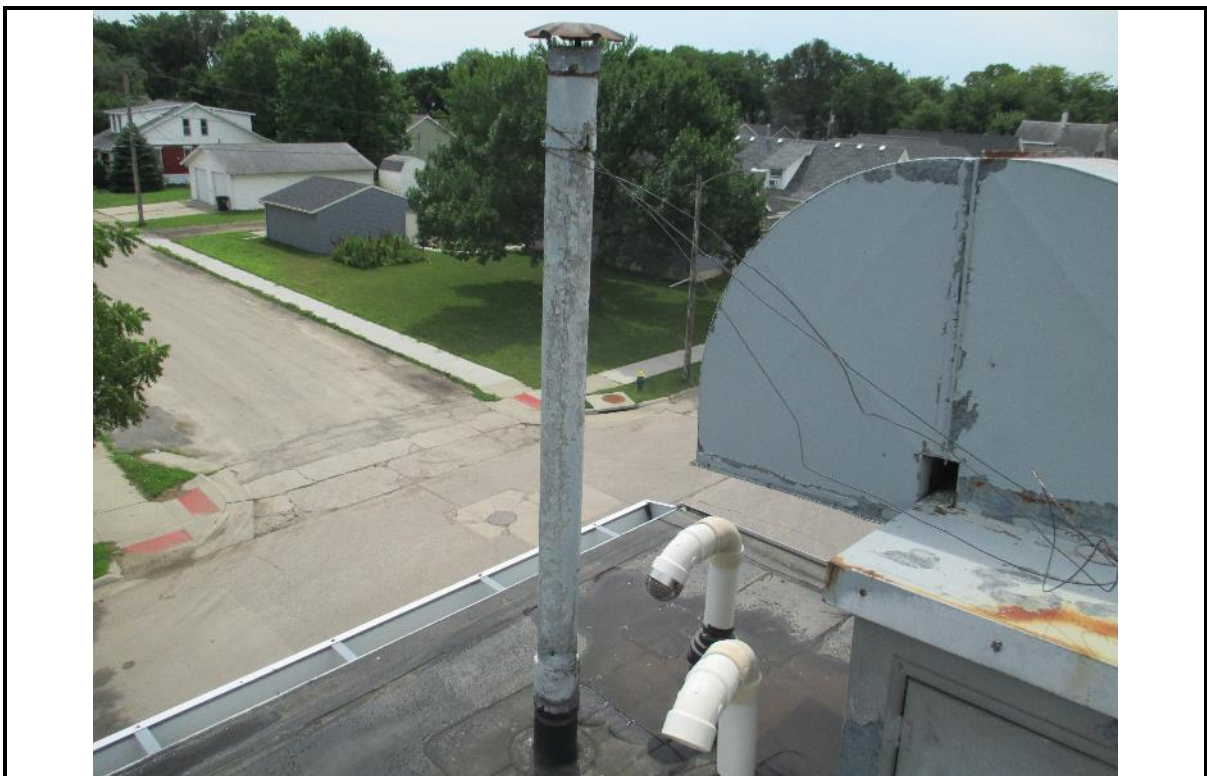
Asbestos-containing cement piping was identified on the southeastern corner of the lower roof and is a Category II nonfriable ACM in good condition; however, it was supported by a wire attached to the adjacent mechanical duct. A qualified asbestos abatement firm should remove and properly dispose of this material prior to the roof replacement activities.

Photo 4: View of asbestos-containing cement pipe on lower roof, southeast corner.

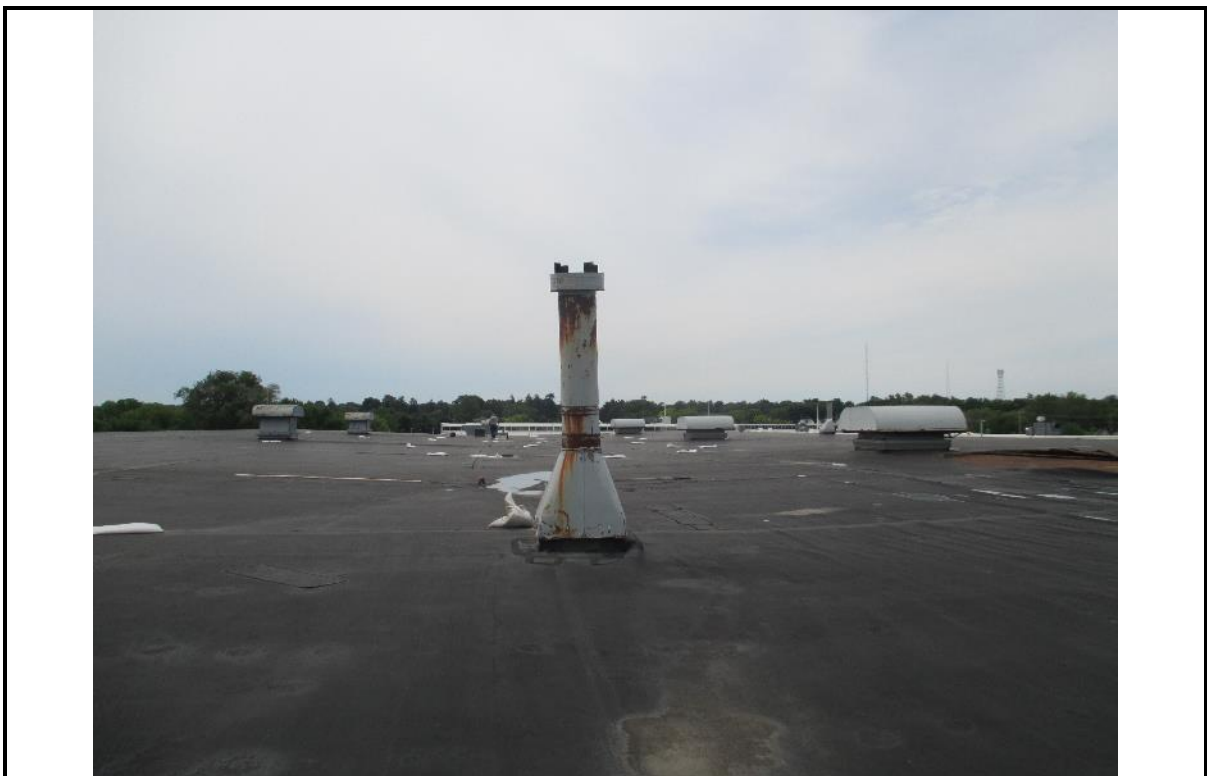
Photo 6: Picture showing the asbestos-containing flashing on the round vent on the north side of the upper roof.

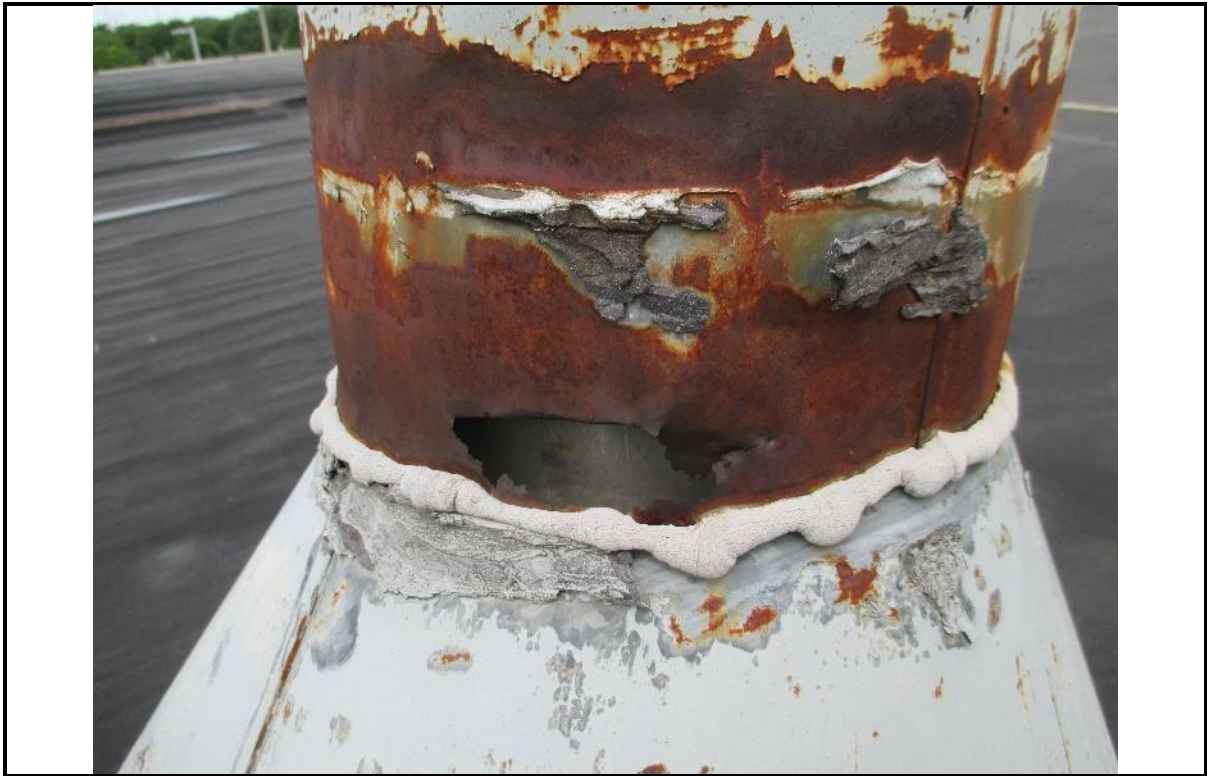
Photo 7: View the asbestos flashing on the north side round vent.

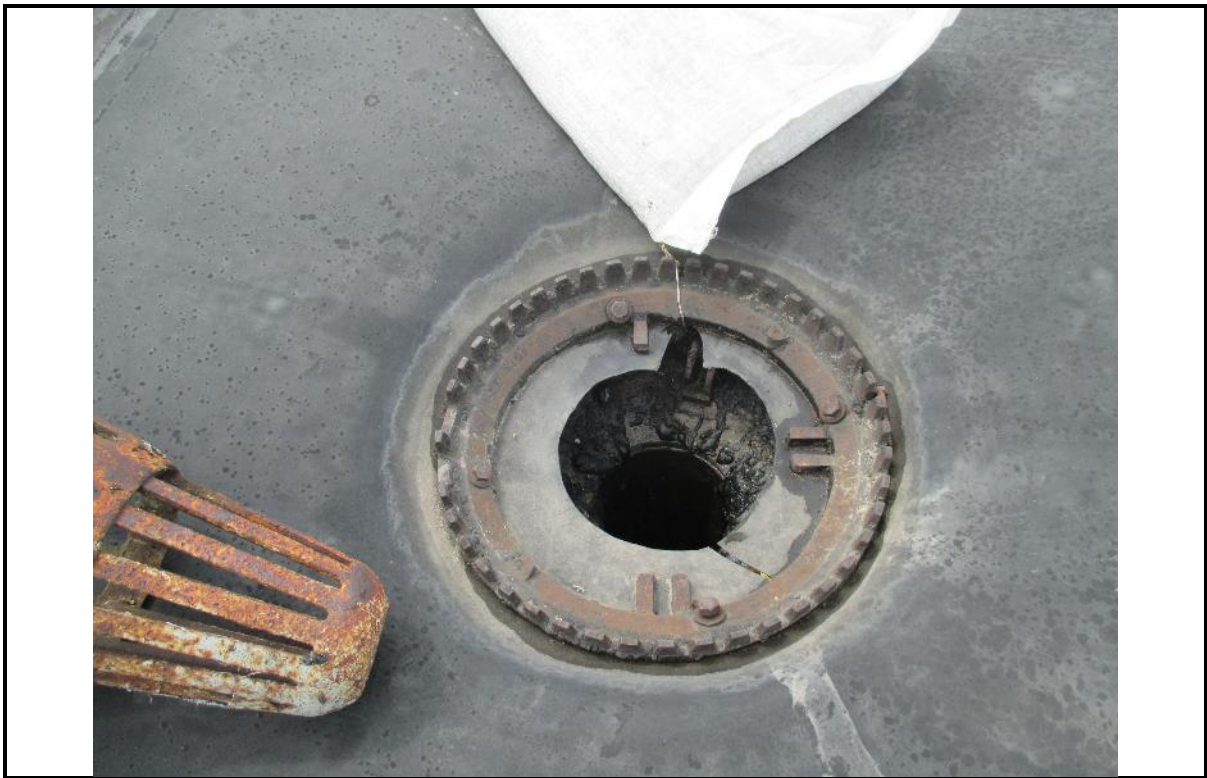
Photo 8: Picture showing the bituminous coating in the upper roof drains.

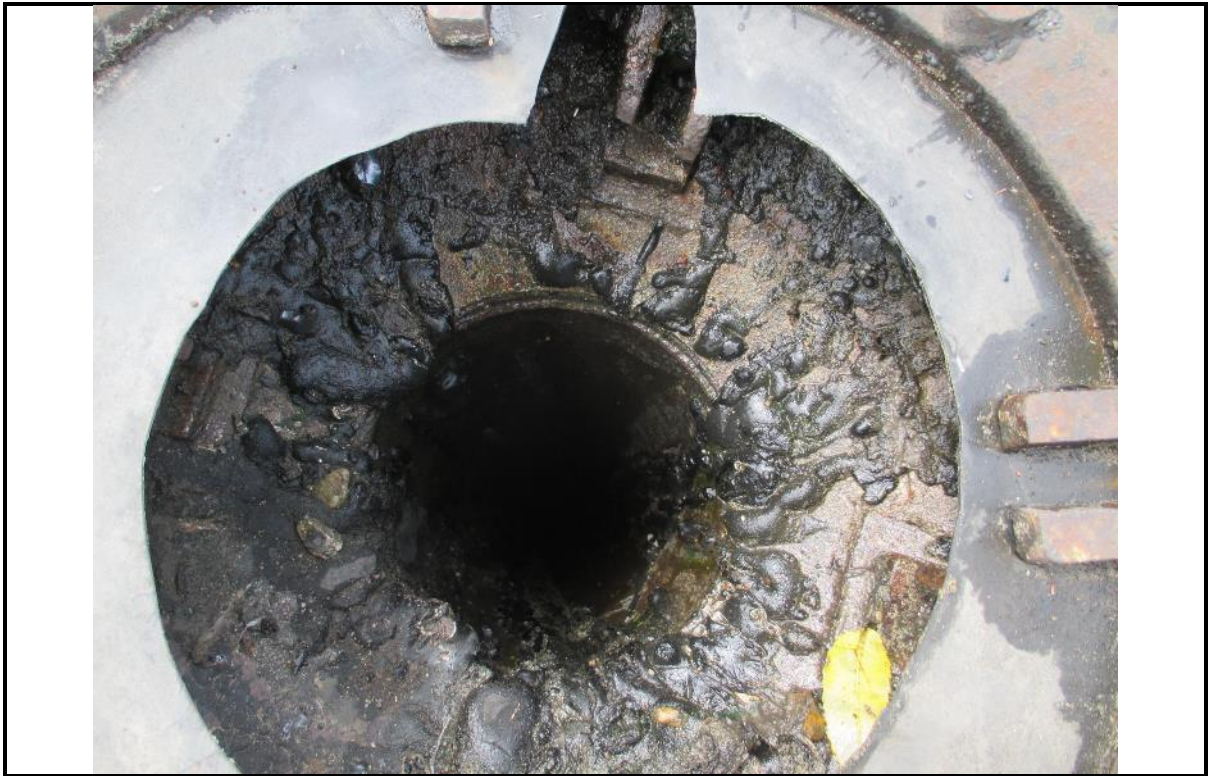
Photo 9: View of the asbestos bituminous coating in the roof drain

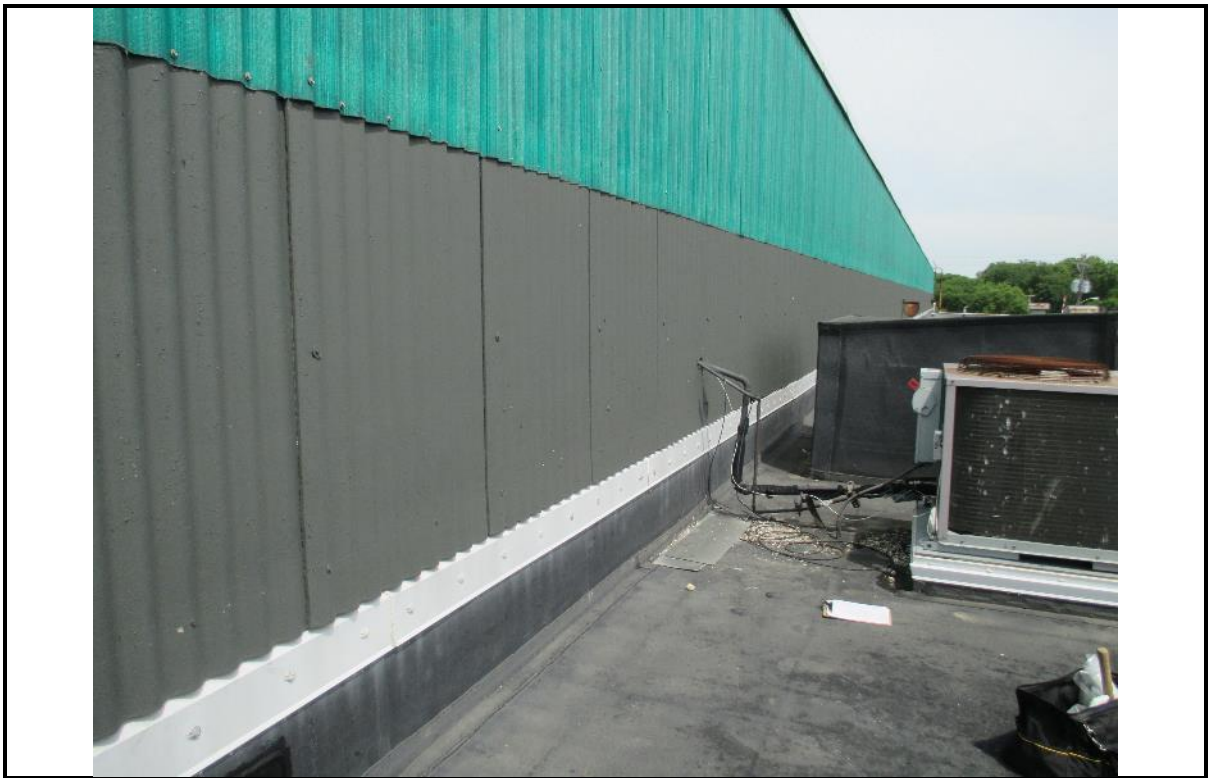
Contractors should also be aware of the corrugated cement asbestos board (Transite™) siding on the building. As part of the Public Works demolition project, laboratory analysis of the corrugated Transite™ siding indicated concentrations of 19% chrysotile (Terracon Project No. 06117036).

Photo 10: Picture of the asbestos cement board siding on the building.
