ENVIRONMENTAL ASSESSMENT REPORT

**City of Cedar Rapids
Hubbard Ice Property
1124 / 1125 1st Street NW
Cedar Rapids, IA**

Project Report Dated: March 5, 2018

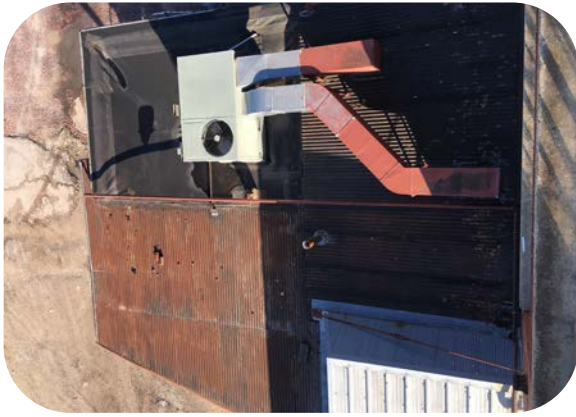
Tar Coated Corrugated
Metal

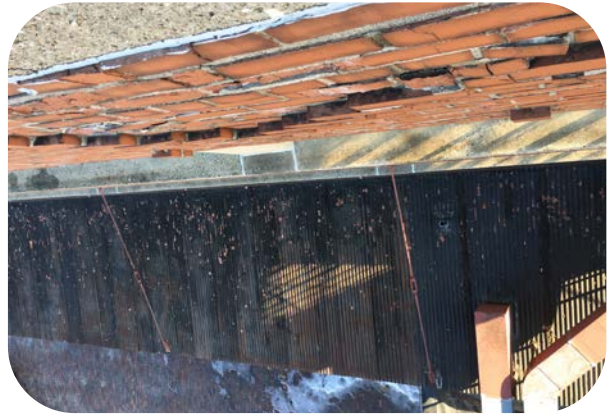
Tar Coated Corrugated
Metal

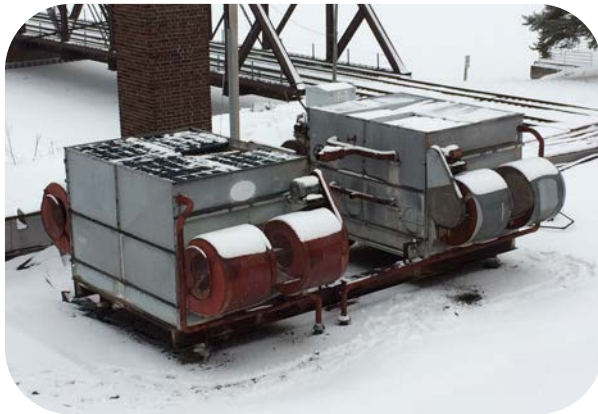
Roof or roofing systems were sampled and included in this report. The mechanical building roof field was determined to be asbestos-containing. The rooftop chiller units on the Mechanical Building Roof have asbestos caulk which seals the exterior metal panels of the units. Contractors shall verify the structural integrity of the roof, parapet walls and roof deck prior to any work. Deterioration of the structure in this area is evident.

Chiller Units (caulk)
Mech. Room Roof

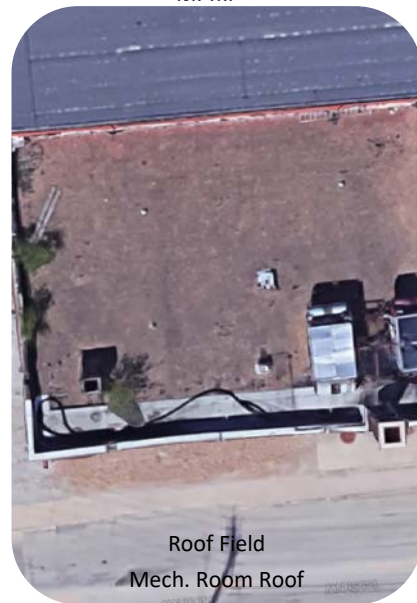
Roof Field
Mech. Room Roof

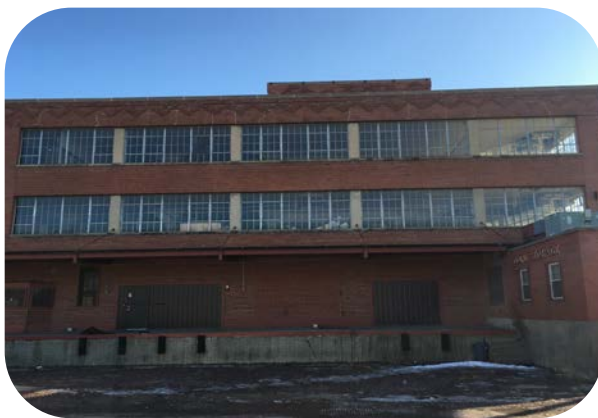
North Elevation Windows
(Caulk & Glazing)

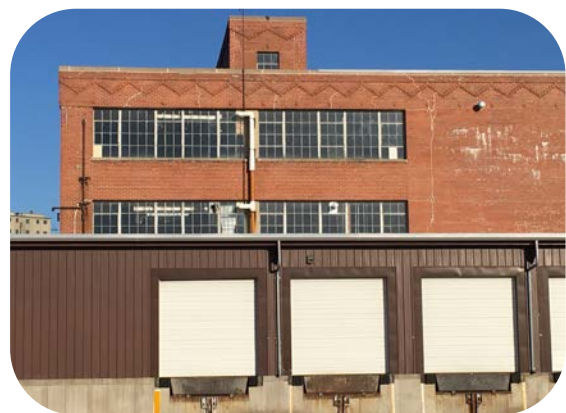
West Elevation Windows
(Caulk & Glazing)

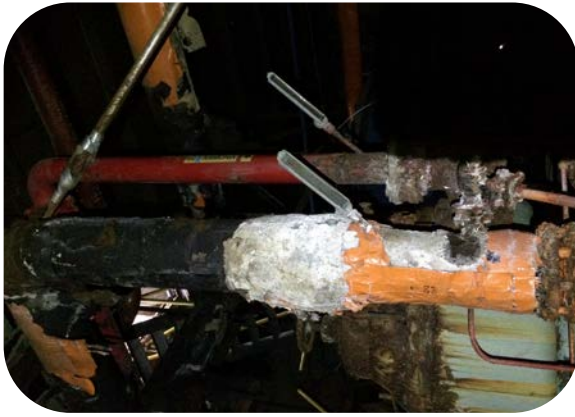
Pipe Insulation & Muddied Fittings (Mech Room)

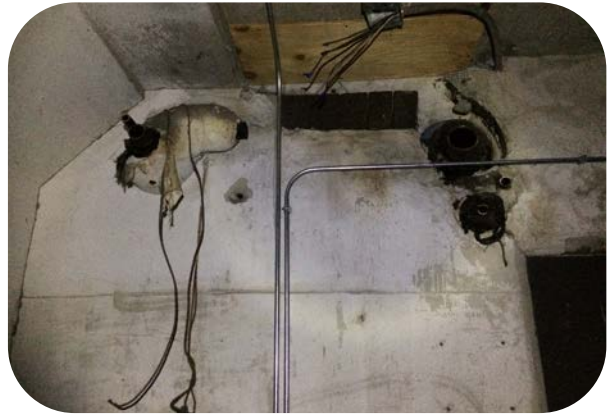
Pipe insulation tar/ mastic (black) in the cold storage areas throughout was determined to be asbestos-containing. This mastic may be present in locations within walls and chases where it was not currently accessible for quantification. The abatement contractor is responsible for demolition necessary to access these materials for removal.

Muddied Fittings & Pipe Mastic (Coolers)

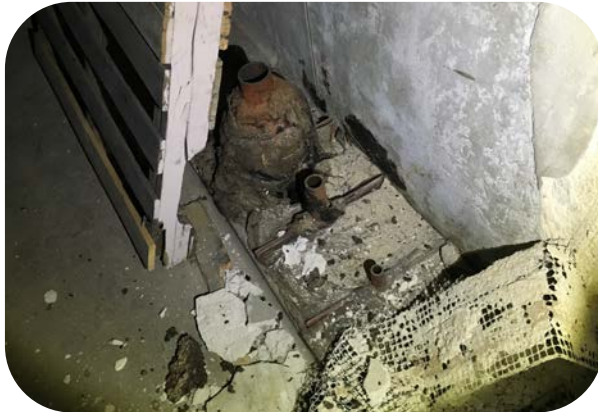
Pipe Mastic (Coolers)

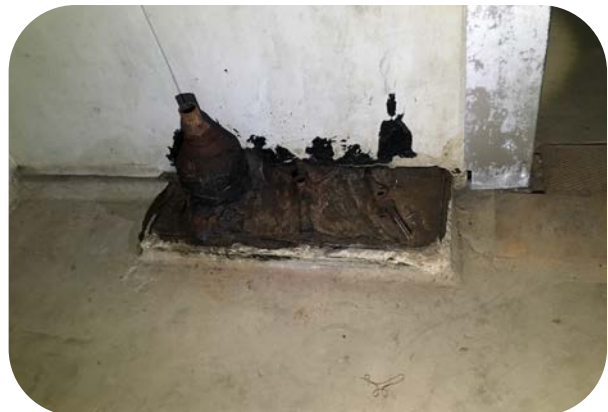
Pipe Mastic (Coolers)

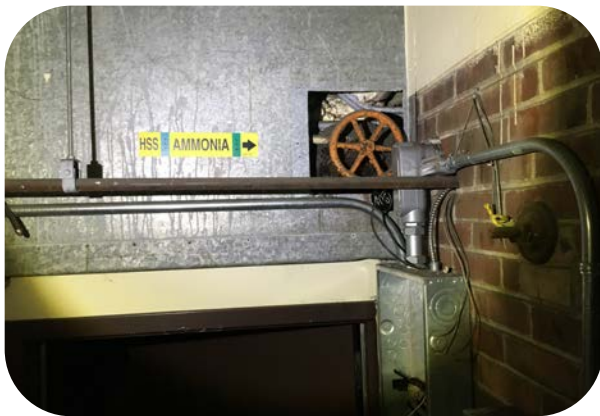
Pipe Mastic (1st Floor Stairwell)

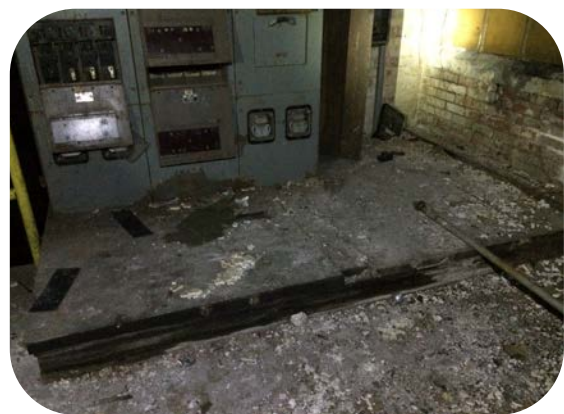
Transite Floor Panel (Mech. Bldg.)

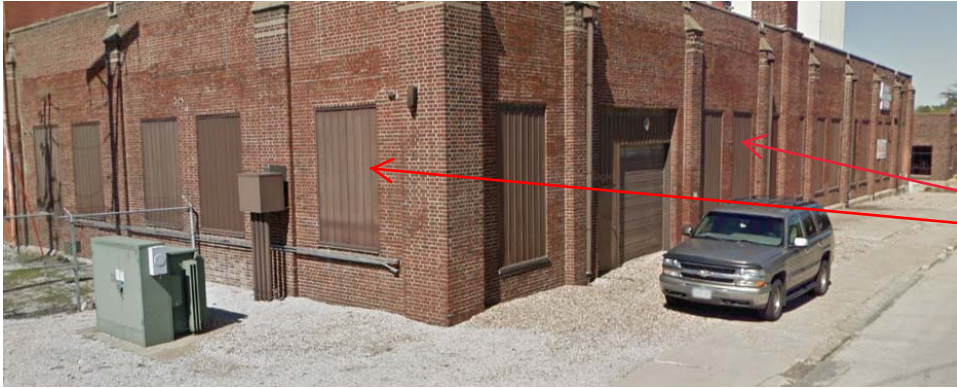
Window Caulk & Glazing
Mechanical Building
(Beneath Metal Panels)

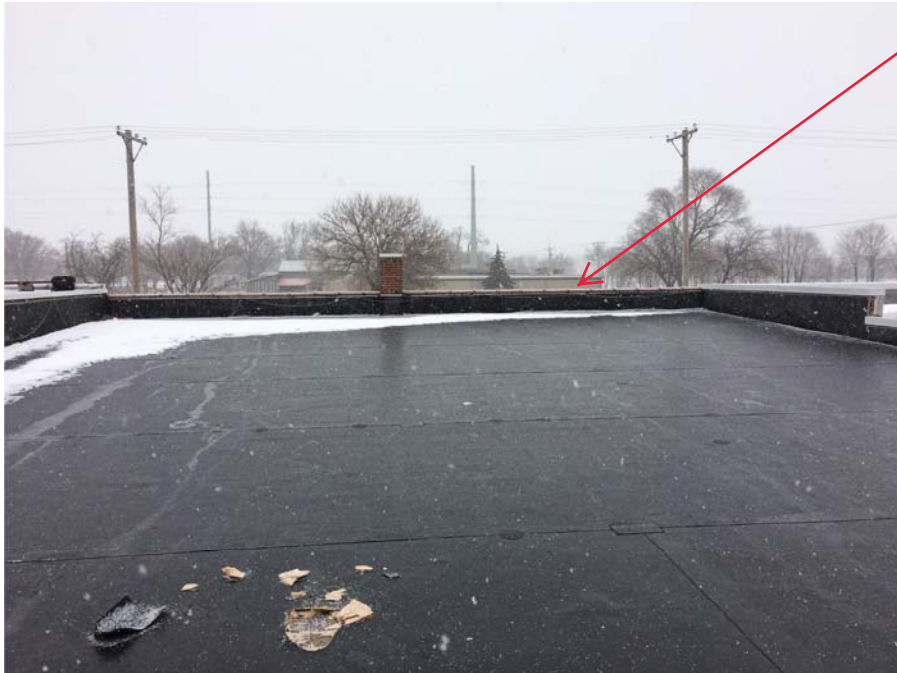
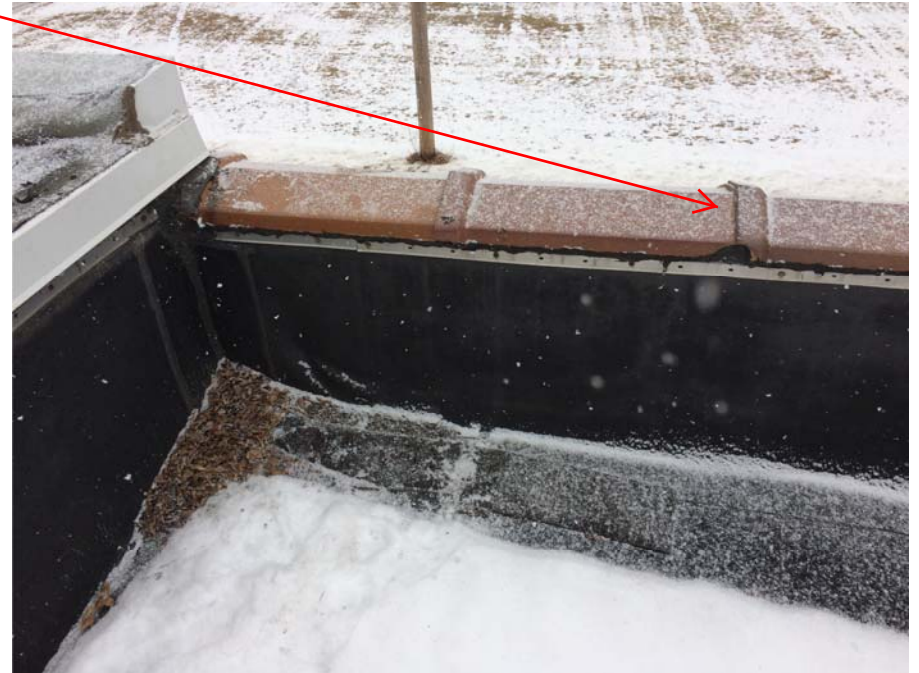
Storage 1 -
Parapet Wall Tar

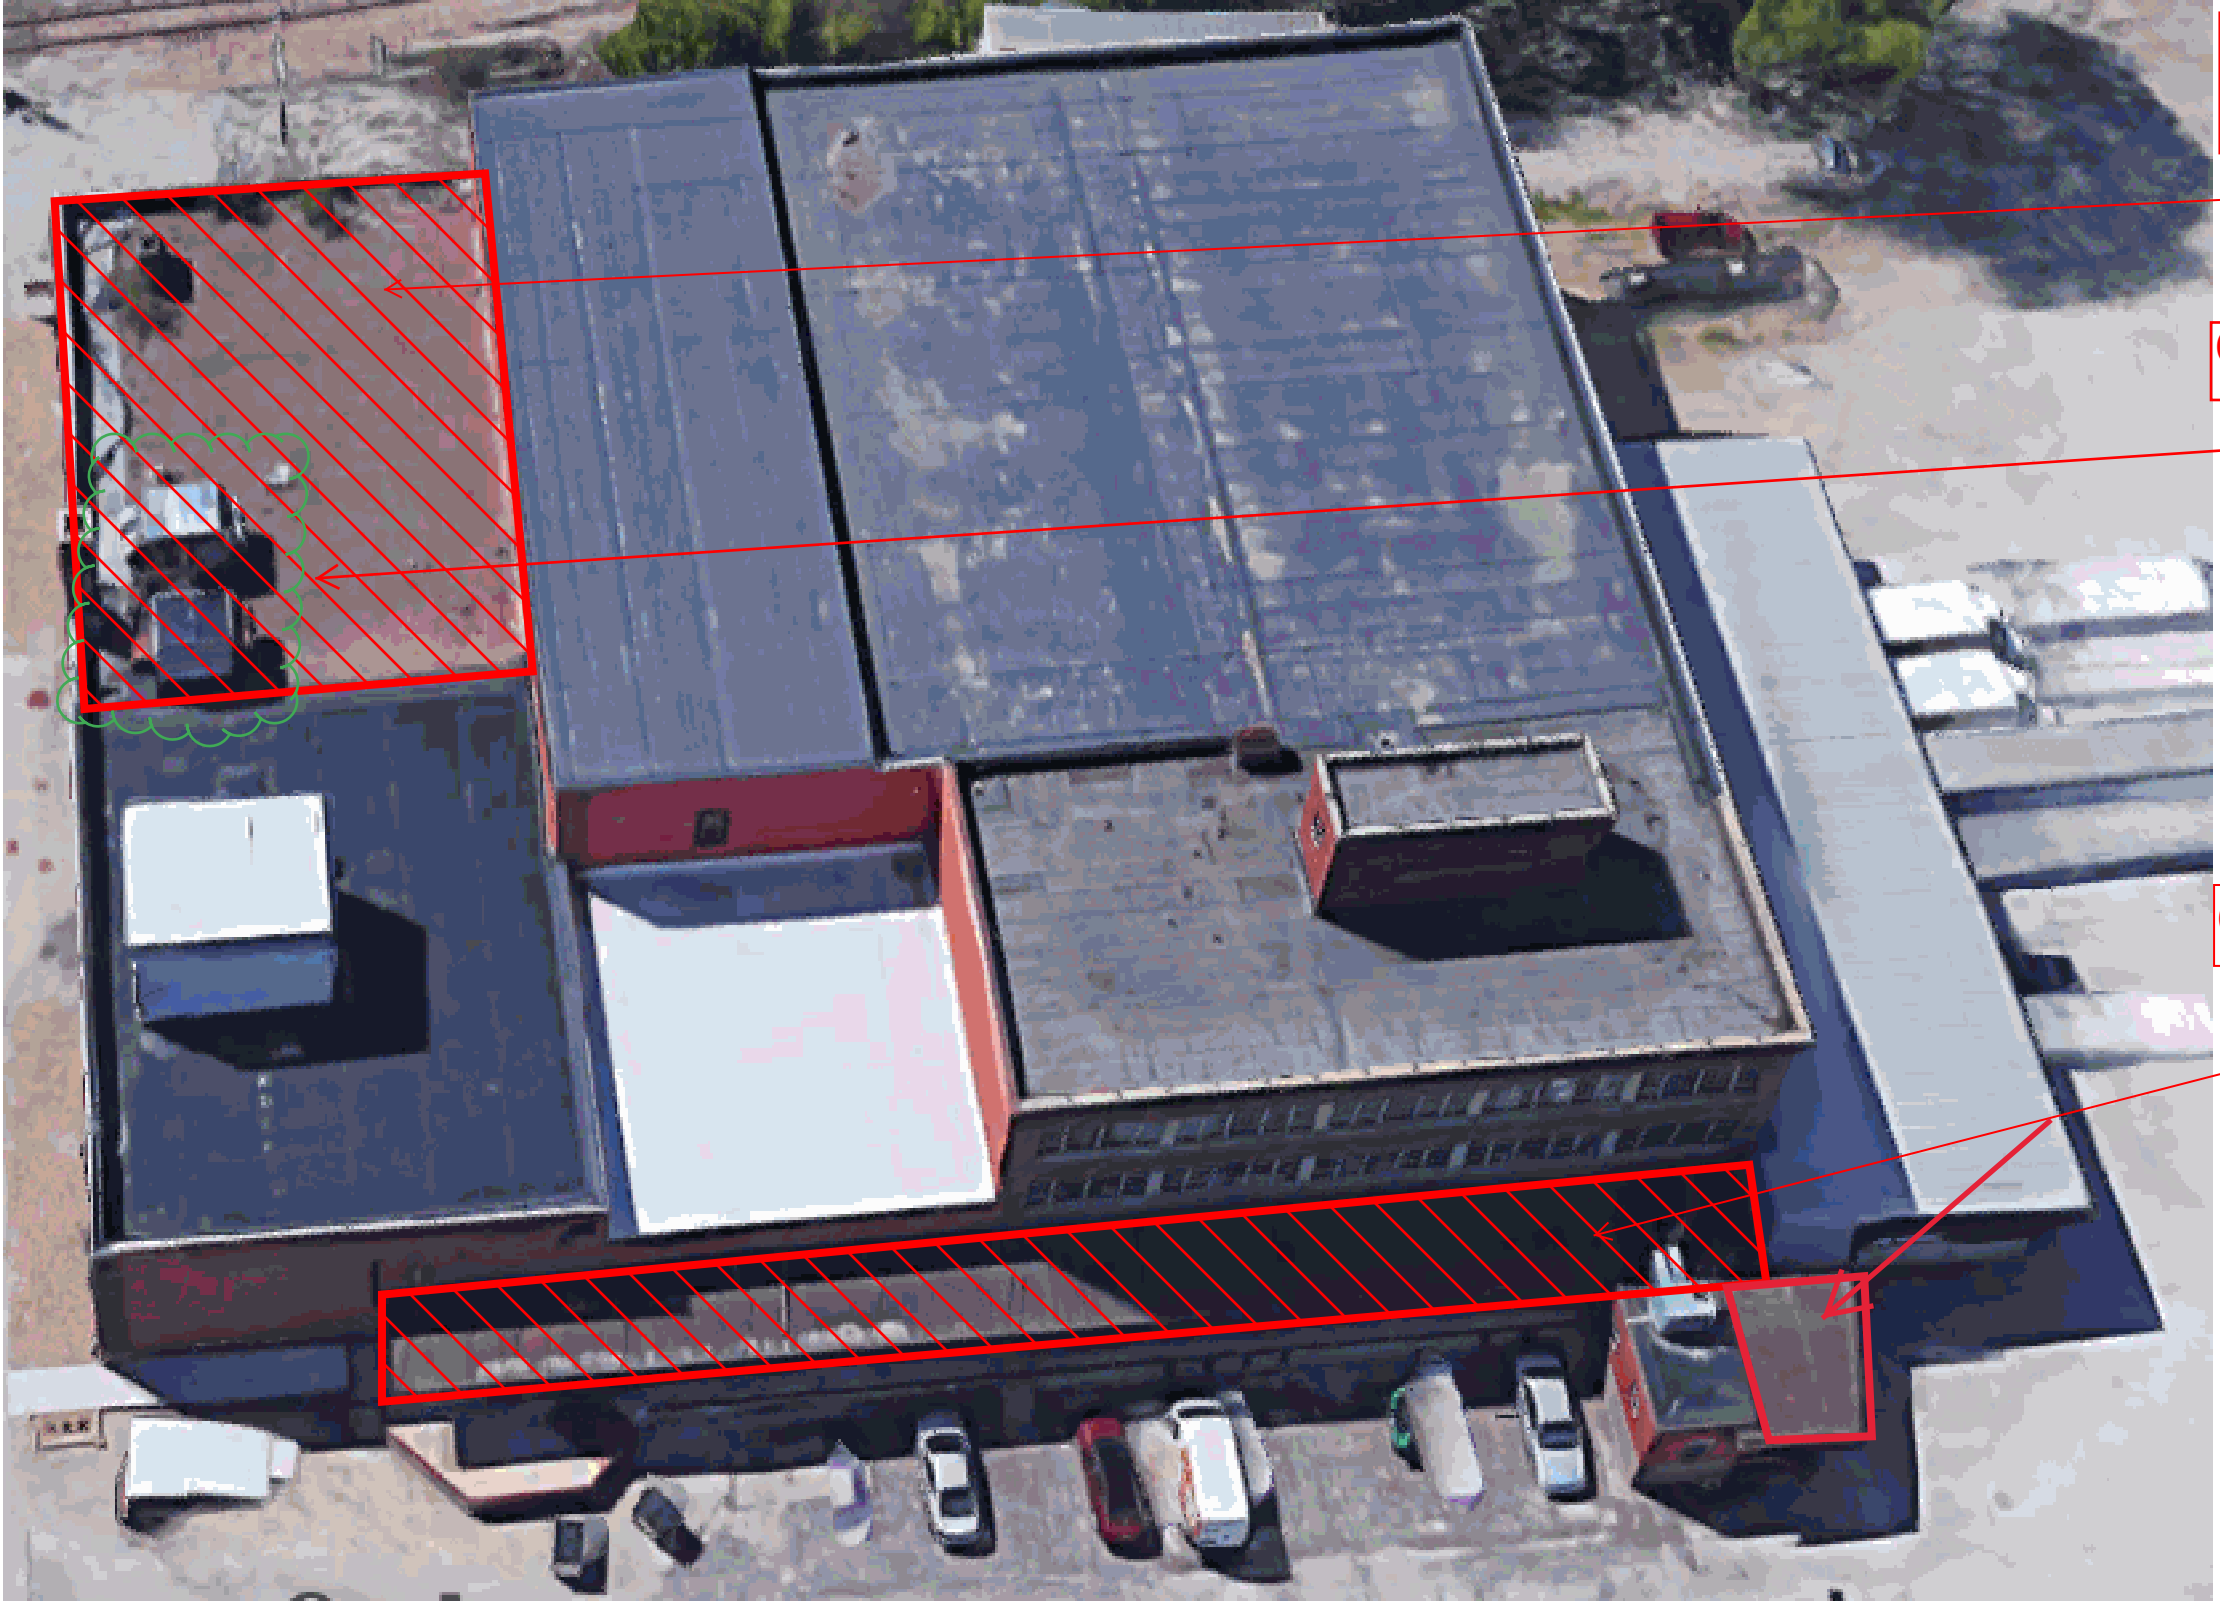
Built-Up Roofing
(Mech. Bldg. Roof)

Cooling Towers

Corrugated Metal with Tar
