# WHY SHOULDN'T I REPLACE MY WINDOWS?

## The Repair of Historic Wooden Windows

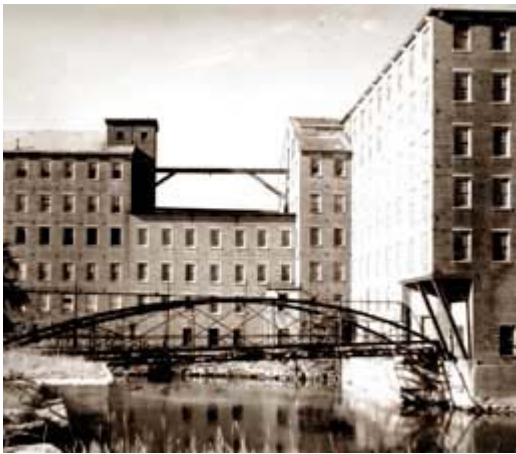
Windows are frequently important visual focal points, especially on simple facades such as this mill building. Replacement of the multi-pane windows with larger panes could dramatically alter the appearance of the building. Photo: NPS files.

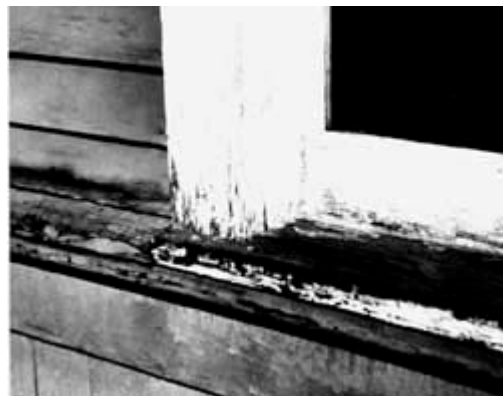
Deterioration of poorly maintained windows usually begins on horizontal surfaces and at joints, where water can collect and saturate the wood. Photo: NPS files.

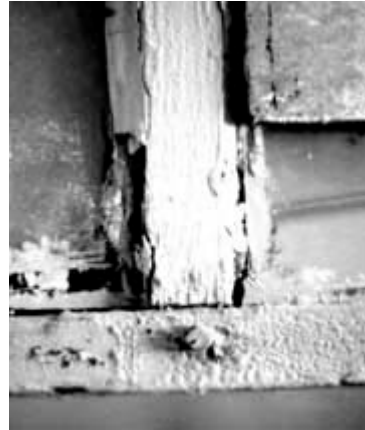
This historic double-hung window has many layers of paint, some cracked and missing putty, slight separation at the joints, broken sash cords, and one cracked pane. Photo: NPS files.

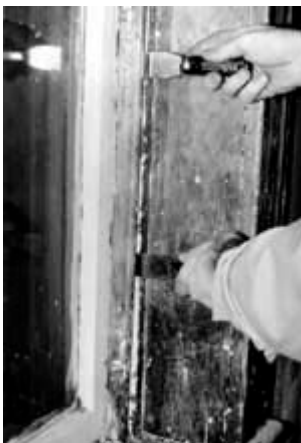
After removing paint from the seam between the interior stop and the jamb, the stop can be pried out and gradually worked loose using a pair of putty knives as shown. Photo: NPS files.

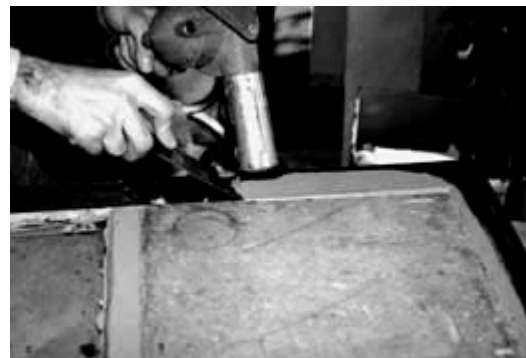
Sash can be removed and repaired in a convenient work area. Paint is being removed from this sash with a hot air gun. Photo: NPS files.

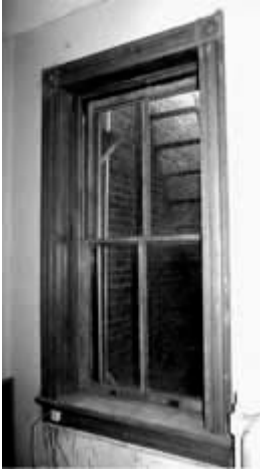
Following the relatively simple repairs, the window is weathertight, like new in appearance, and serviceable for many years to come. Photo: NPS files.

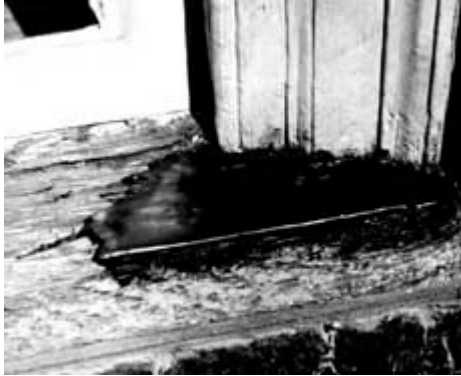
**This illustrates a two-part epoxy patching compound used to fill the surface of a weathered sill and rebuild the missing edge. When the epoxy cures, it can be sanded smooth and painted to achieve a durable and waterproof repair. Photo: NPS files.**

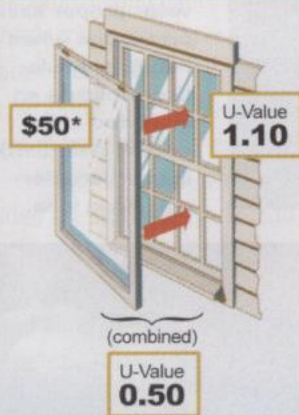
U-Value = A measure of air-to-air heat transmission (loss or gain) due to thermal conductance and the difference in indoor and outdoor temperatures

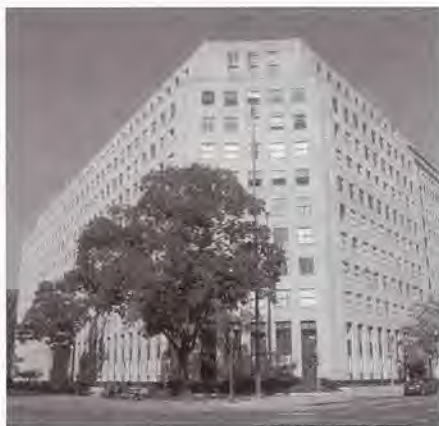
Fig. 1. Southwest elevation, Lafayette Building, Vermont Avenue and H Street NW, Washington, D.C. The building's neoclassical exterior has regularly placed, double-hung steel windows. All images by authors.

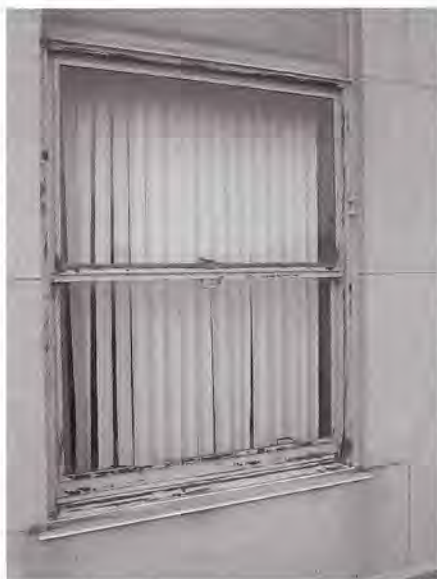
Fig. 2. View of an unrepaired steel-framed window on the east elevation of the Lafayette Building. Note the loss of paint coatings and corrosion of the built-up steel frame.

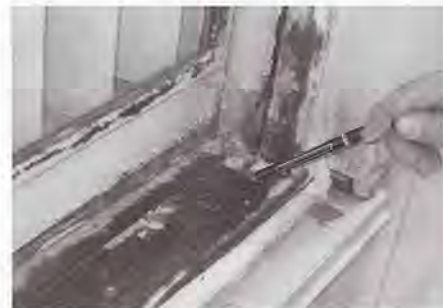
Fig. 3. View of a steel window sill on the east elevation of the eleventh floor. Note the significant corrosion of the steel frame at the sill-to-jamb corner.

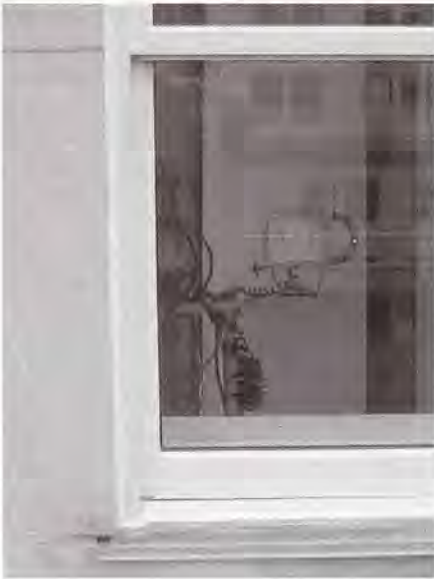
Fig. 4. Sill of the replacement window.

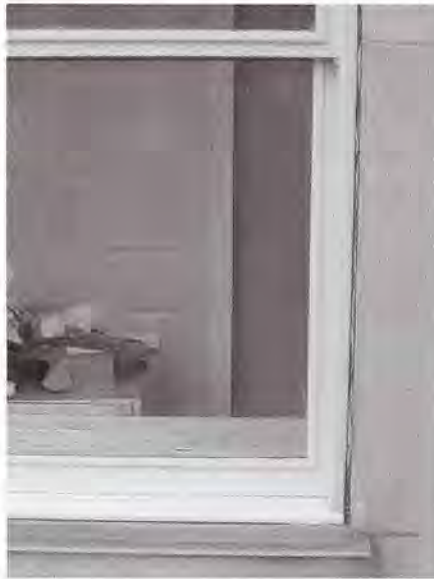
Fig. 5. Sill of the repaired window.

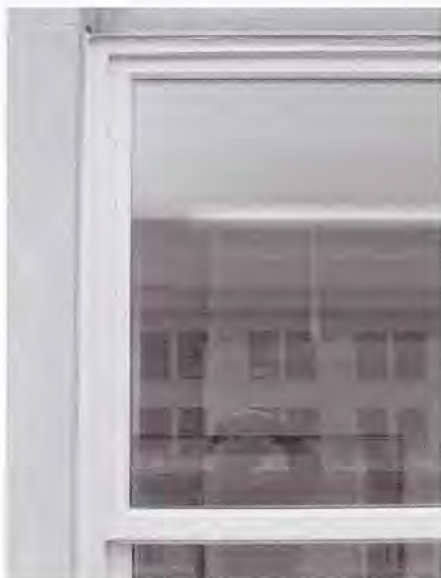
Fig. 6. Head of the replacement window.

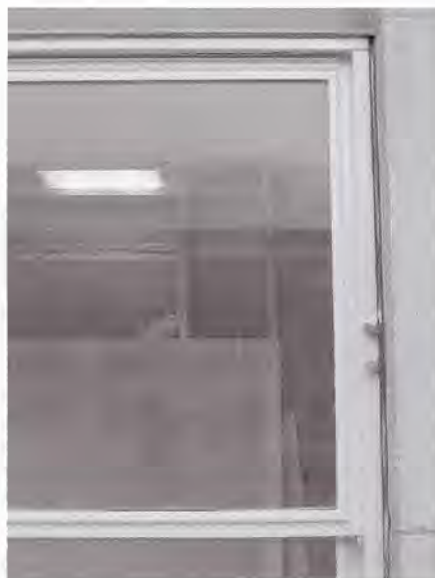
Fig. 7. Head of the repaired window. Note the similar sight lines but missing articulations and accessories of the replacement window when viewed in conjunction with the repaired window.

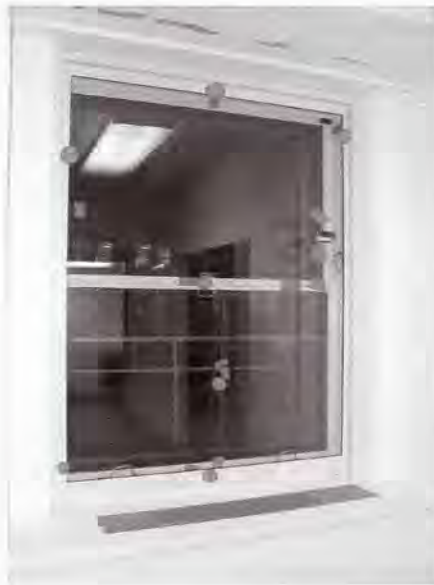
Fig. 8. Interior view of the repaired window prior to installation of the interior chamber. Note the thermal and relative-humidity sensors are indicated with dots. Some sensors are installed on the repaired window, and others are installed on the storm sash, resulting in more sensor locations than on the replacement window.

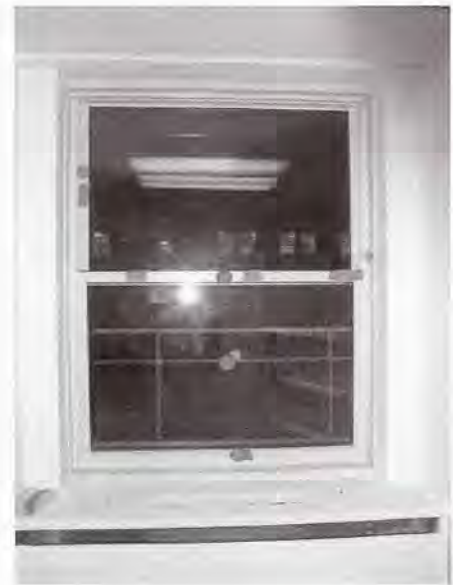
Fig. 9. View of the replacement-window mock-up prior to the installation of the interior chamber. The temperature sensors are indicated with dots.

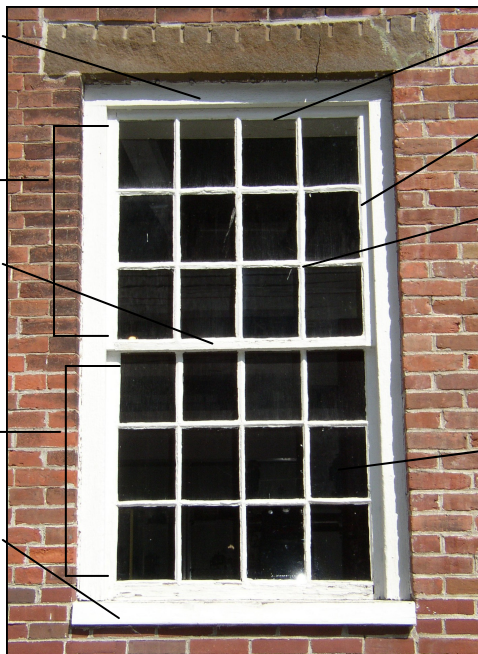
A c. 1846 wood window in the former Robbins and Lawrence Armory, now the American Precision Museum in Windsor, VT.

**Sill** (exterior, horizontal piece at the bottom of the window frame, commonly wood, stone, or brick)

**Stool** (interior shelf-like board at the bottom of a window against which the bottom rail of the sash rests)

**Rail** (horizontal part of sash)

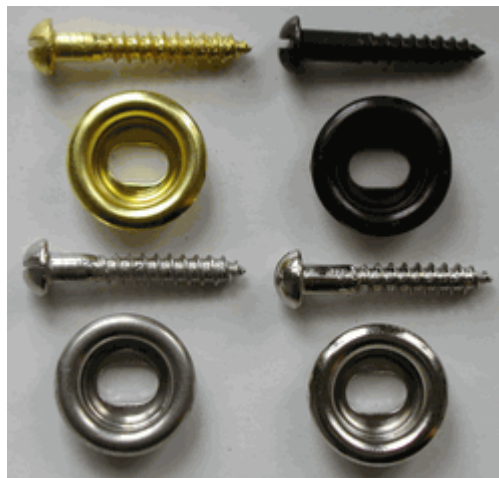
## Stop Bead Adjuster

A solid brass stop bead adjuster for mounting removable window stops. The slotted screw hole permits 1/8" of lateral adjustment.
