**Architectural Reconnaissance Survey
for Beverly Hill Additions
to Cedar Rapids
(57-090)**

Linn County, Iowa

**The Louis Berger Group, Inc.
950 50th Street
Marion, Iowa 52302**

June 25, 2009

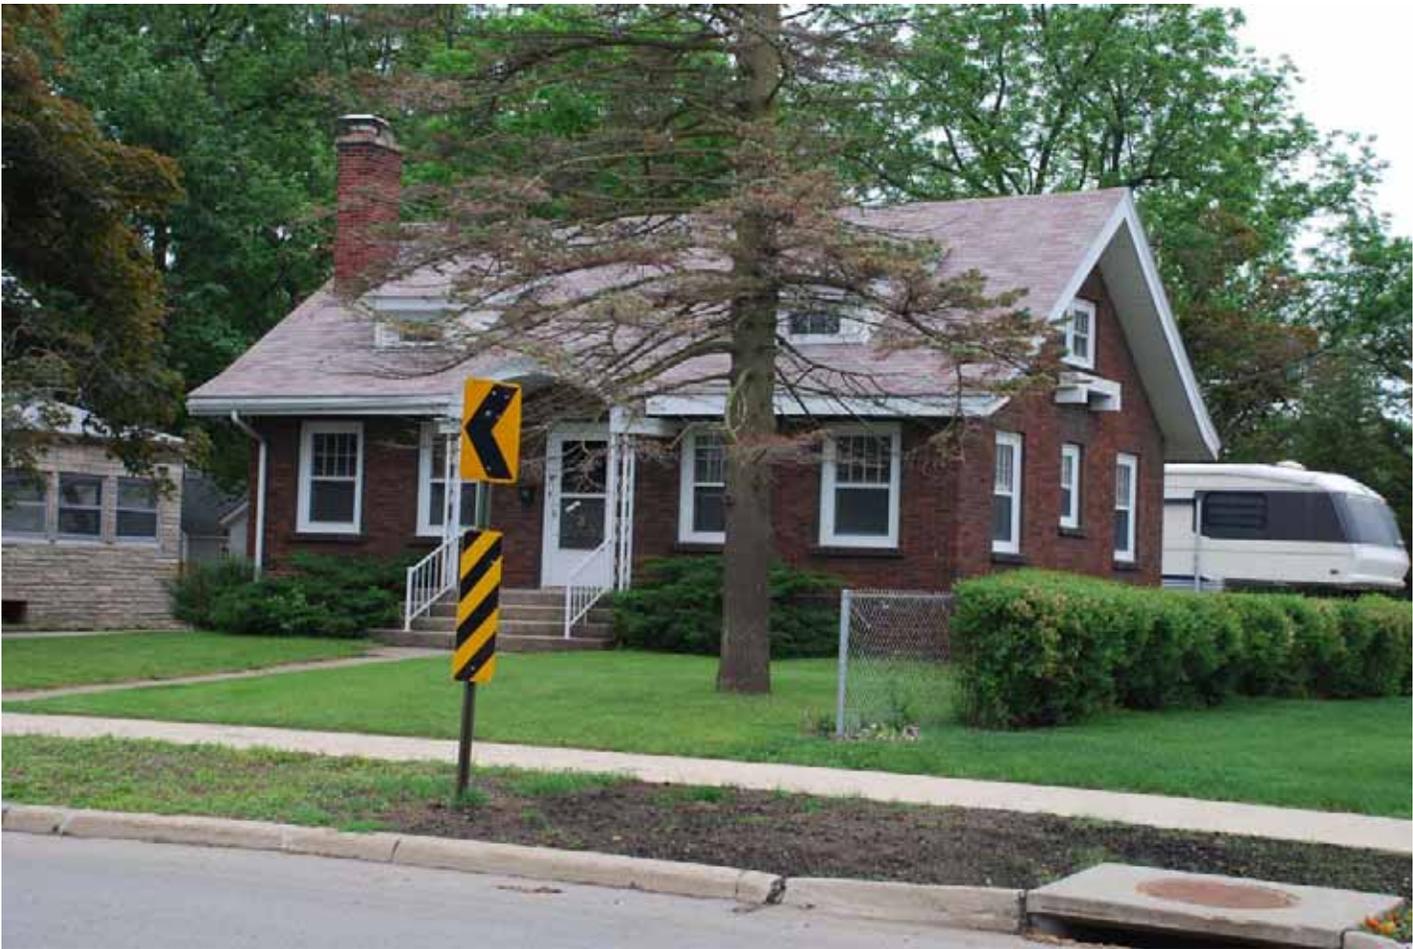
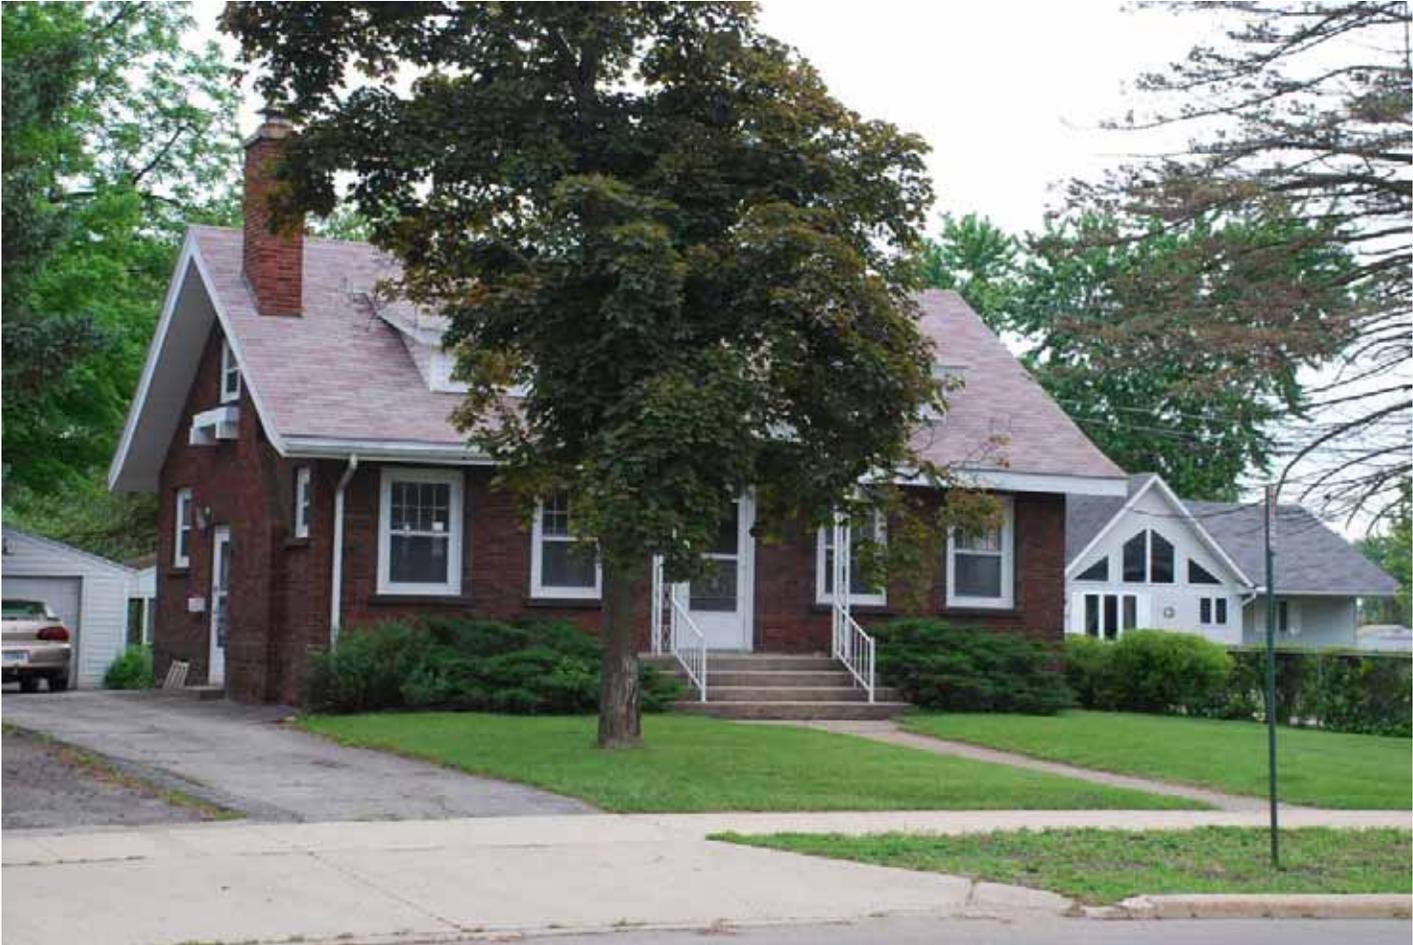
1815 Ellis Blvd NW_View NE.jpg

1815 Ellis Boulevard NW (1923) – This 1 ½-story, five-bay brick Craftsman-style dwelling has a side gable asphalt shingle roof with projecting eaves and two shed roof front dormers. The central front entrance is comprised of a single-leaf entrance door accessed from a one-bay portico with an arched roof supported by decorative metal posts. Three concrete steps with metal vertical picket handrails lead to the poured concrete portico floor. The majority of the windows in the house are 8/1 double-hung wood sash windows with exterior storm windows. The windows in the dormers appear to be three-light awning windows, while the windows in the second story at the gable ends appear to be 4/1 double-hung. The brick exterior is laid in a common bond pattern and there is a large rectangular interior brick end chimney at the northern end of the house. The shouldered chimney projects out two wythes deep from the north elevation, which also contains a side entrance. There is a vinyl-clad front gable wood frame garage located at the end of the concrete driveway at the rear of the property. The house retains a high level of architectural integrity and may potentially be eligible under Criterion C, as it represents the rare use of brick masonry in a Craftsman-style dwelling in Cedar Rapids - where most buildings of this style are of wood frame construction.

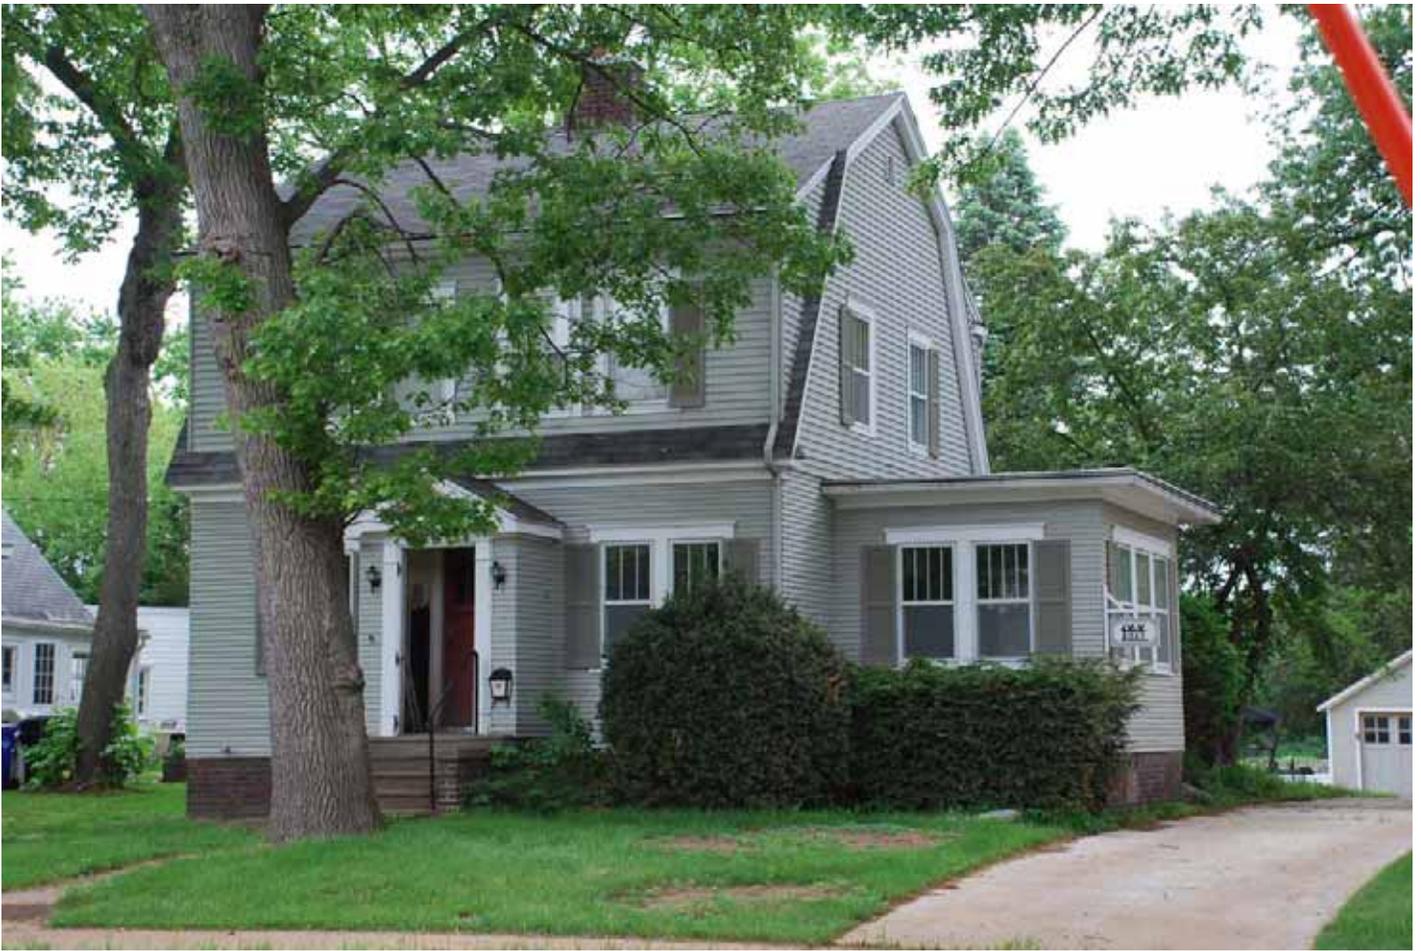
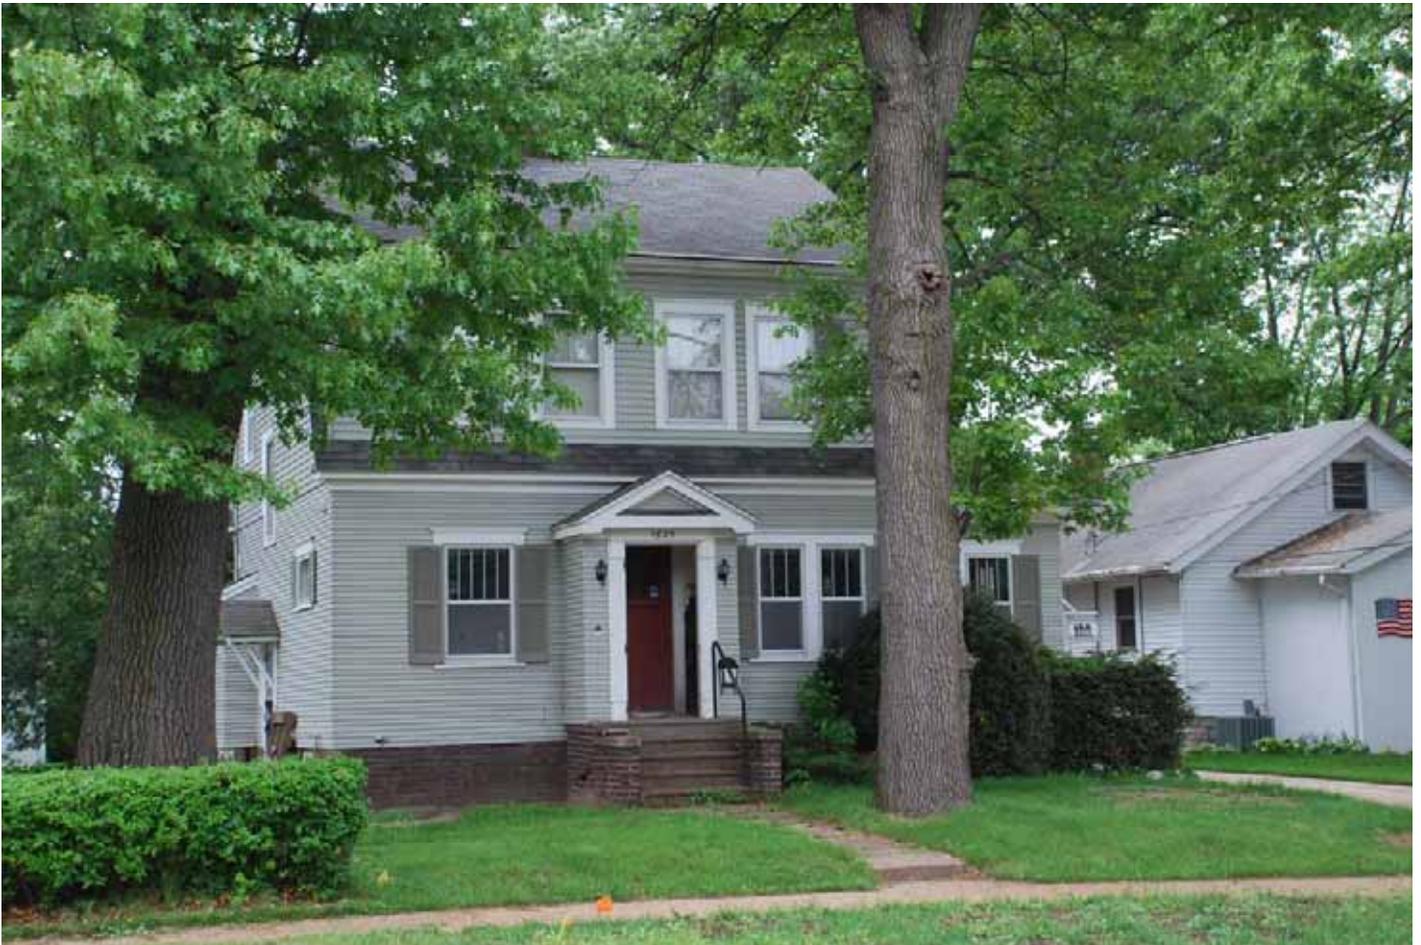
1825 Ellis Blvd NW_View NE.jpg

1825 Ellis Boulevard NW (1923) – This two-story wood frame Dutch Colonial Revival dwelling has a side-facing asphalt shingle gambrel roof with a central brick chimney and full-width shed roof front and rear dormers. The foundation is brick and the siding appears to be either vinyl or aluminum; however, the width of the siding varies between the first and second stories, with a notably smaller reveal at the first story. Although the entrance is centered on the main façade, the window configuration is asymmetrical and the house features 5/1, 4/1, paired 4/1, and paired 3/1 double-hung wood sash windows flanked by louvered wood shutters. The central entrance consists of a partially enclosed one-bay portico with a front gable roof, and the single-leaf entrance door is a Craftsman-style 6-light wood door. There is a one-story flat-roofed addition on the south elevation and a side entrance on the north elevation. The side entrance is covered with a projecting front gable roof with angle brackets. The house retains a high level of architectural integrity and may potentially be eligible under Criterion C, as a well-preserved example of a single dwelling constructed in the Dutch Colonial Revival style. This style is fairly rare in Cedar Rapids and especially in this particular neighborhood, which is dominated by working class vernacular dwellings.

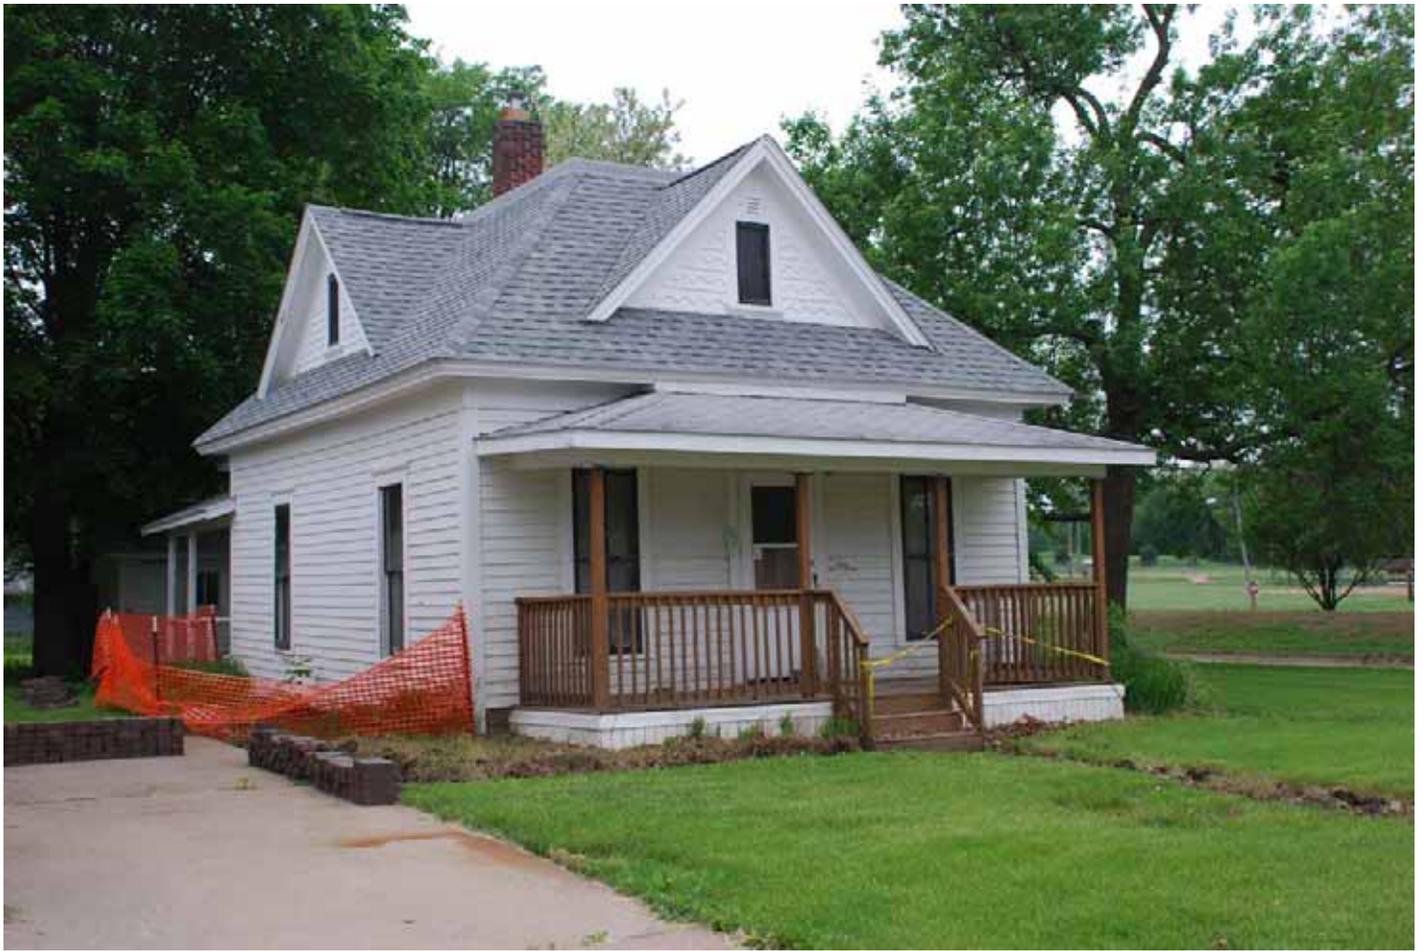
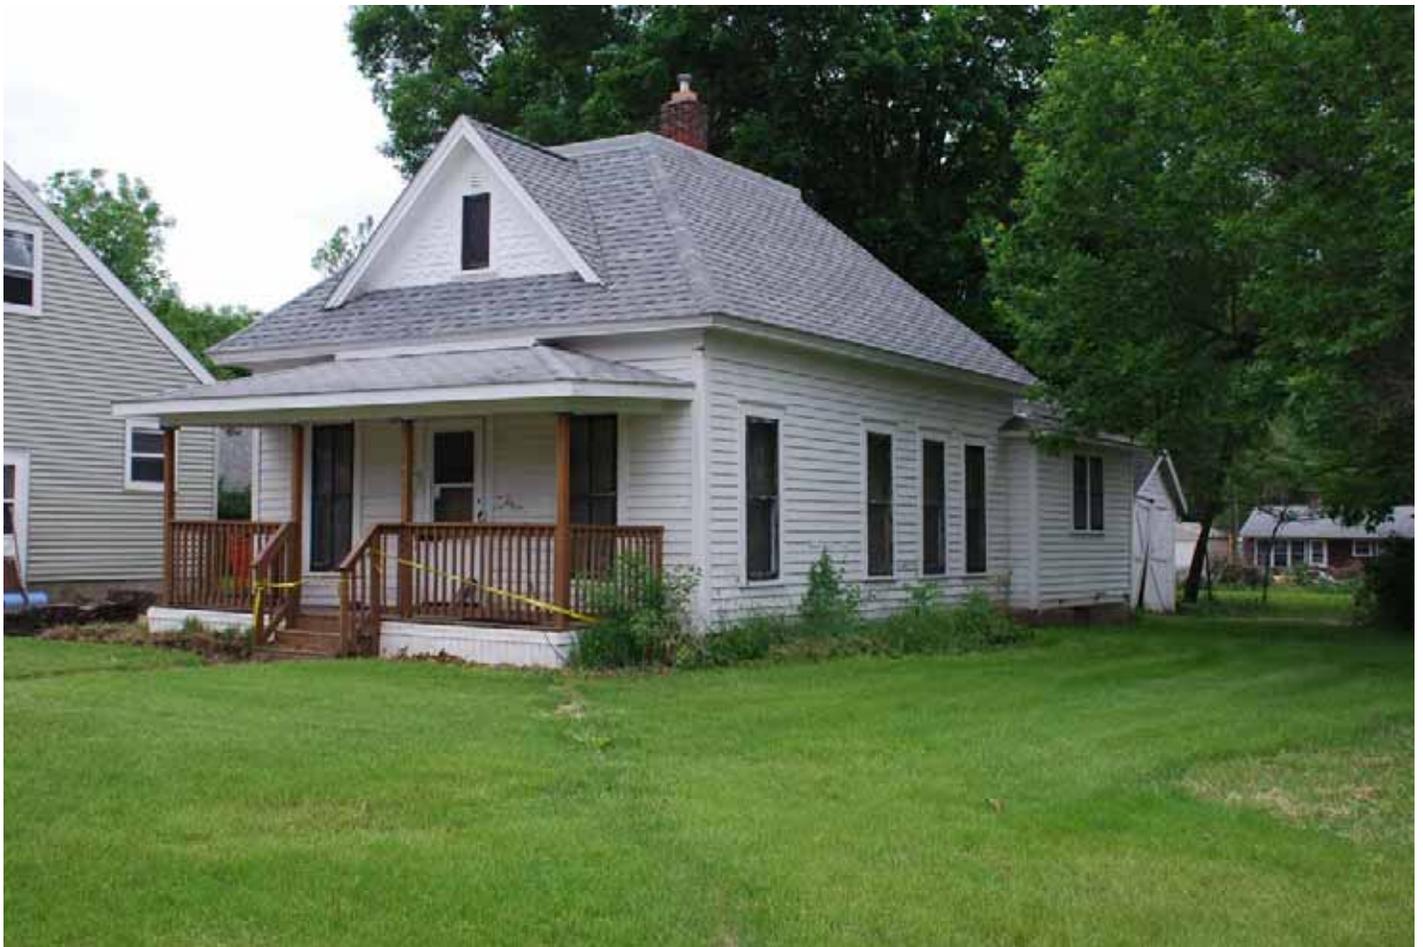
1884 Ellis Blvd NW_View NW.jpg

1884 Ellis Boulevard NW (1895) – This vernacular, 1 ½ story hipped roof house has a hipped roof open porch with modern posts and railing, clapboard siding, original 1/1 wood windows and storms, gable front dormers with shingle siding, and a rear hipped roof addition. Although the original porch that consisted of tapered round columns and simple railing has been replaced, the house still retains a high degree of integrity of workmanship, materials, feeling, and association. Despite the alteration, the house is still potentially eligible under Criteria A for its significant association to the early residential development of the northern sections of Ellis Boulevard. If the porch were to be more sympathetically constructed, the house would be an excellent example of a vernacular hipped roof cottage that was less commonly built in the area around the turn of the century.
