**Architectural Reconnaissance Survey
for Brown's Additions
to Cedar Rapids
(57-085)**

Linn County, Iowa

**June 2, 2009
Revised March 10, 2010**

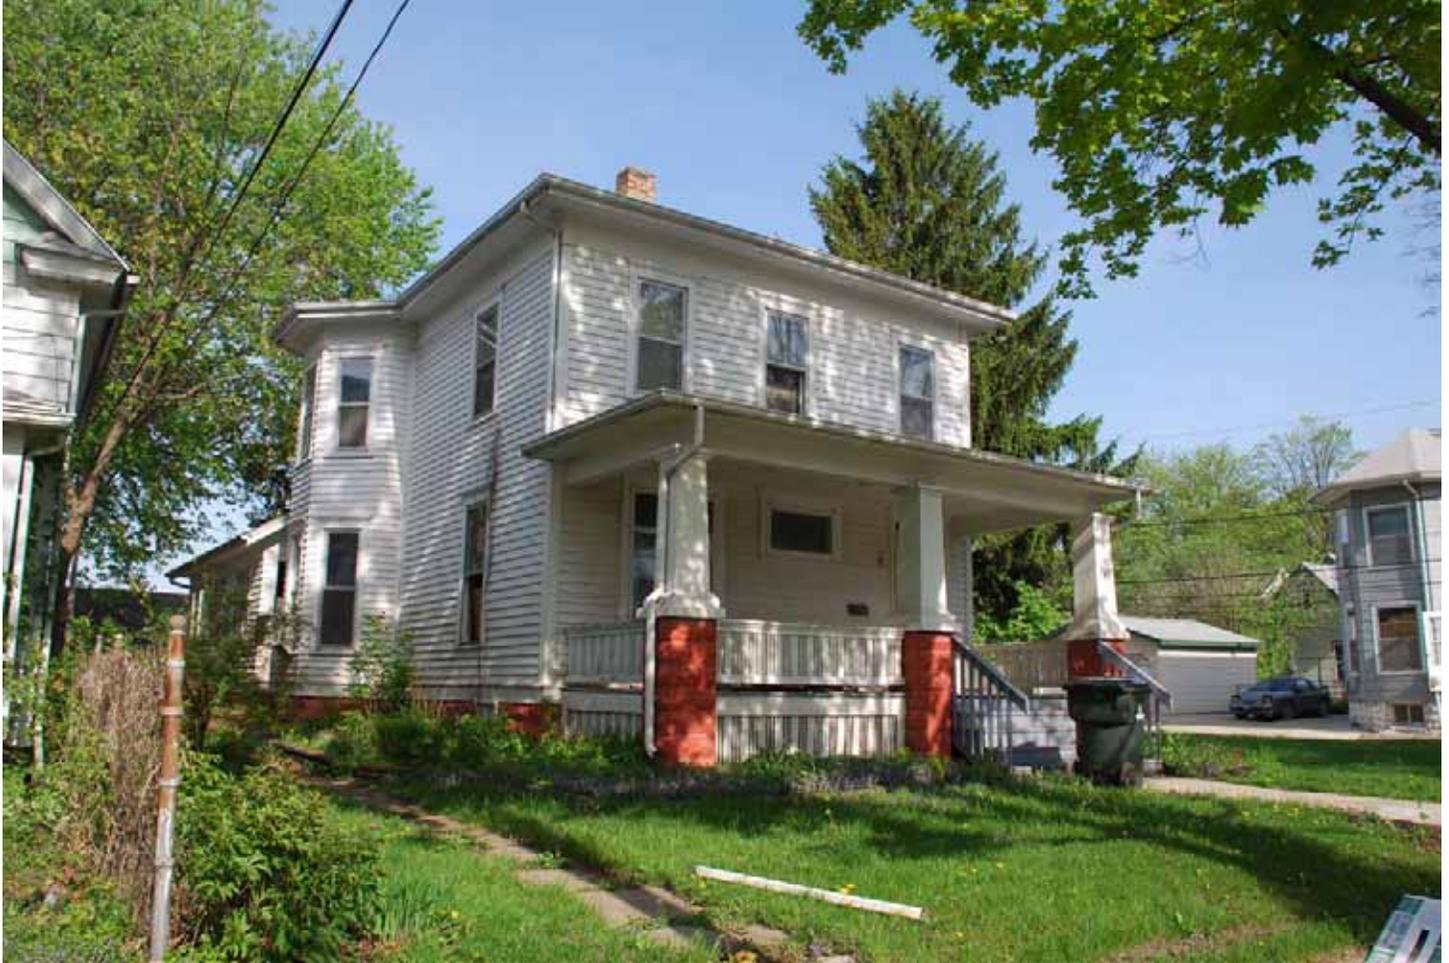
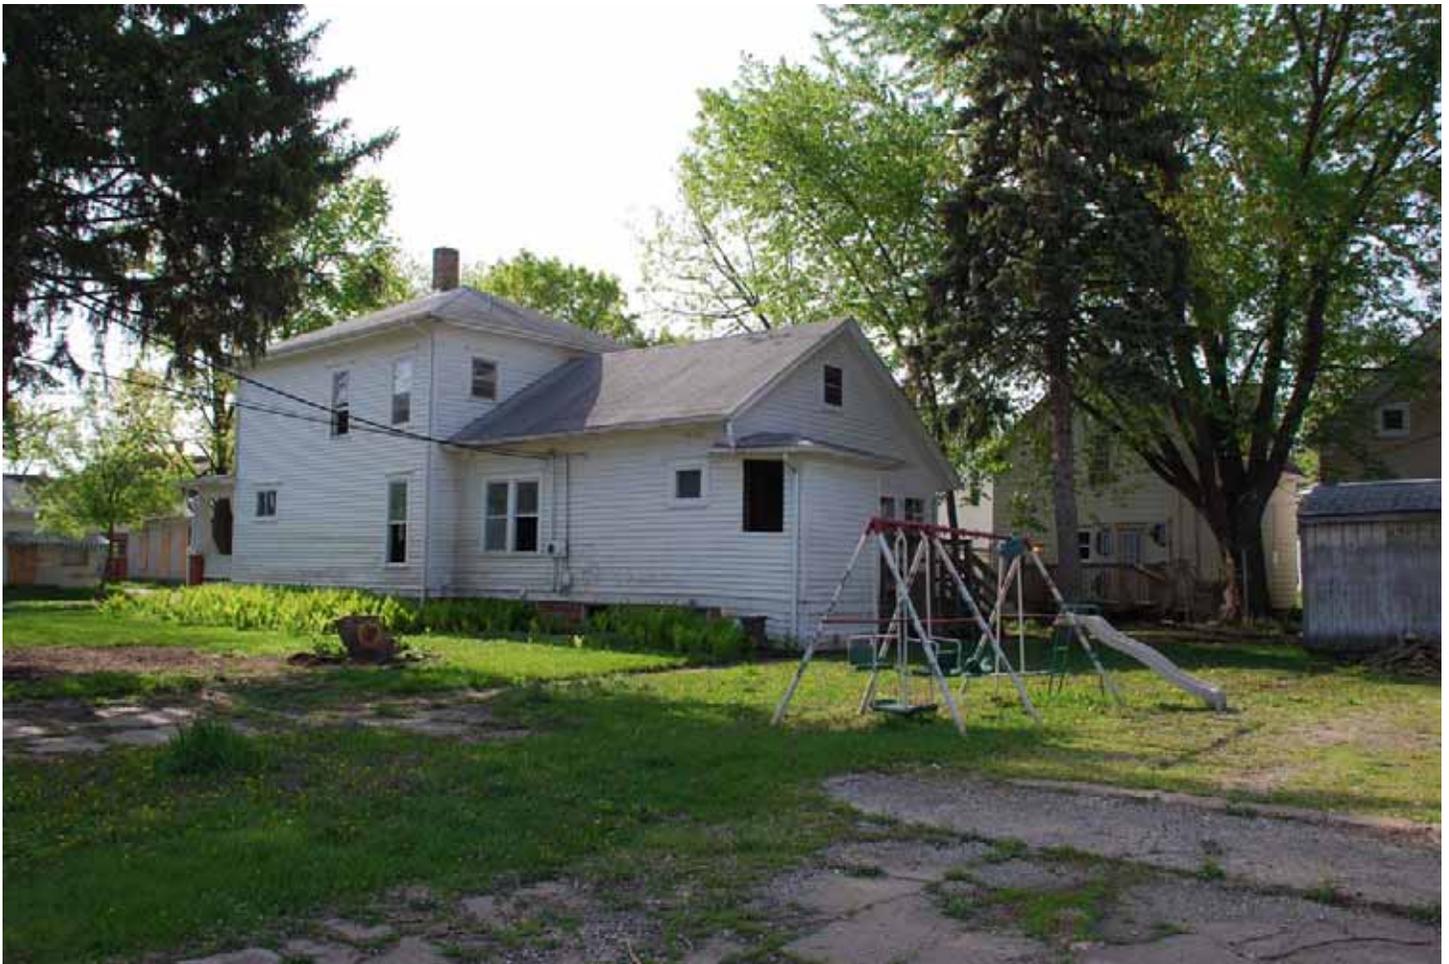
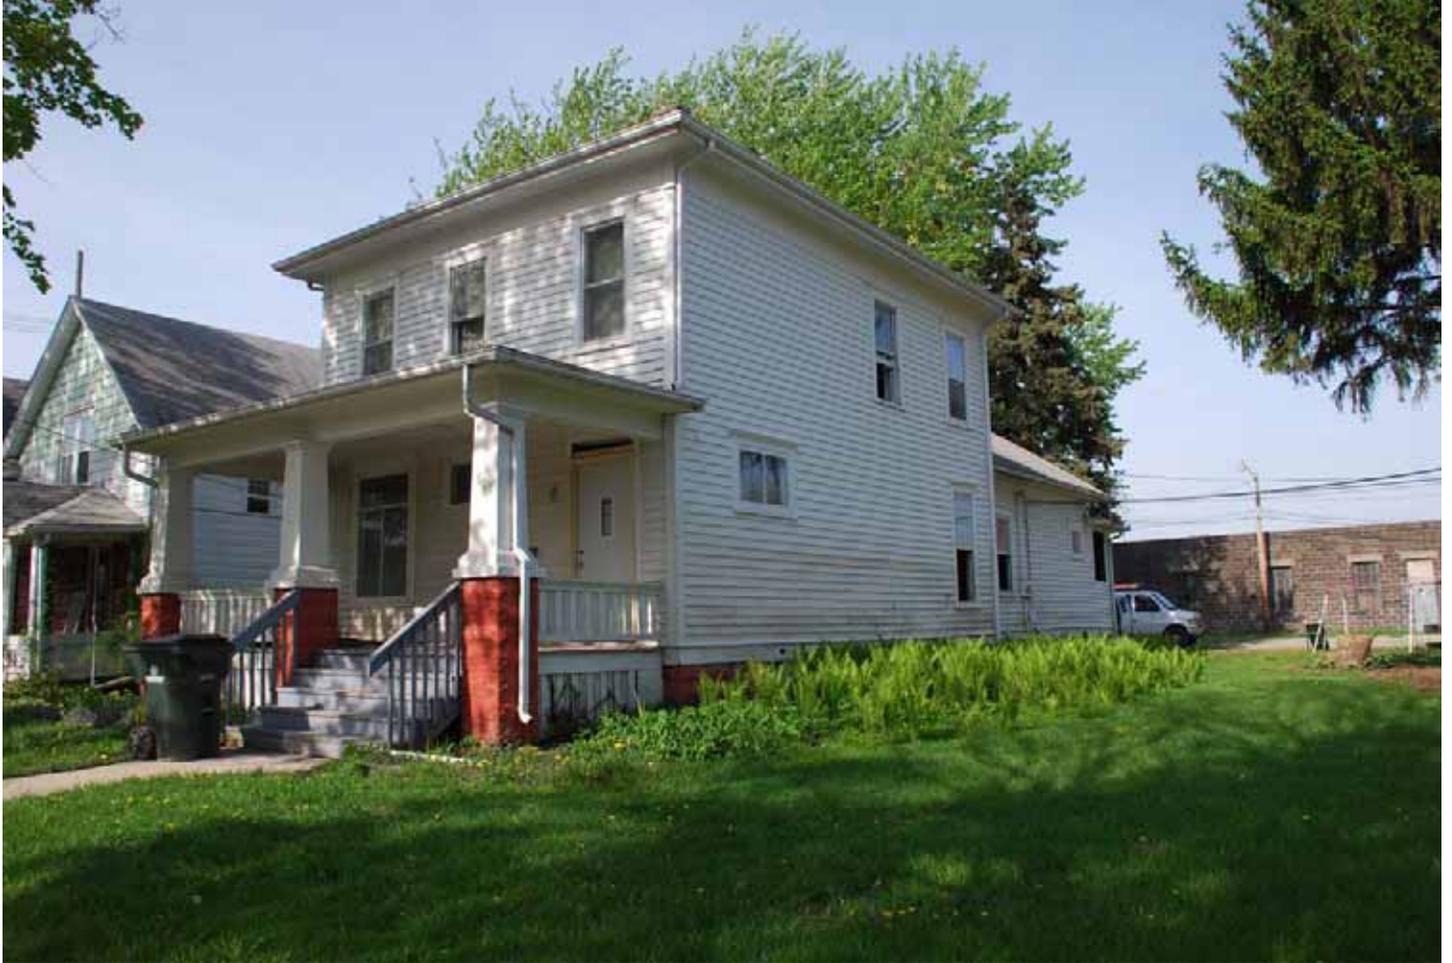
608 4th Street NW_View NW.jpg

608 4th Street NW (1880) – Two story hipped roof frame house with an early twentieth century porch, two story bay window, 1 ½ story rear addition, central brick chimney, and an enclosed rear porch. The house was likely originally built in the Italianate style; but has since lost much of its ornament such as eave brackets. However, the house retains sufficient integrity to be potentially eligible under Criterion A or B. Given the size of the original property—six standard lots—the original owner may have been an important person in the city. The house does not retain sufficient integrity to be eligible under Criterion C.

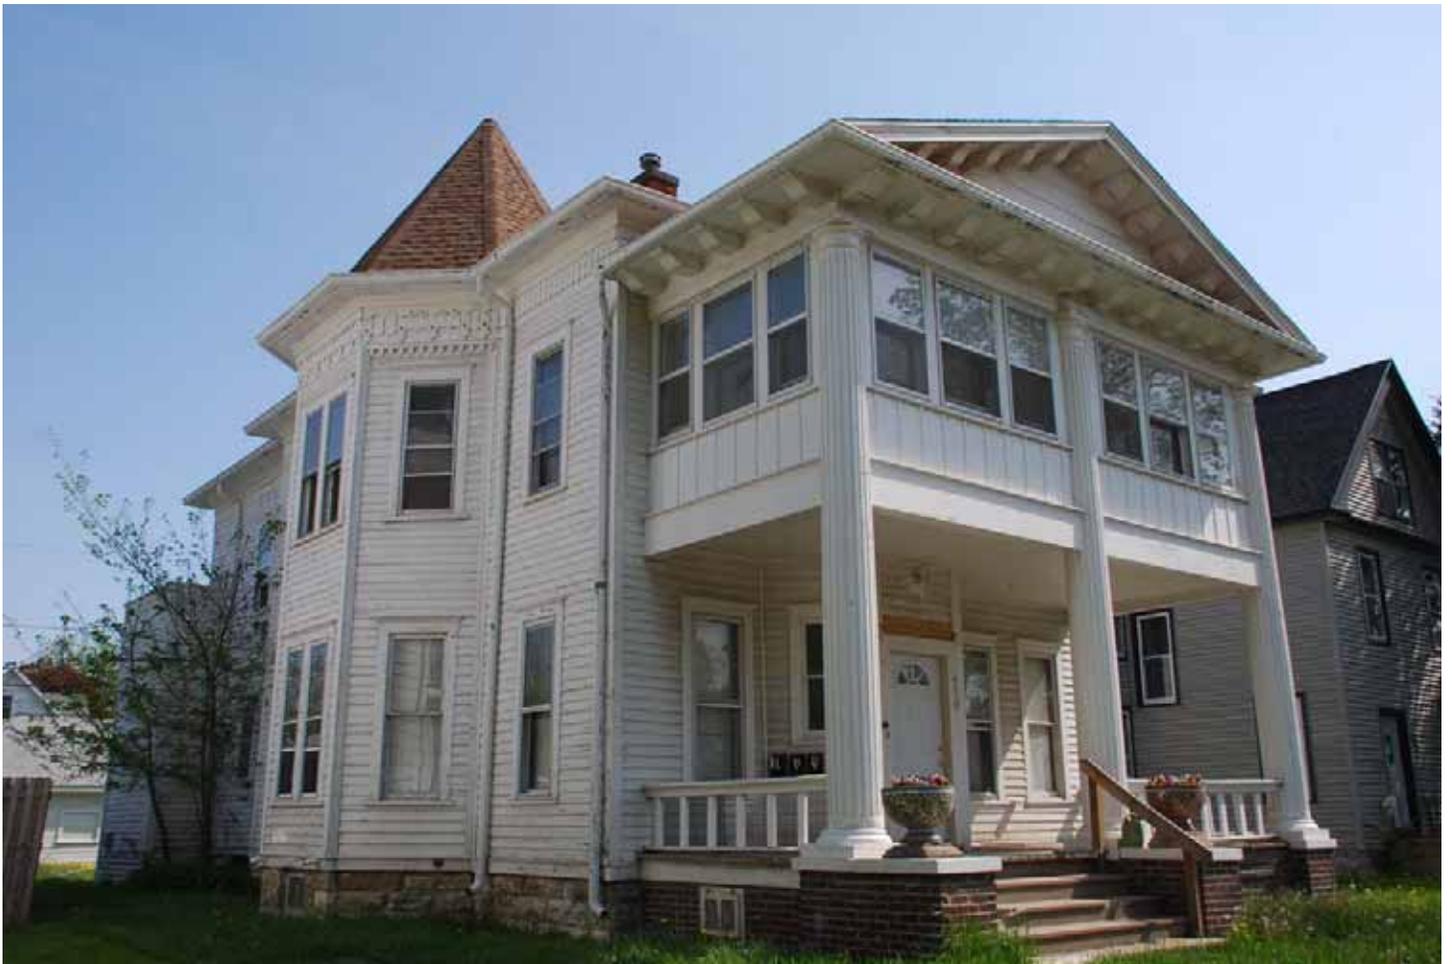
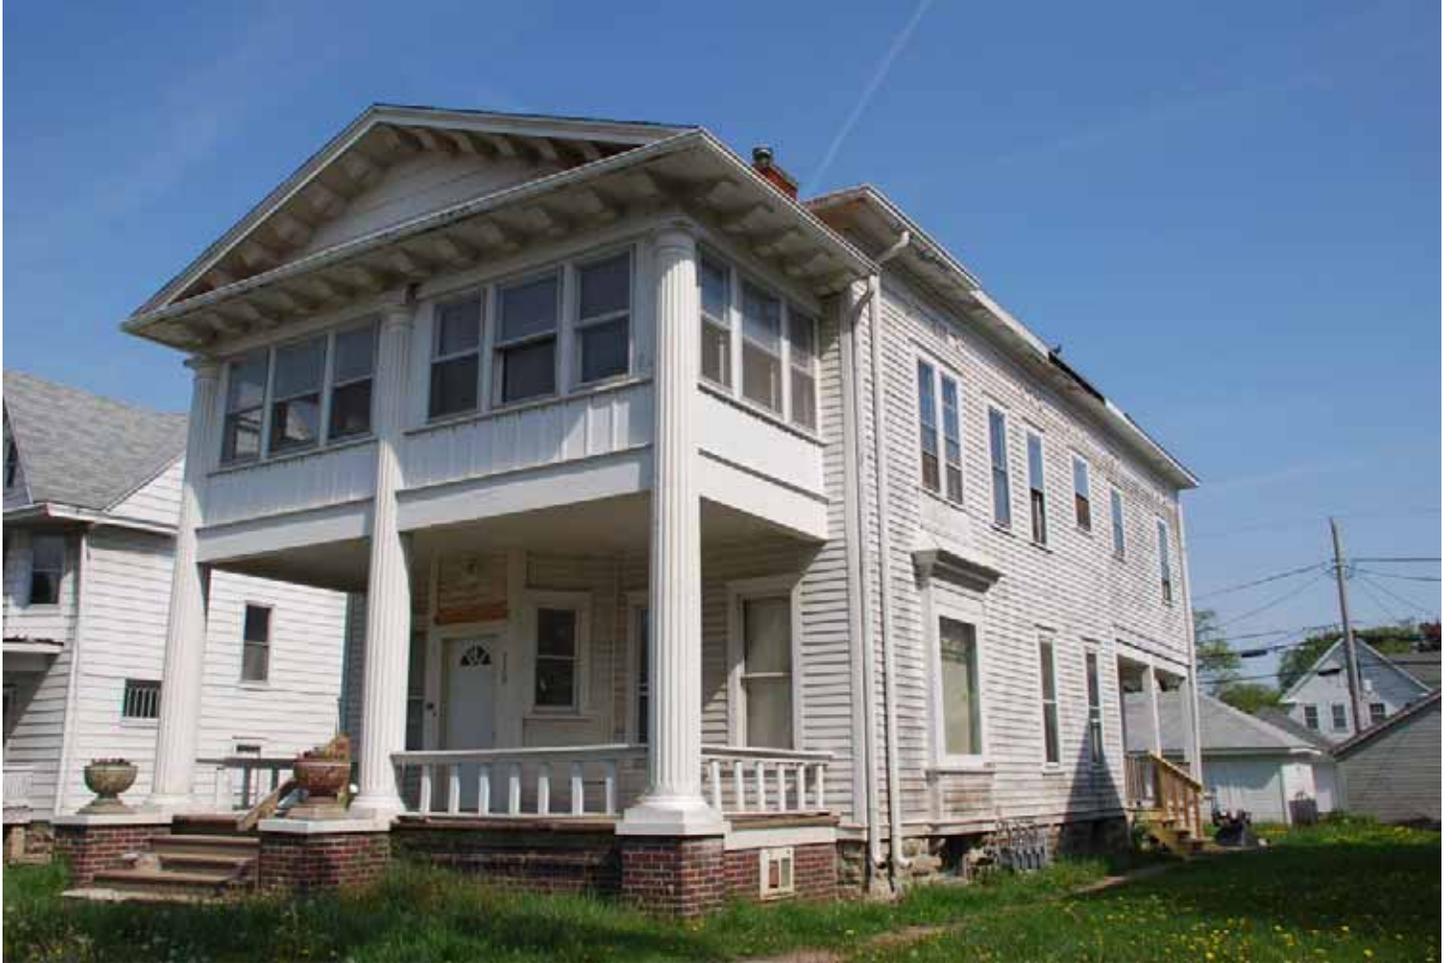
710 F Avenue NW_View NE.jpg

710 F Avenue NW (ca. 1900) – Two story Queen Anne/Neoclassical style frame dwelling with a limestone foundation, clapboard siding, an octagonal roof tower, a two-story Neoclassical style porch with the upper story enclosed, and deep eaves with an ornamented wood frieze. At the rear of the house a porch is inset within the roof of the main structure. The enclosure of the upper front porch and downsizing of some windows does diminish the integrity of the structure. However, the house sufficient integrity of design, workmanship, materials, feeling, location, and setting to be eligible under Criterion A or B. Sanborn fire insurance maps indicate that the structure was a two-family dwelling by 1913. Whether the structure was built as such, is uncertain.

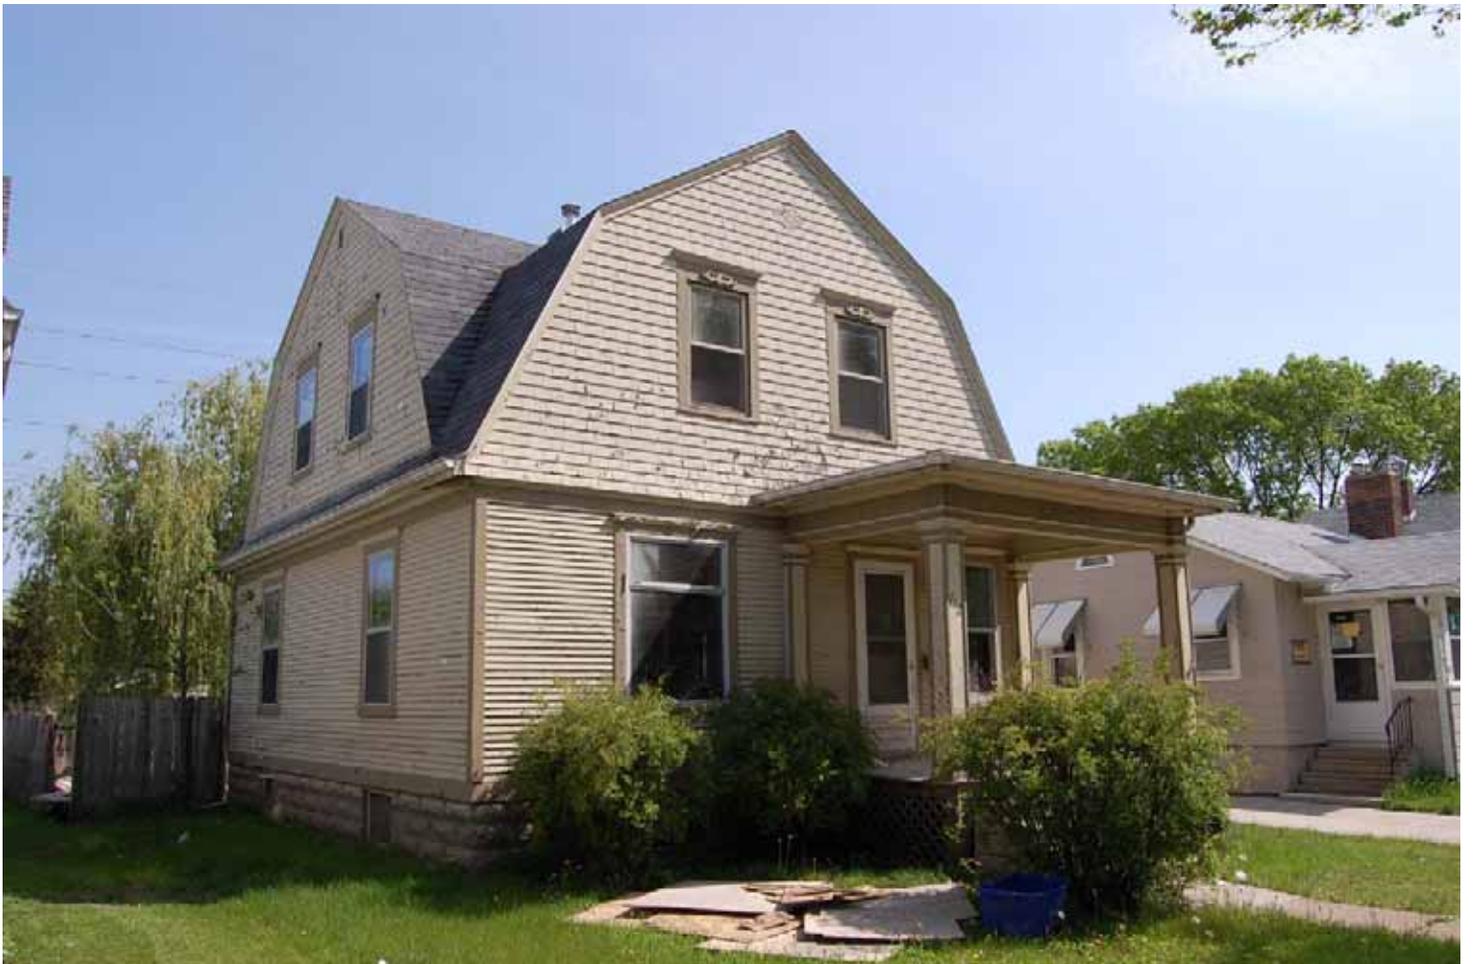
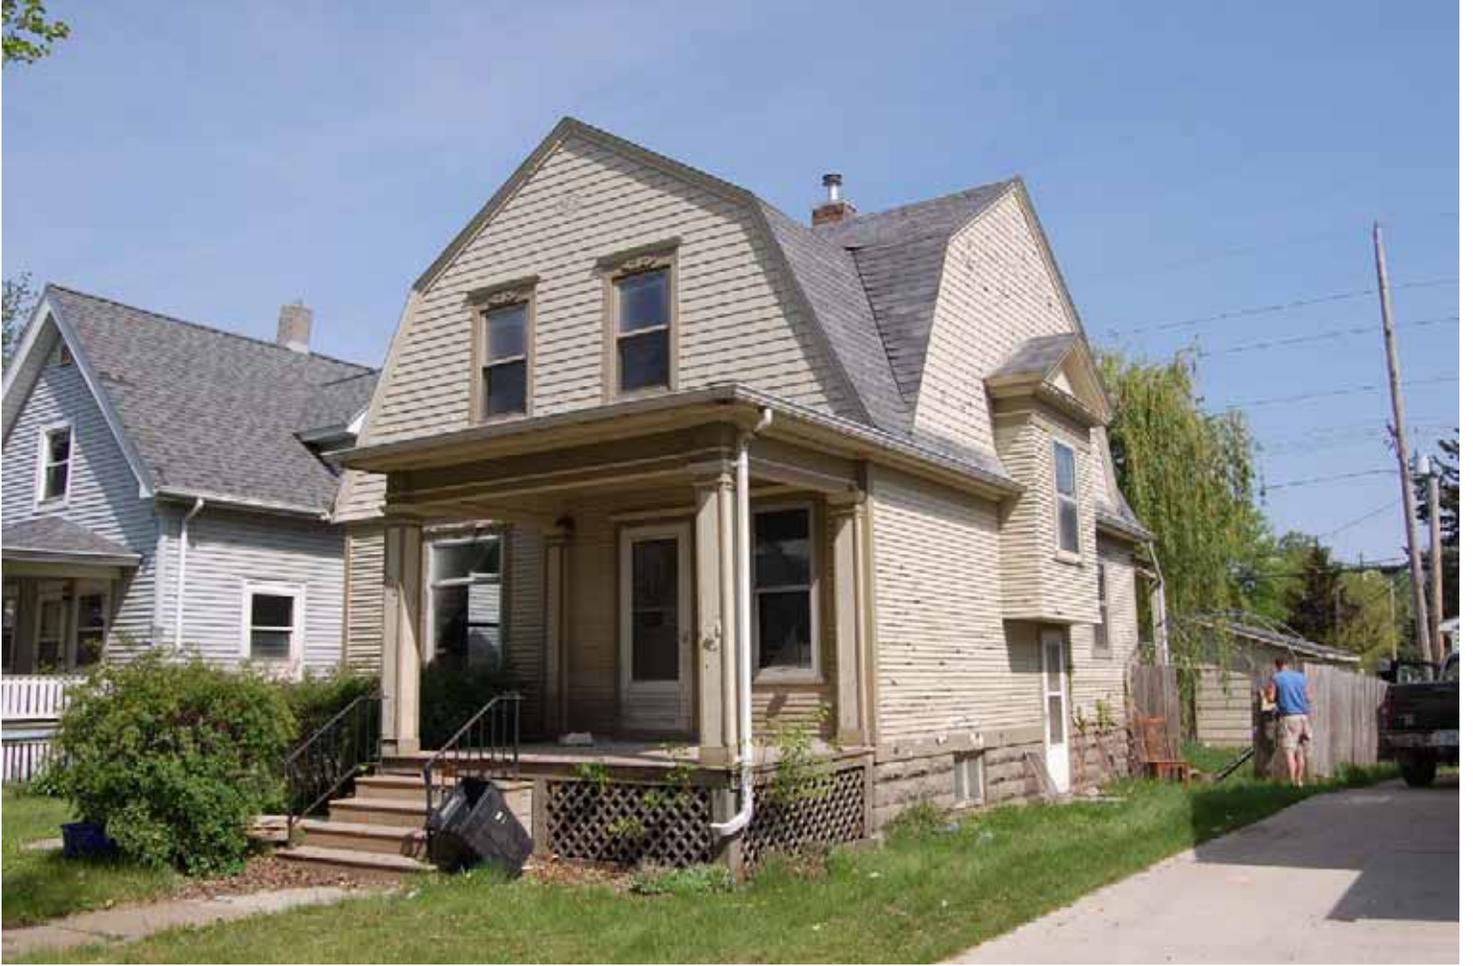
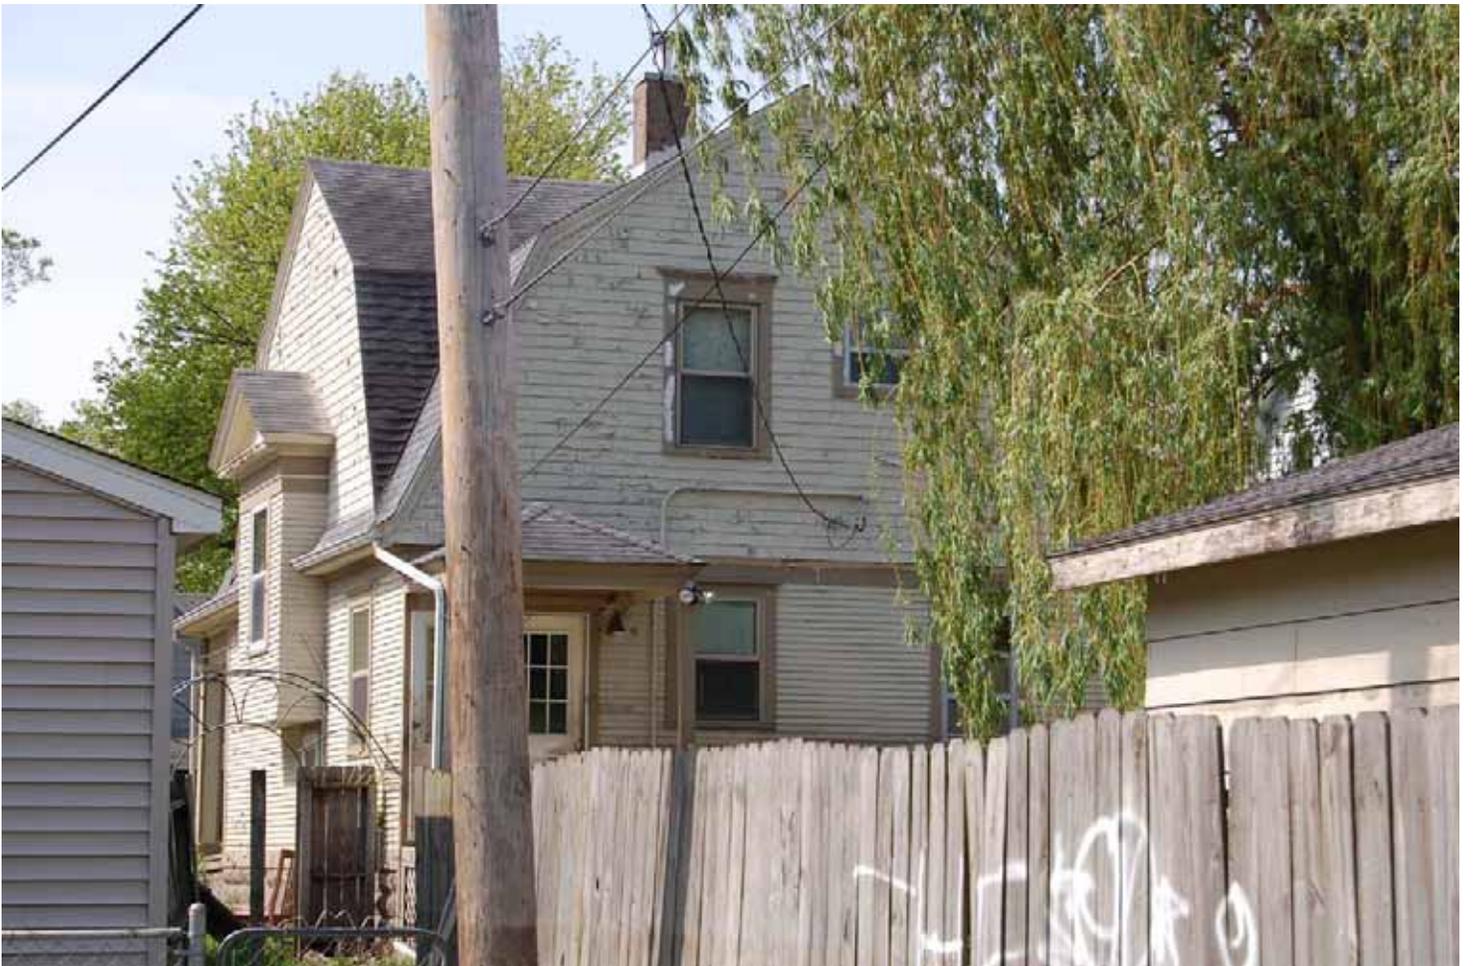
712 H Avenue NW_View NE.JPG

712 H Avenue NW (ca. 1910) – Gambrel roof 1 ½ story frame dwelling features a limestone foundation, clapboard siding, shingle siding on the upper story, a second story bay window, and a partial-width porch with paneled square columns. It appears that the scrollwork on the second story windows is a modern embellishment. This dwelling is an unusual example of a Dutch Colonial Revival style house and as such, is eligible under Criterion C.

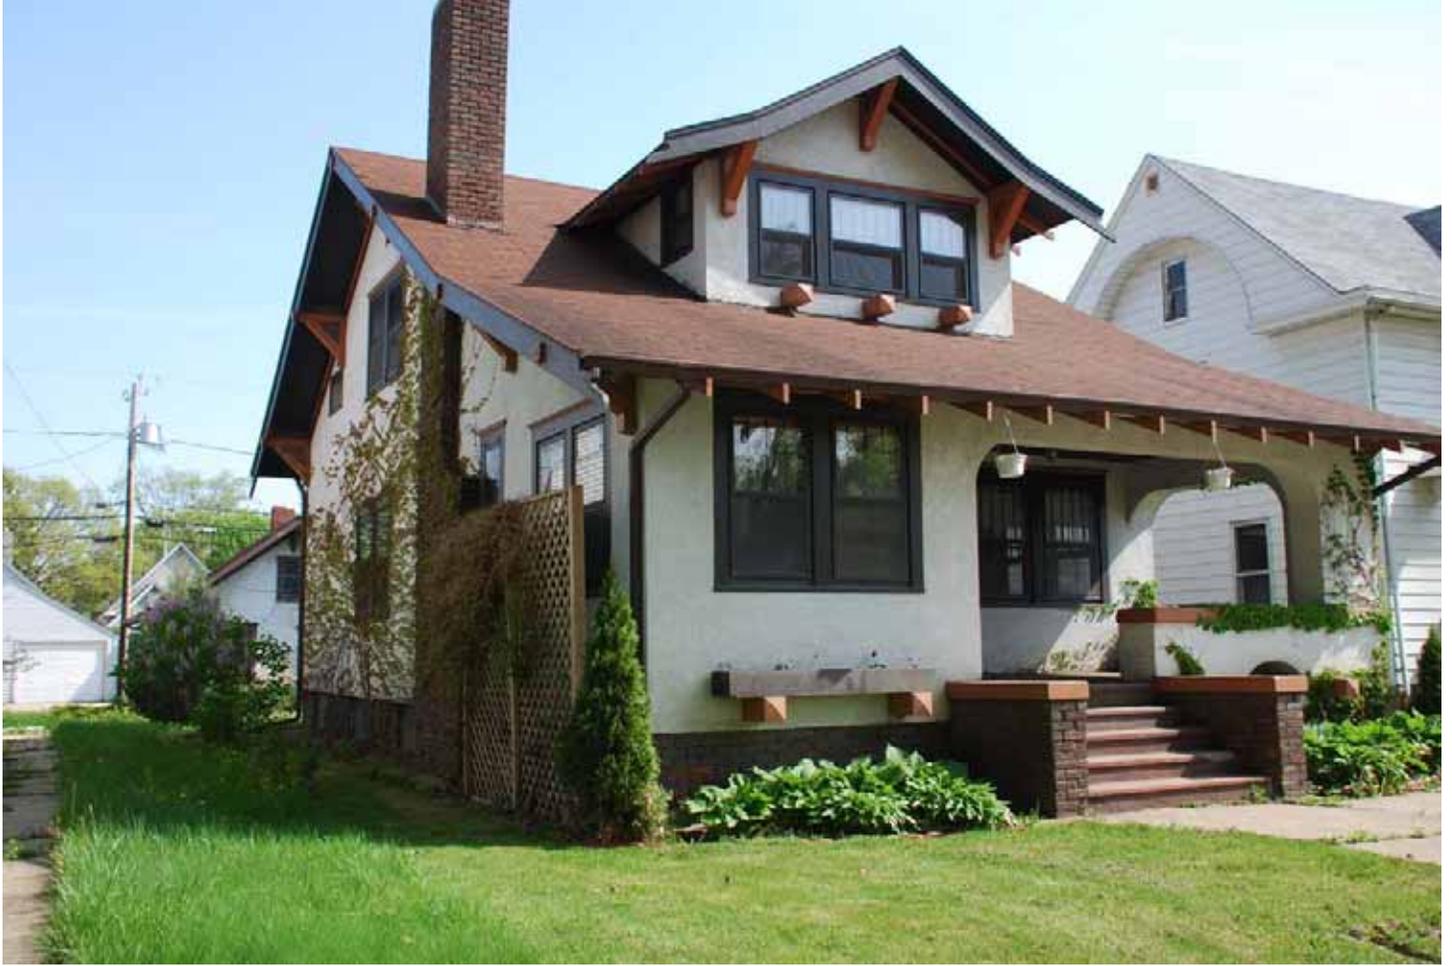
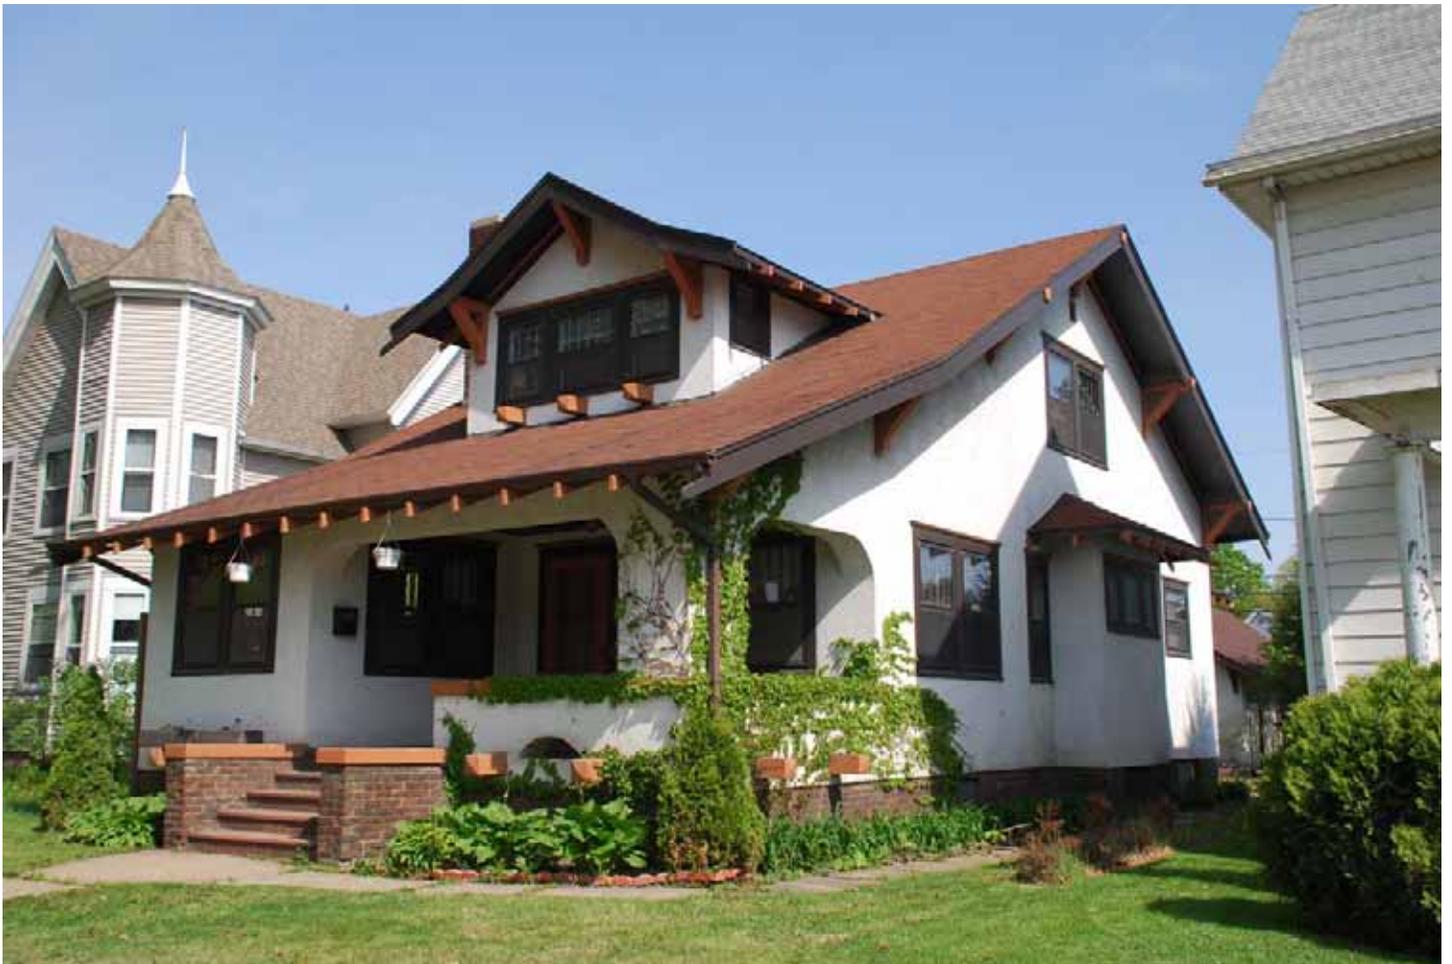
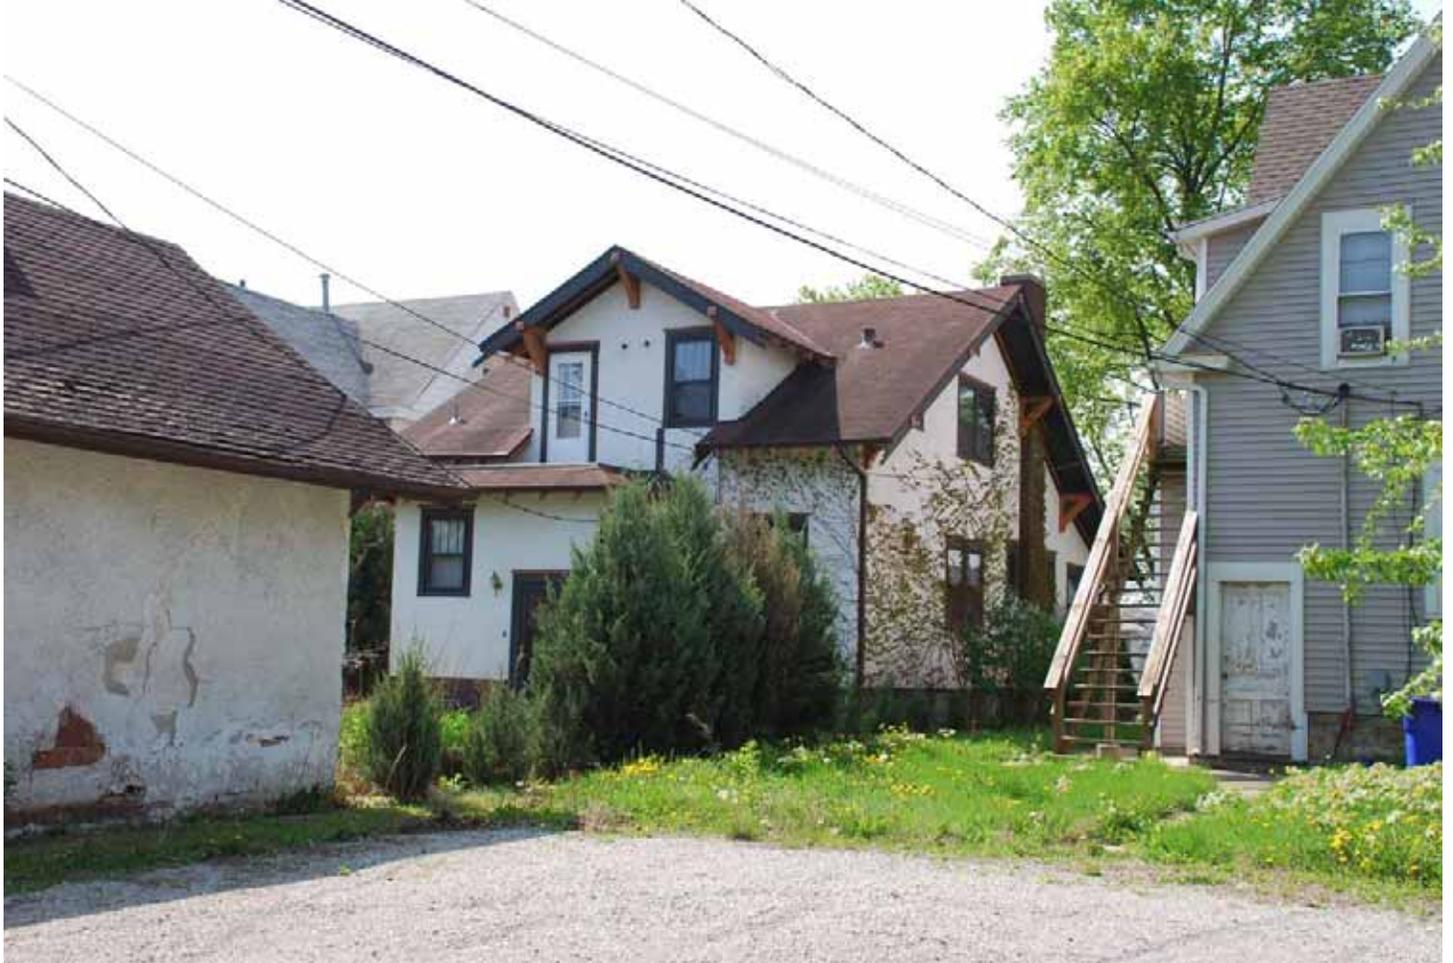
716 F Avenue NW_View NE.jpg

716 F Avenue NW (1921) – Stucco clad 1 ½ story, side-gable bungalow with a gable-front dormer, hipped roof bay window, 6/1 and 4/1 windows, exposed rafter tails, and deep eaves with knee braces. Stiva-like exposed floor joists can be found around the porch and on the gable front dormer. It is rare for a bungalow to exhibit southwestern influences in the Midwest. As such, the dwelling is eligible under Criterion C as an important example of a bungalow with southwestern stylistic influences. The house may also be eligible under other criteria with more research.

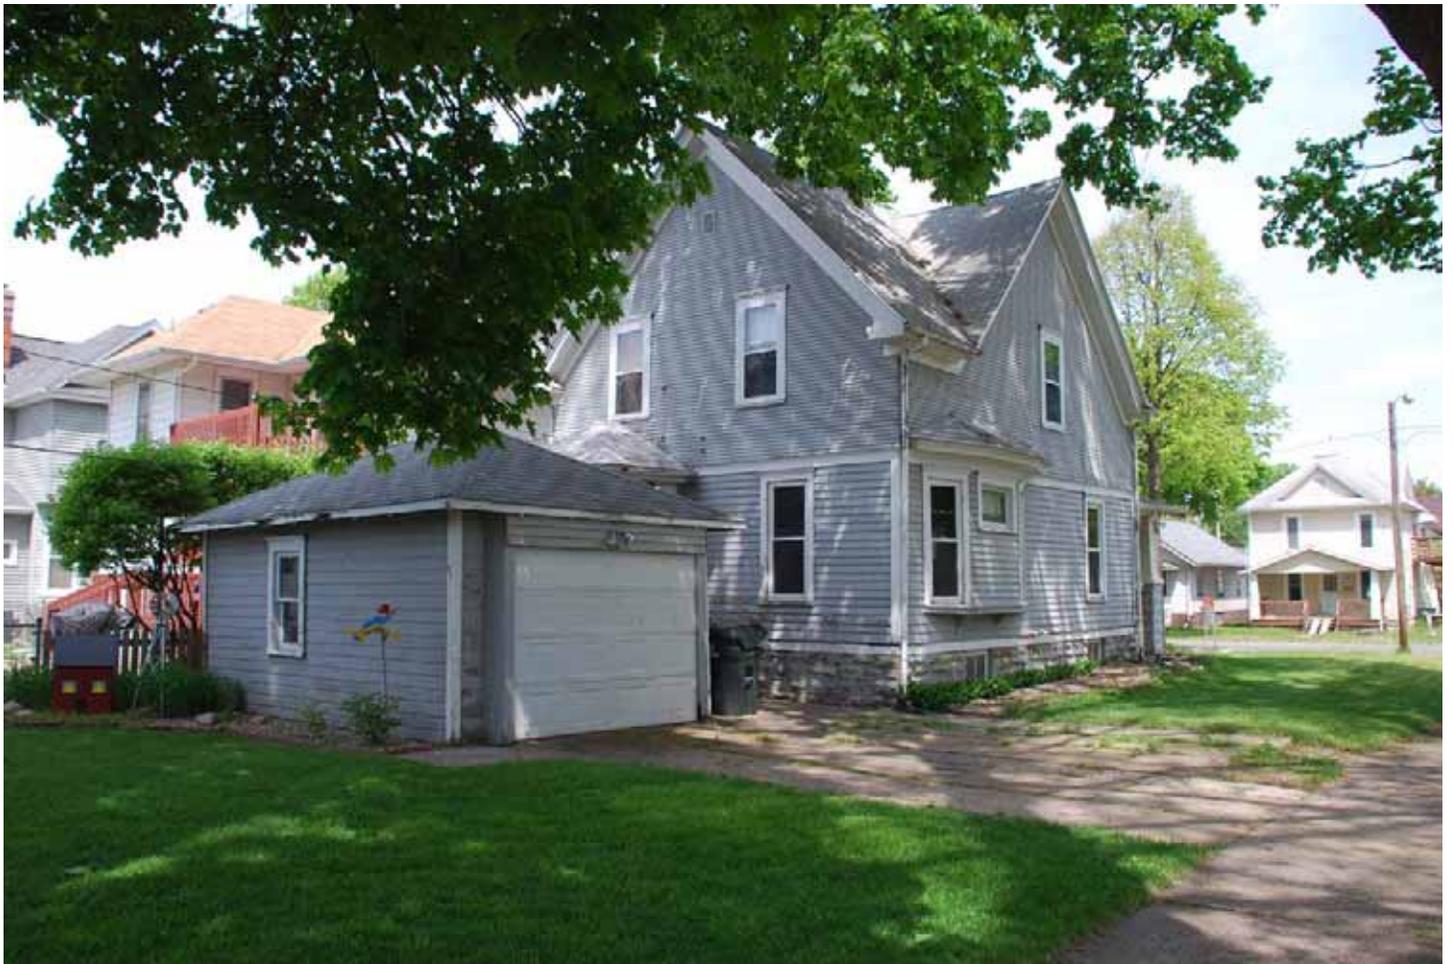
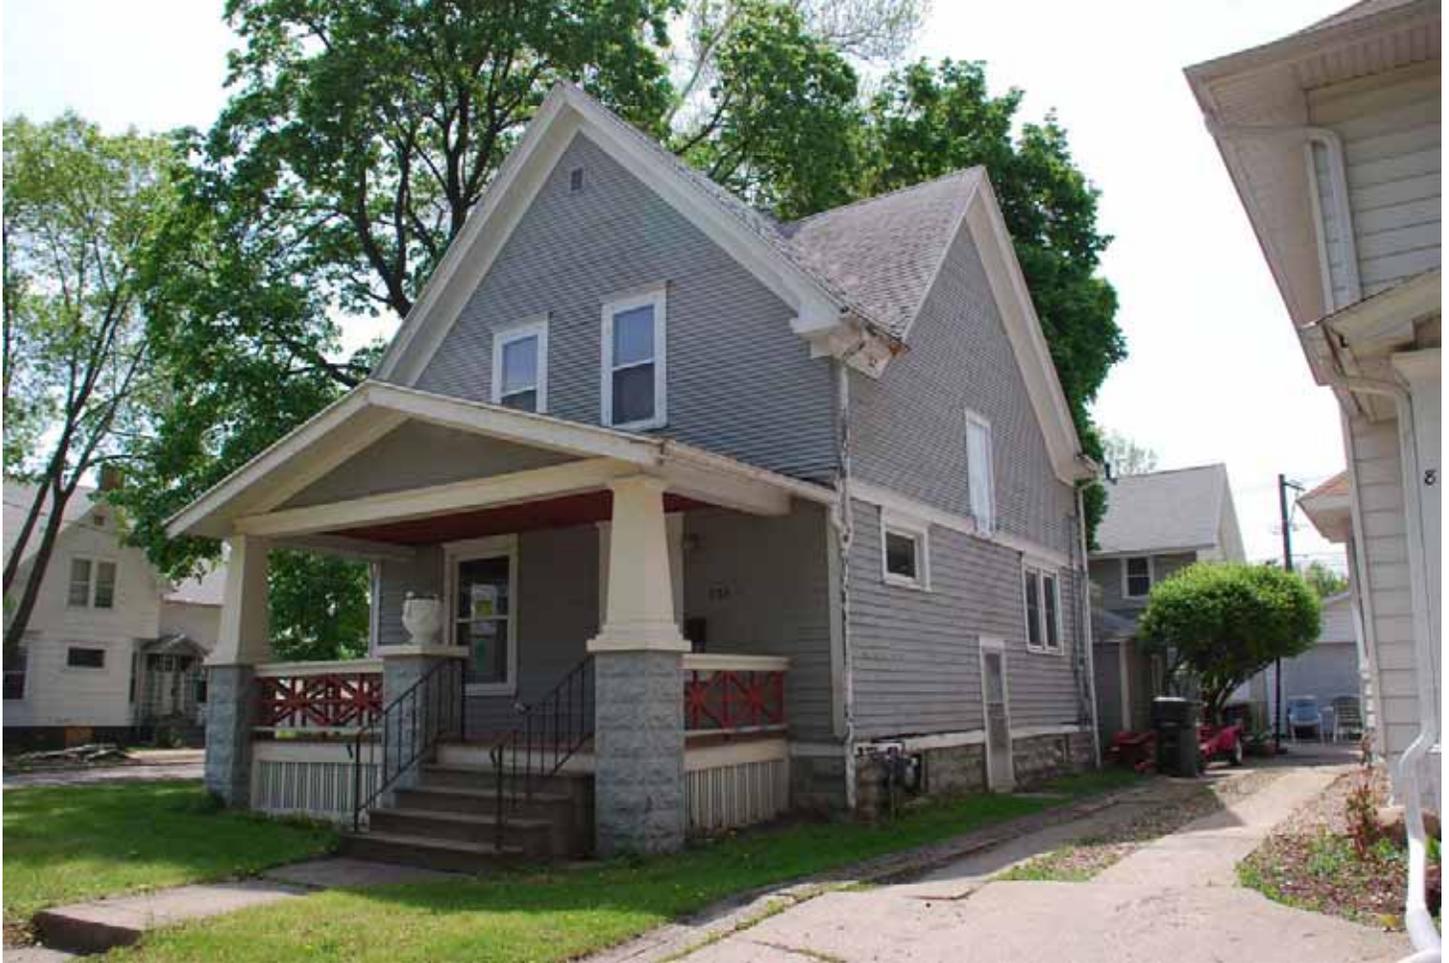
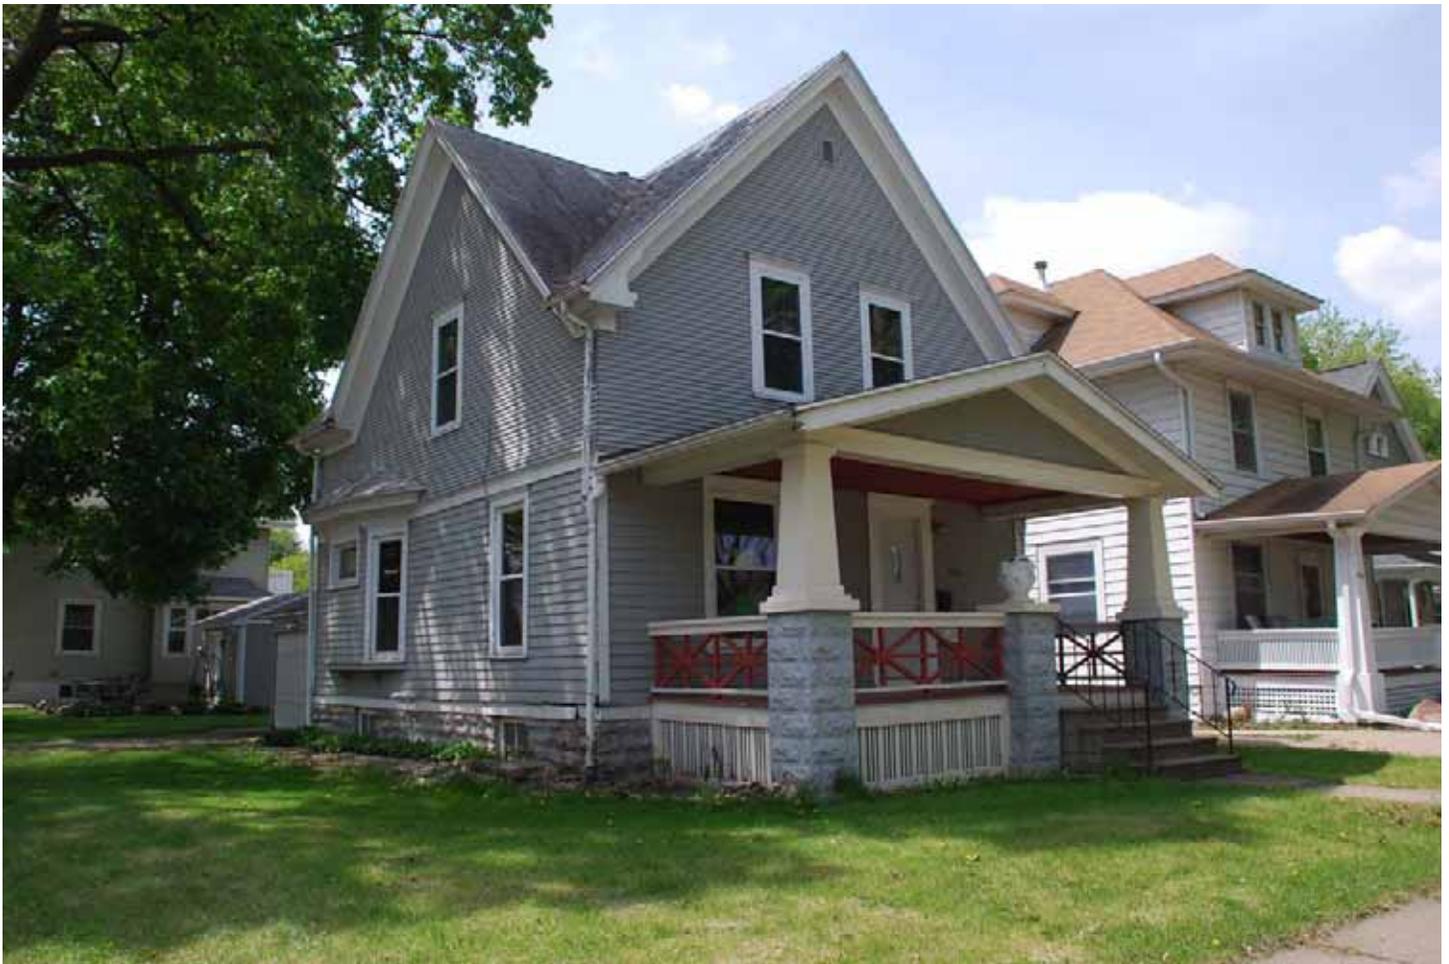
803 F Avenue NW_View NW.jpg

803 F Avenue NW (1909) – Vernacular 1 ½ story cross gable frame dwelling features a gable front open porch with cast concrete block piers, tapered columns, and star motif railing; wide siding on the first floor, narrow siding on the second floor, a bay window, and a limestone foundation. Some of the windows have been replaced. However, the house has sufficient integrity to be eligible under Criterion C as a significant example of an early twentieth century vernacular dwelling.
