**Architectural Reconnaissance Survey
for Brown's Additions
to Cedar Rapids
(57-085)**

Linn County, Iowa

**June 2, 2009
Revised March 10, 2010**

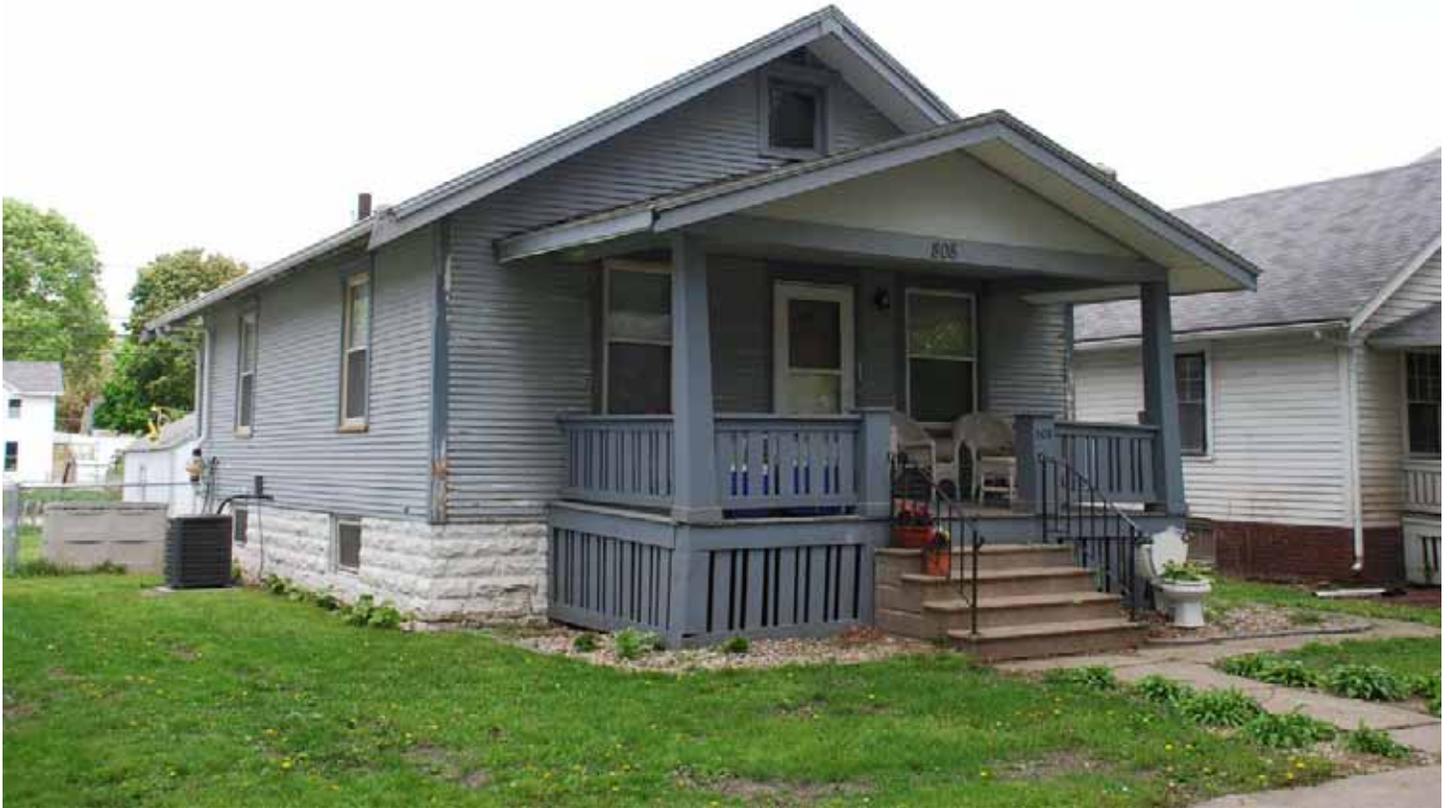
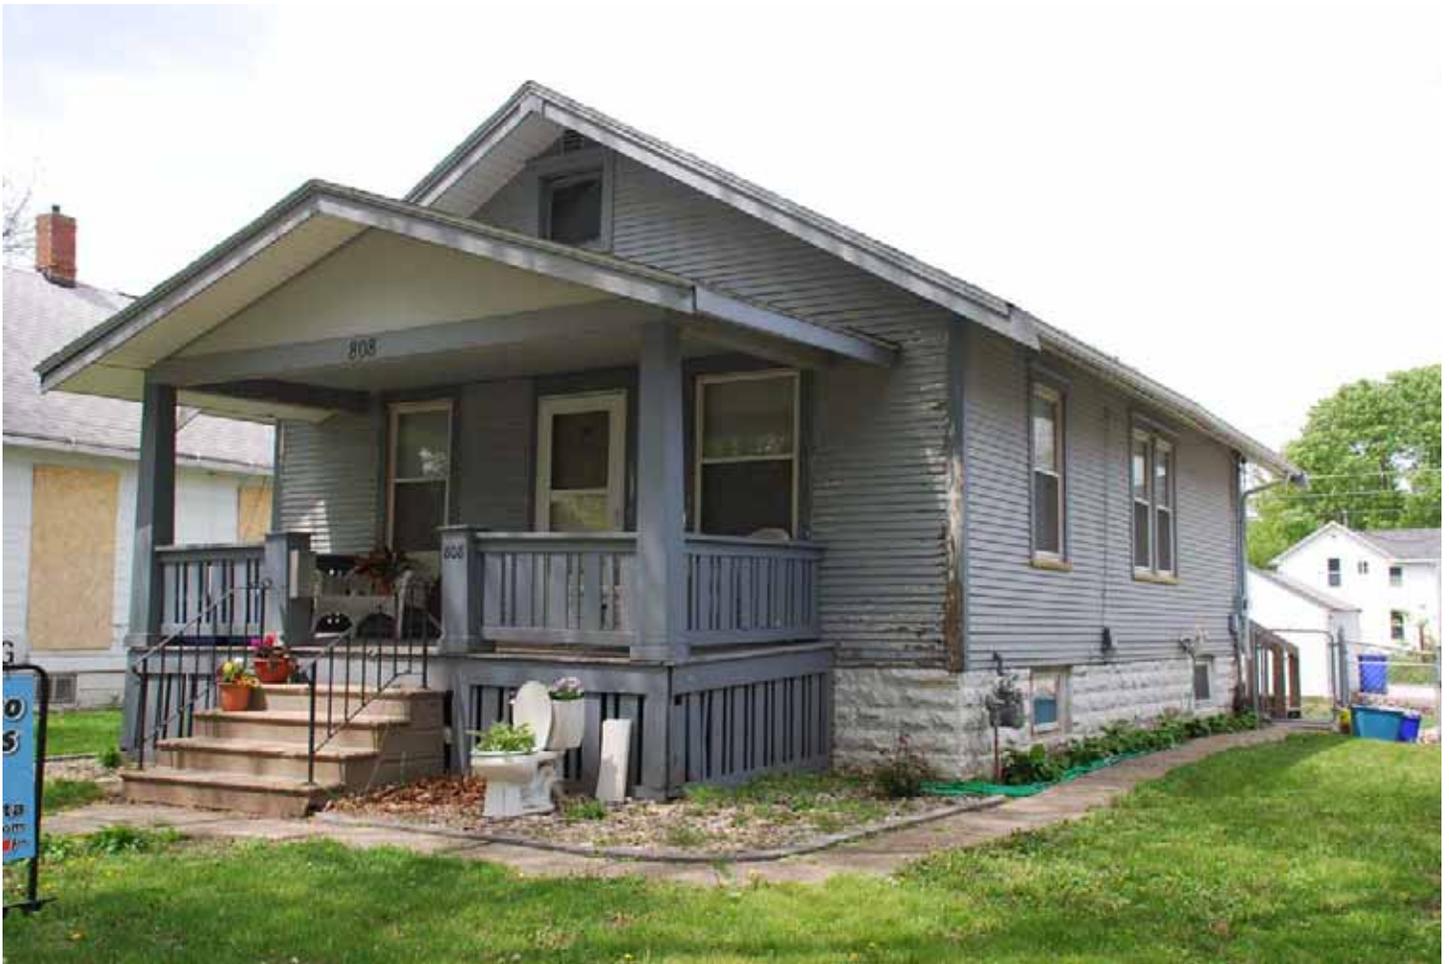
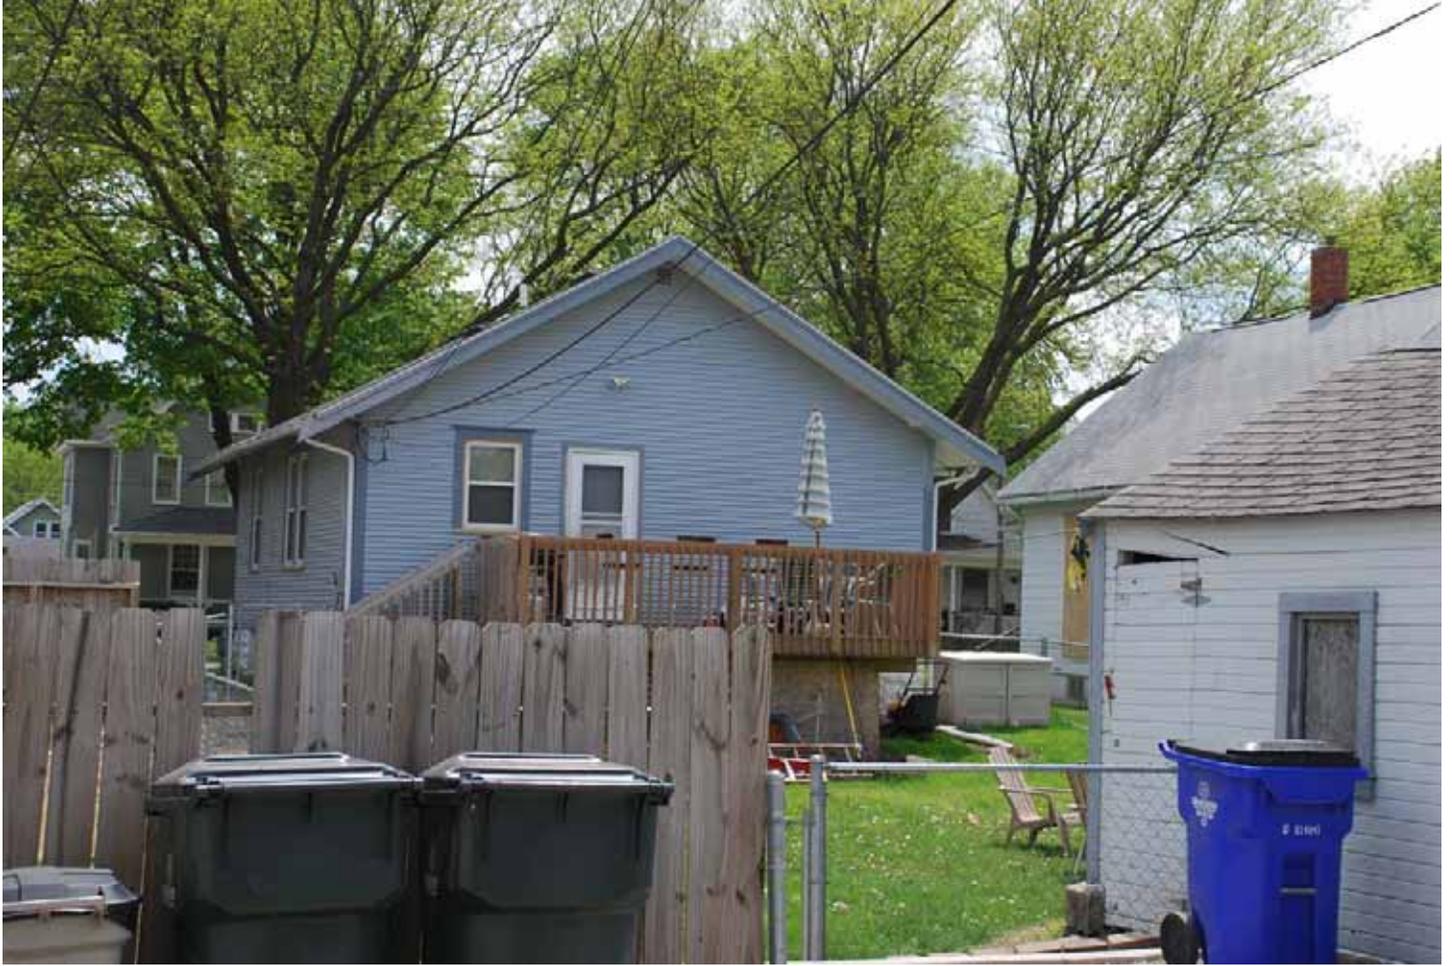
808 F Avenue NW_View NE.jpg

808 F Avenue NW (1918) – Vernacular 1 ½-story, gable-front, frame bungalow is clad with weatherboards, set on a foundation of rock-faced concrete block, and has a full-width front porch supported by tapered wooden posts. In March 2009, Berger recommended the house as is eligible for inclusion in the NRHP as an good, highly intact example of a common gable-front vernacular form that represents the most popular house type in the City, found in all quadrants of the core areas, but particularly in the Time Check neighborhood. The Iowa SHPO concurred with that opinion on April 13, 2009 (Table 1).

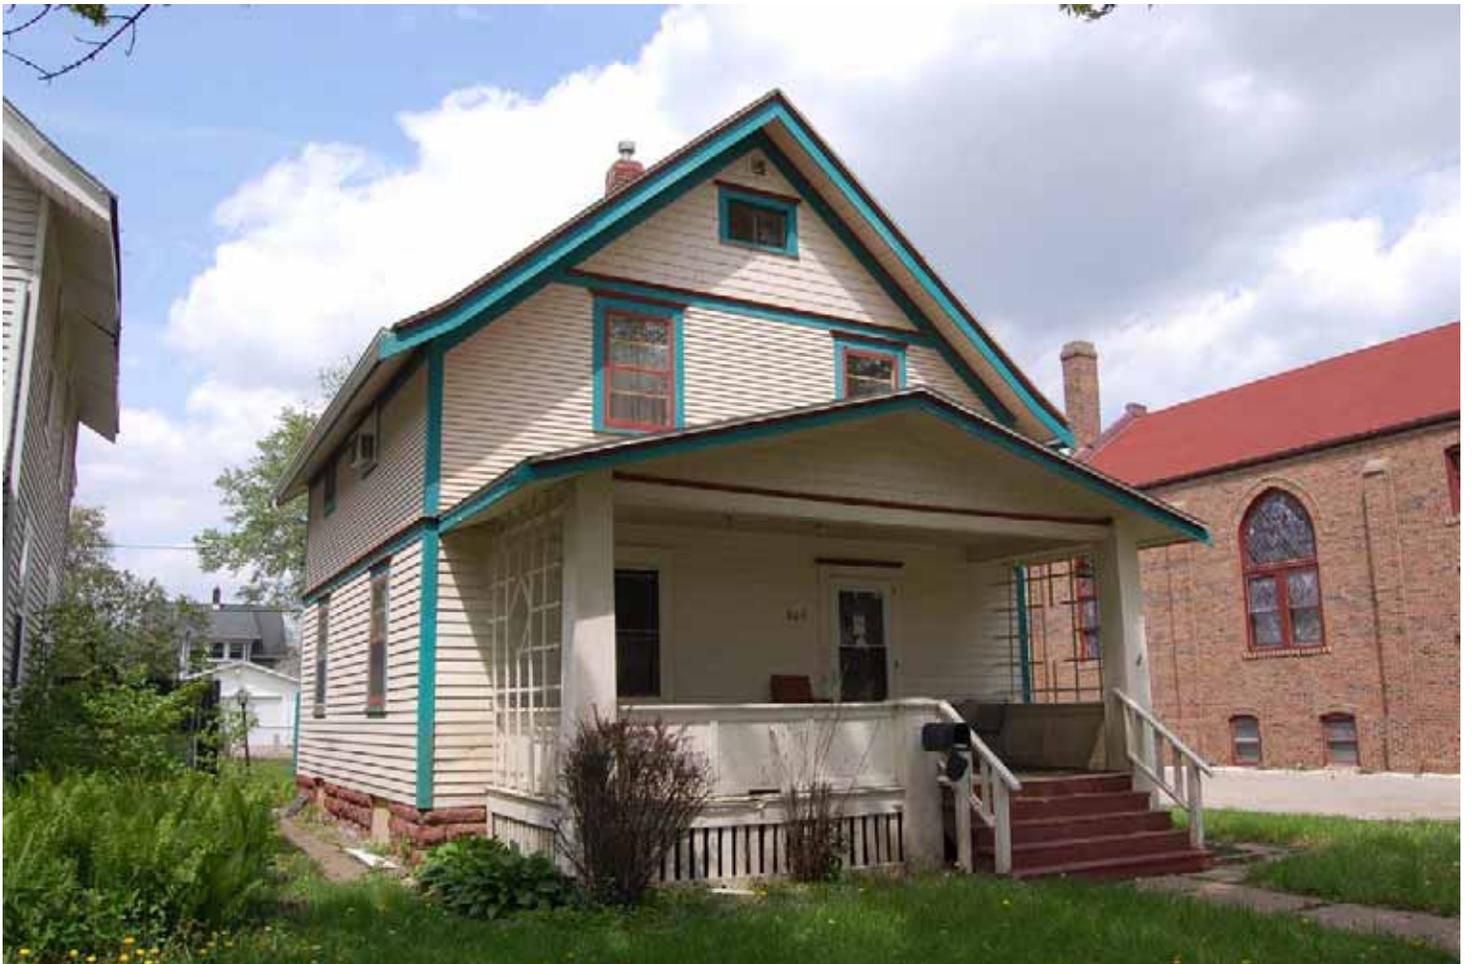
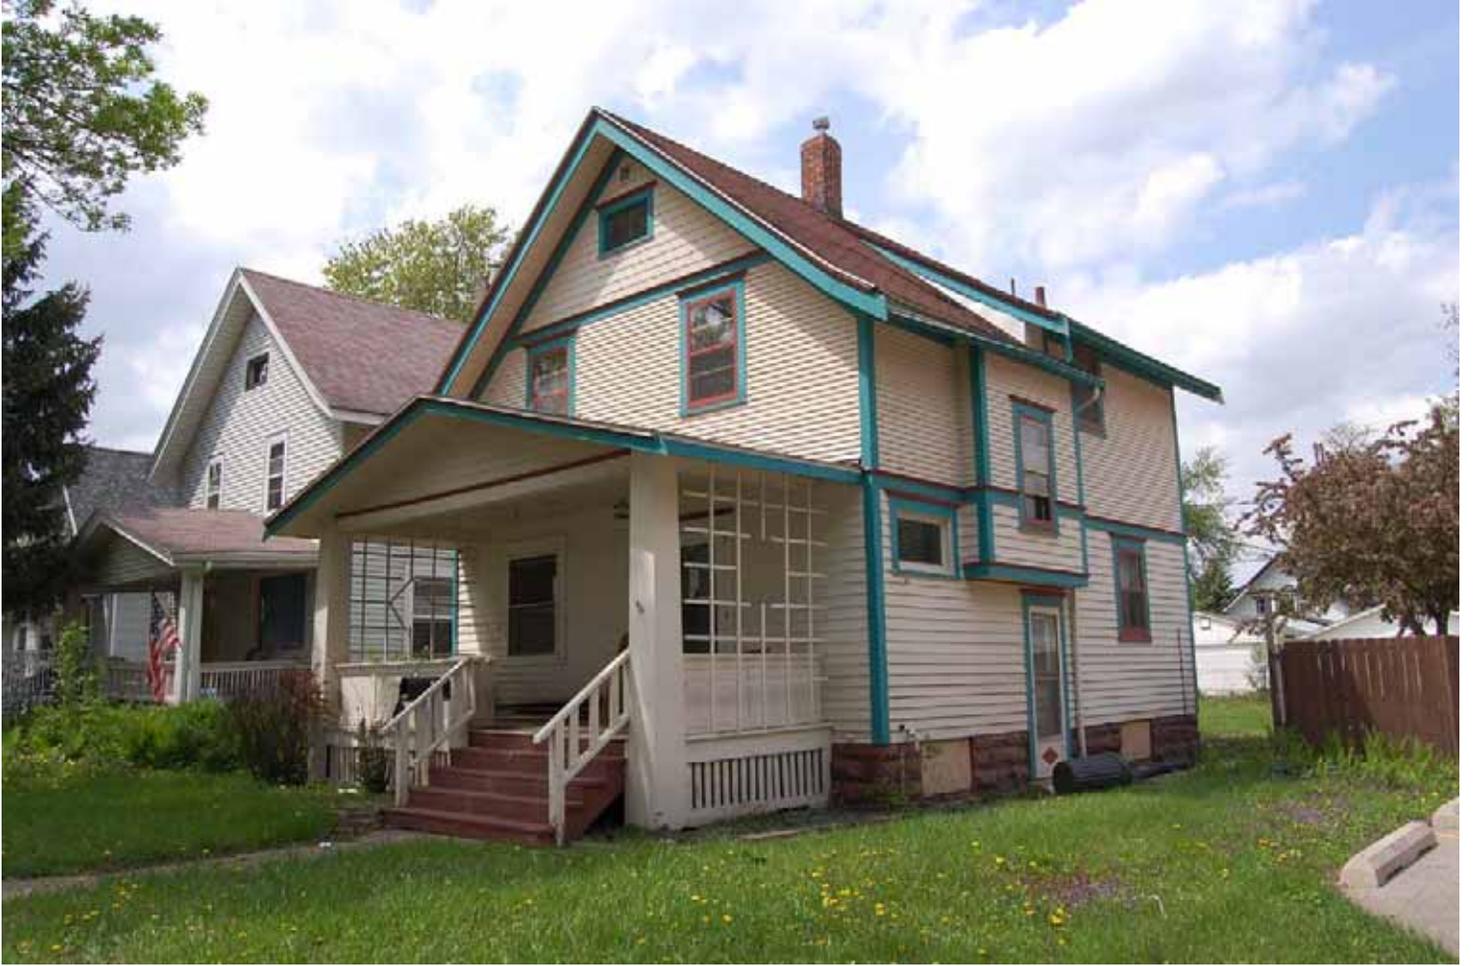
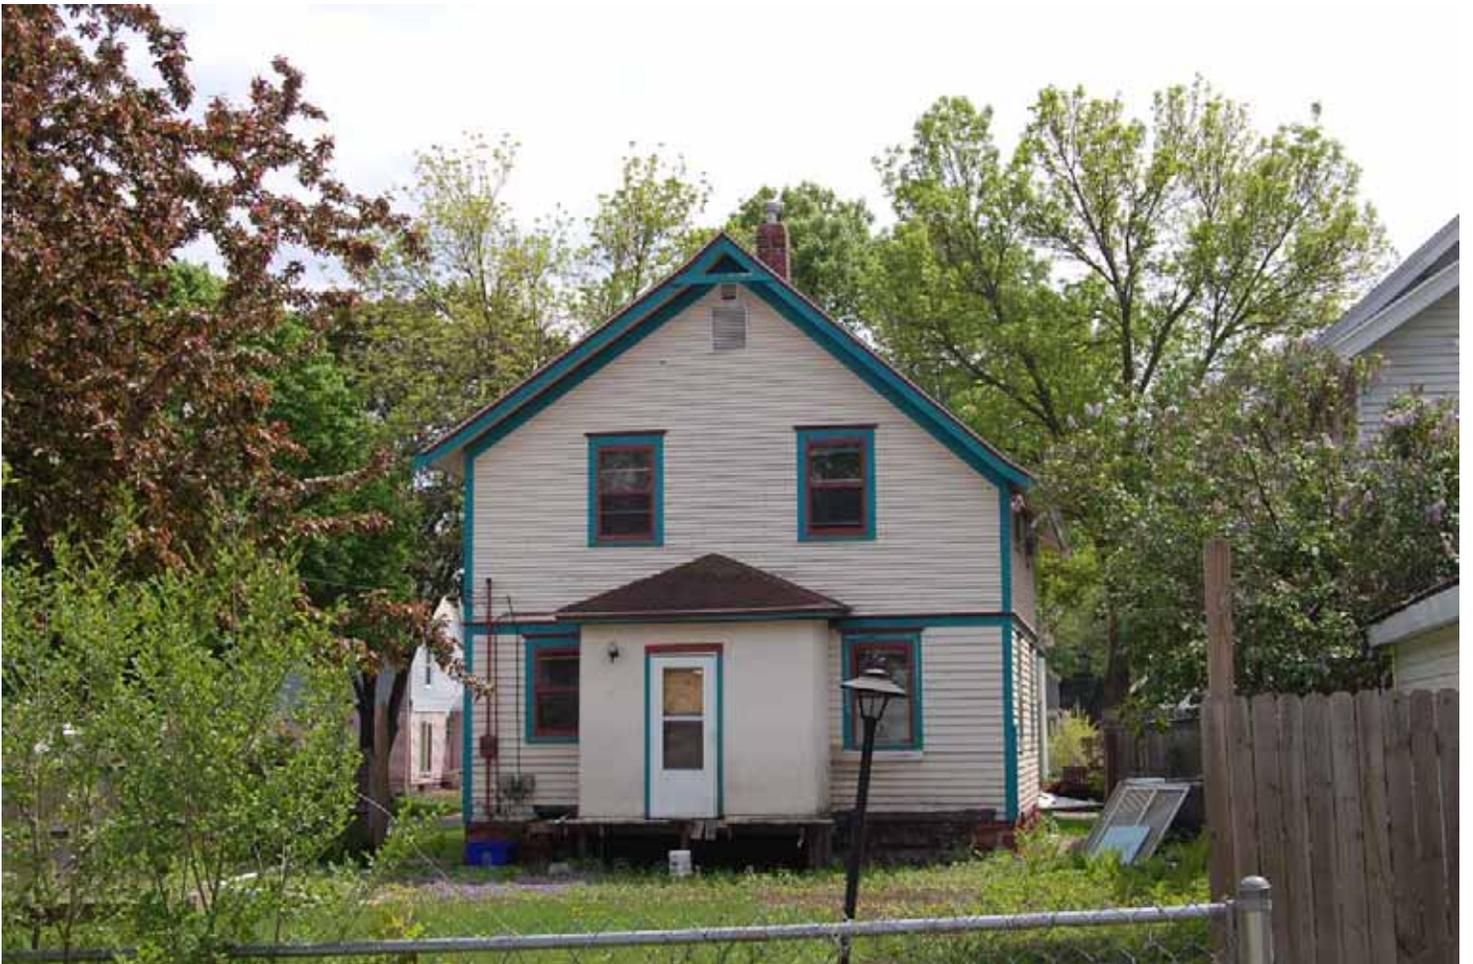
808 G Avenue NW_View NE.JPG

808 G Avenue NW (1912) – Vernacular 1 ½ story gable front frame dwelling features a gable front open porch with tapered square columns, limestone foundation, wide clapboard siding on the first level, narrow clapboard siding on the second level, cove-cut shingles in the gable ends, a second story bay window, and deep flared eaves. The railing of the porch has been altered. Despite this, the house is eligible under

Criterion C as an important example of a highly intact 1 ½ story gable front vernacular dwelling that was common in the residential neighborhoods of Time Check.

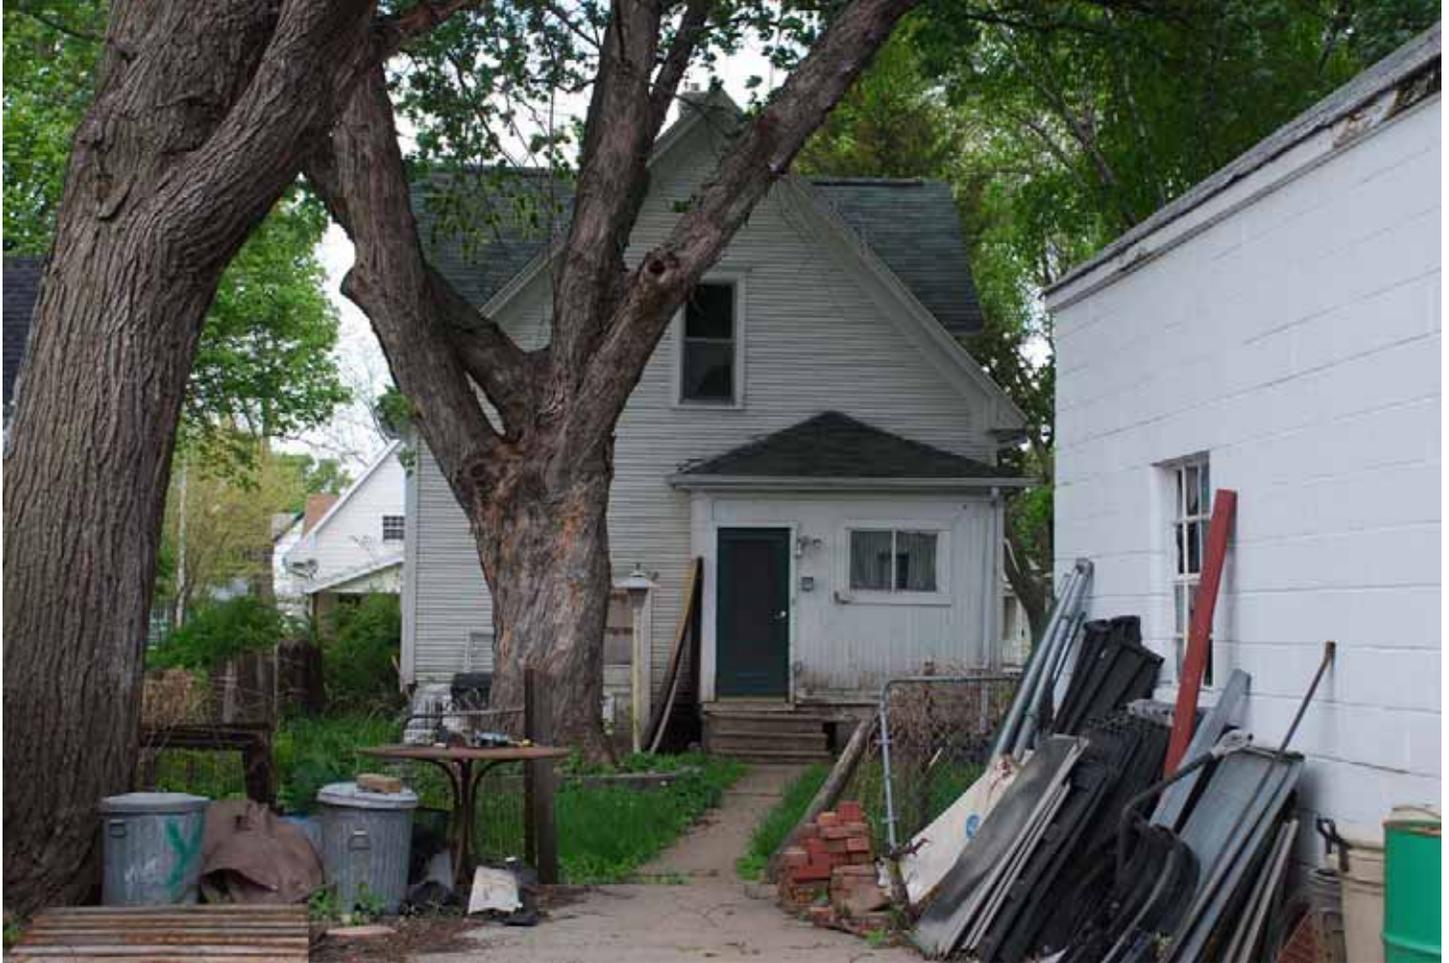
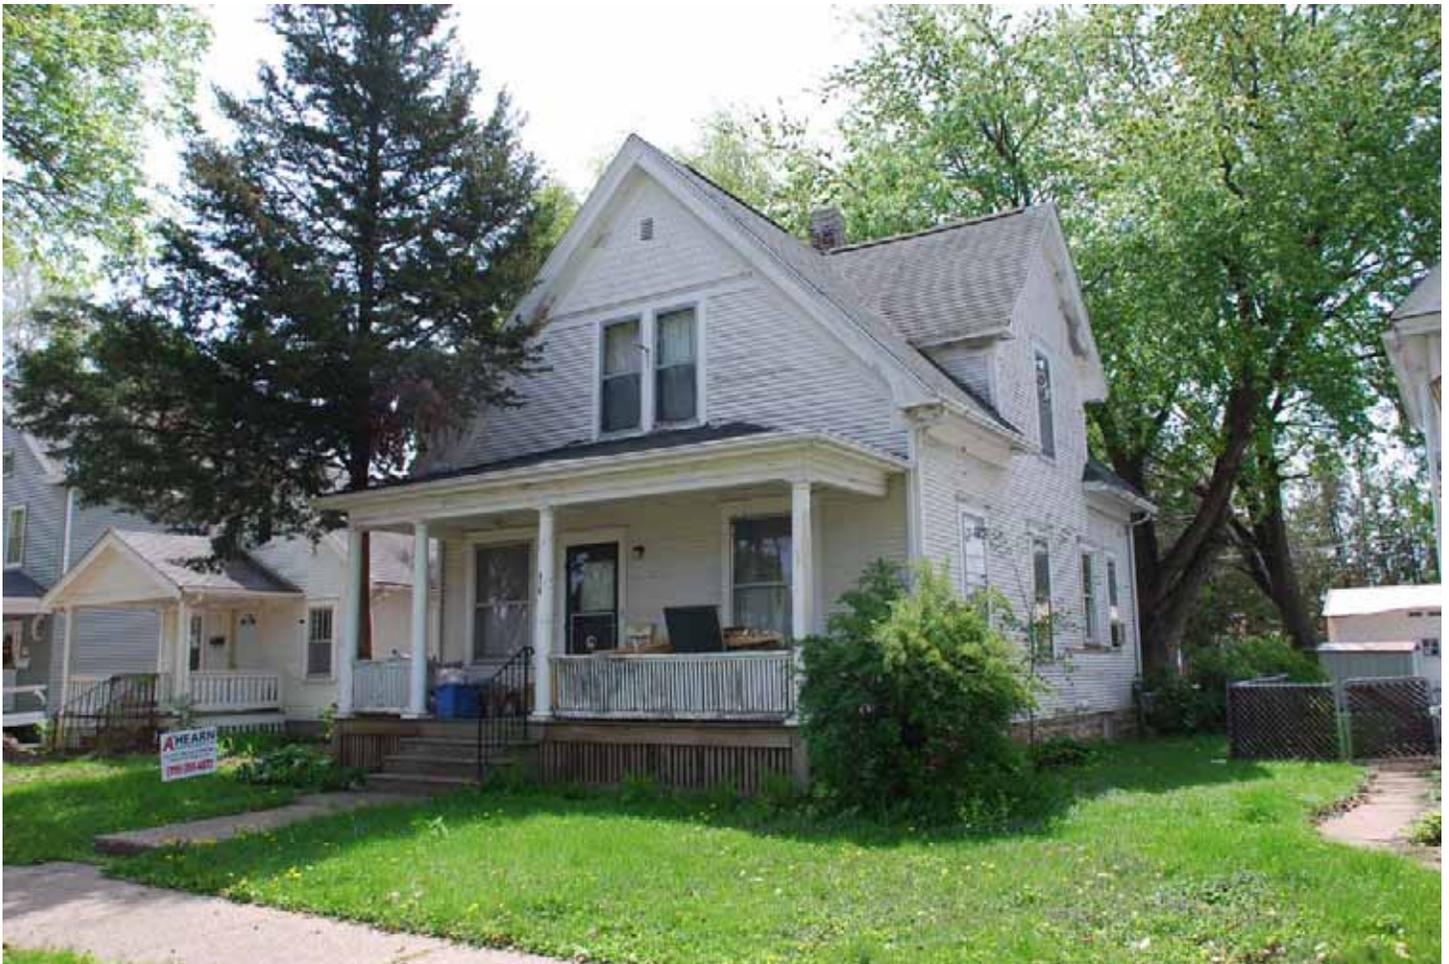
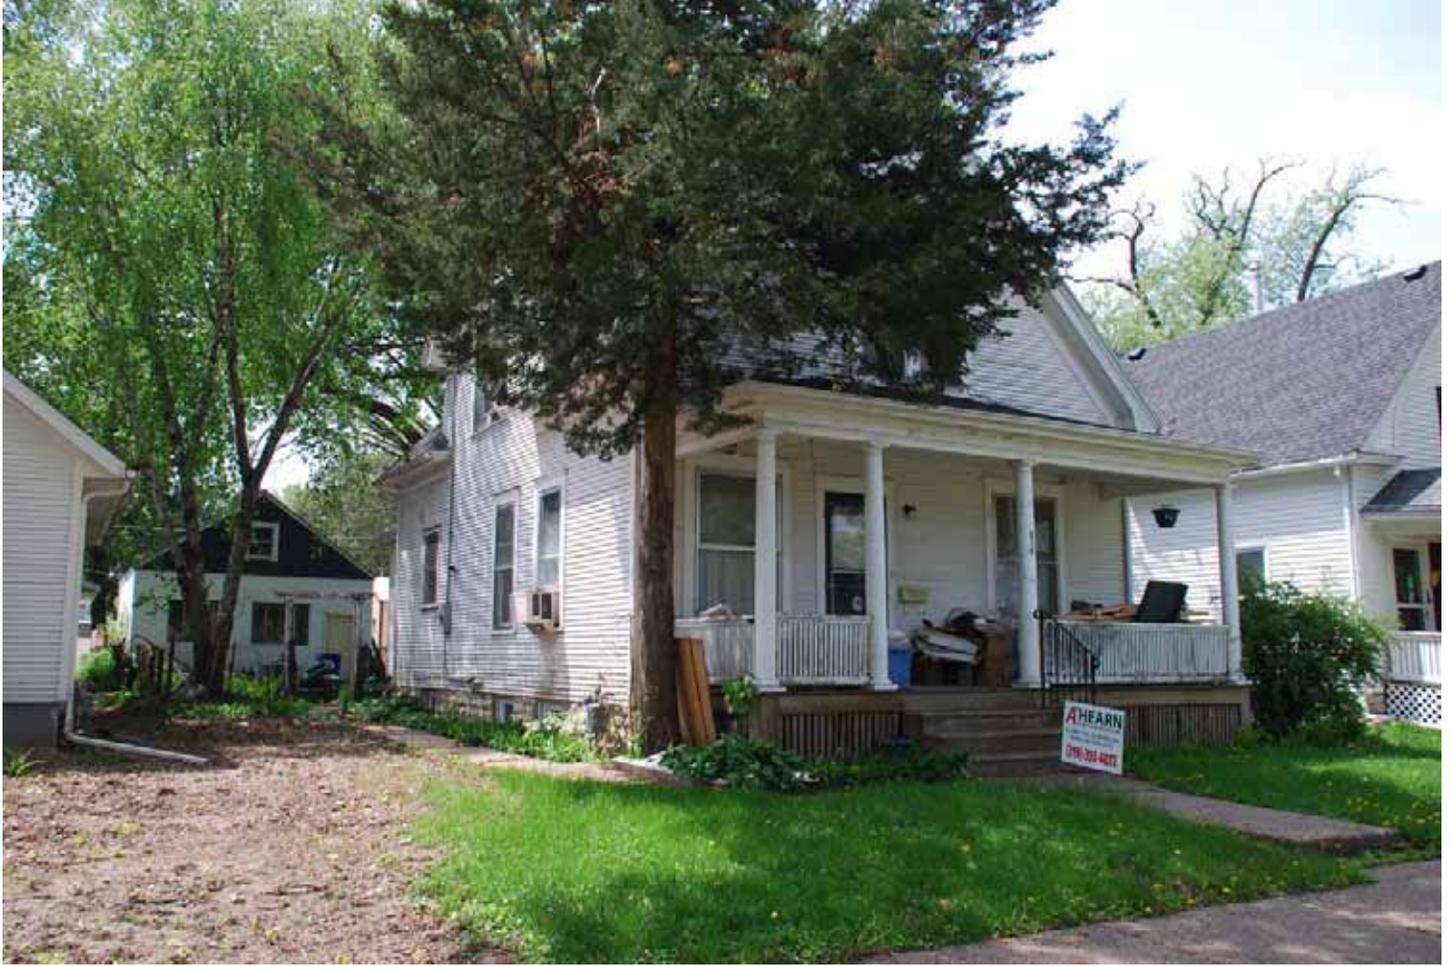
819 F Avenue NW_View N.jpg

819 F Avenue NW (1910) – This vernacular house has all the hallmarks of the 1 ½ -story gable front dwelling that was popular in the Time Check neighborhood including decorative shingles in gable ends and on dormers, a hipped roof open porch with original details, and the siting on a narrow lot with shallow setbacks on both the fronts and sides. Berger recommended the house as eligible for National Register Criterion C as it is a significant example of the gable front vernacular style that represents the most popular house type in the City but particularly in the Time Check neighborhood. Iowa SHPO concurred with that opinion on May 22, 2009 (Table 1).

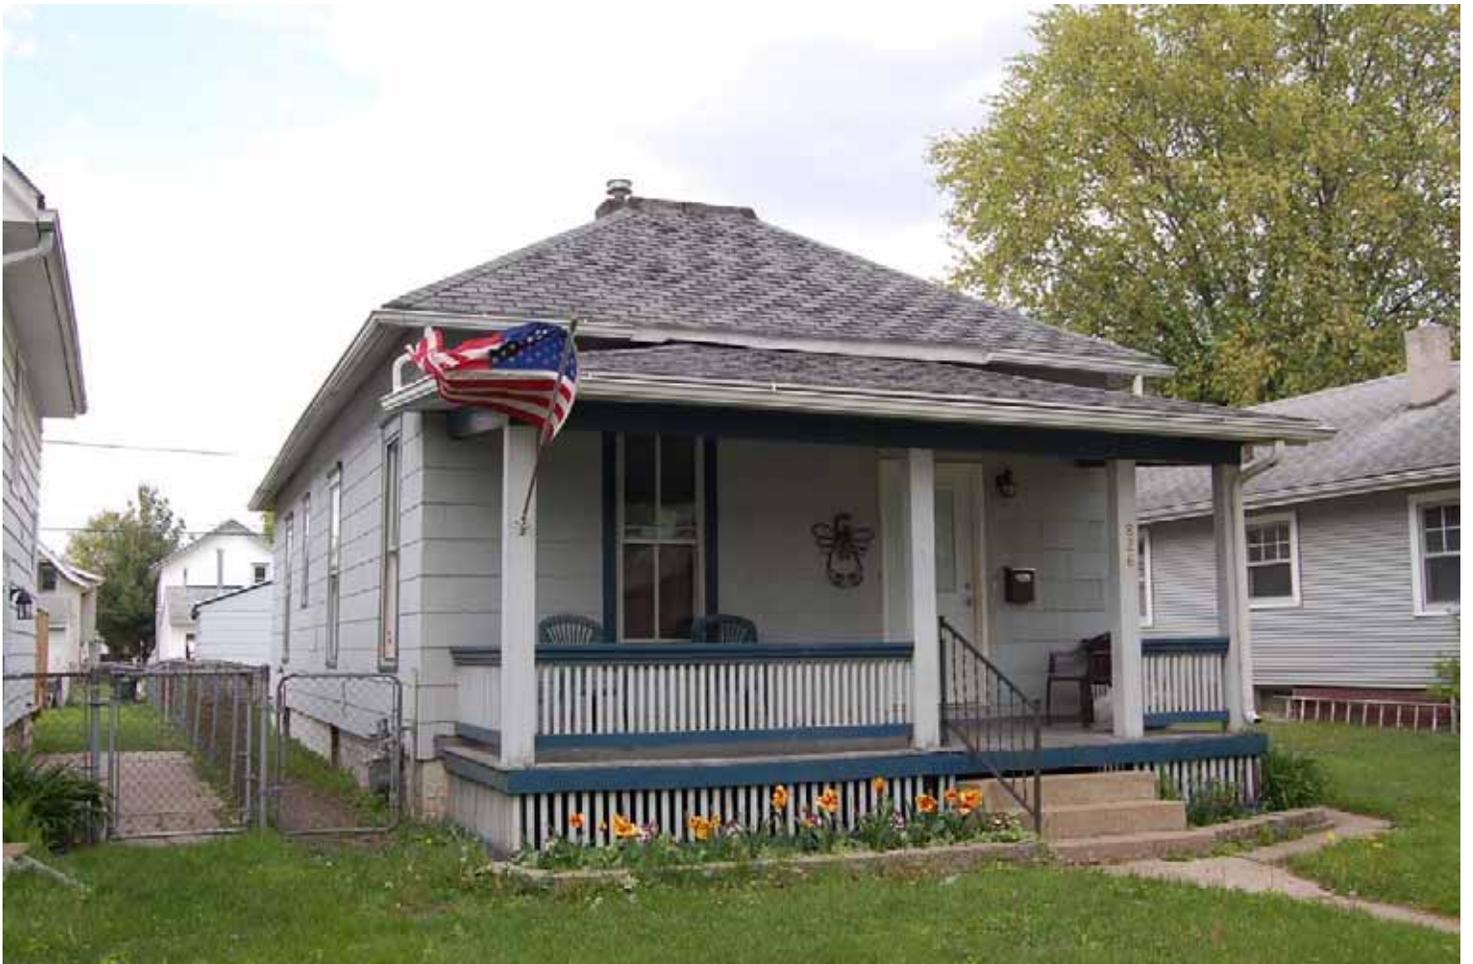
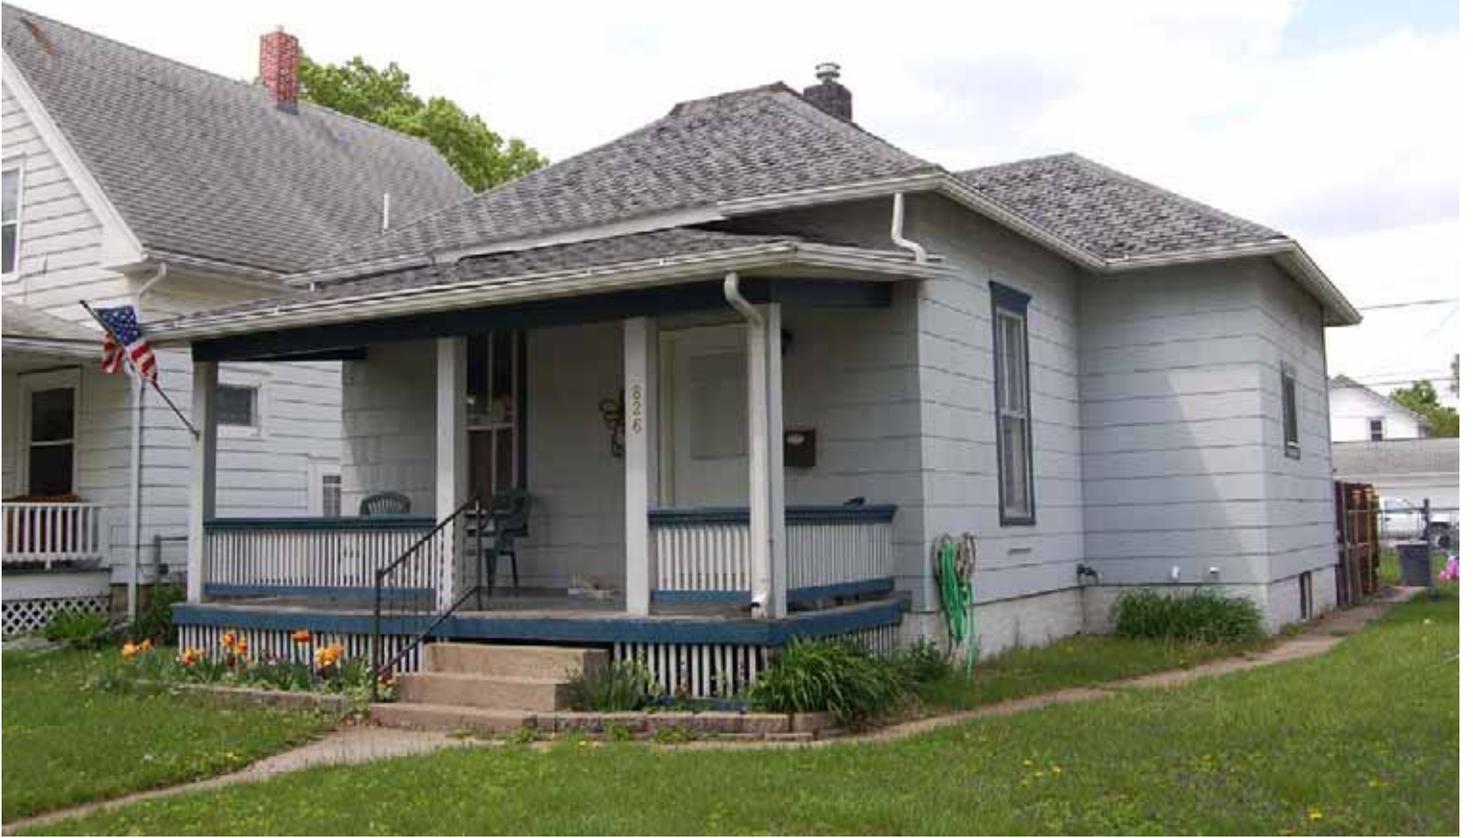
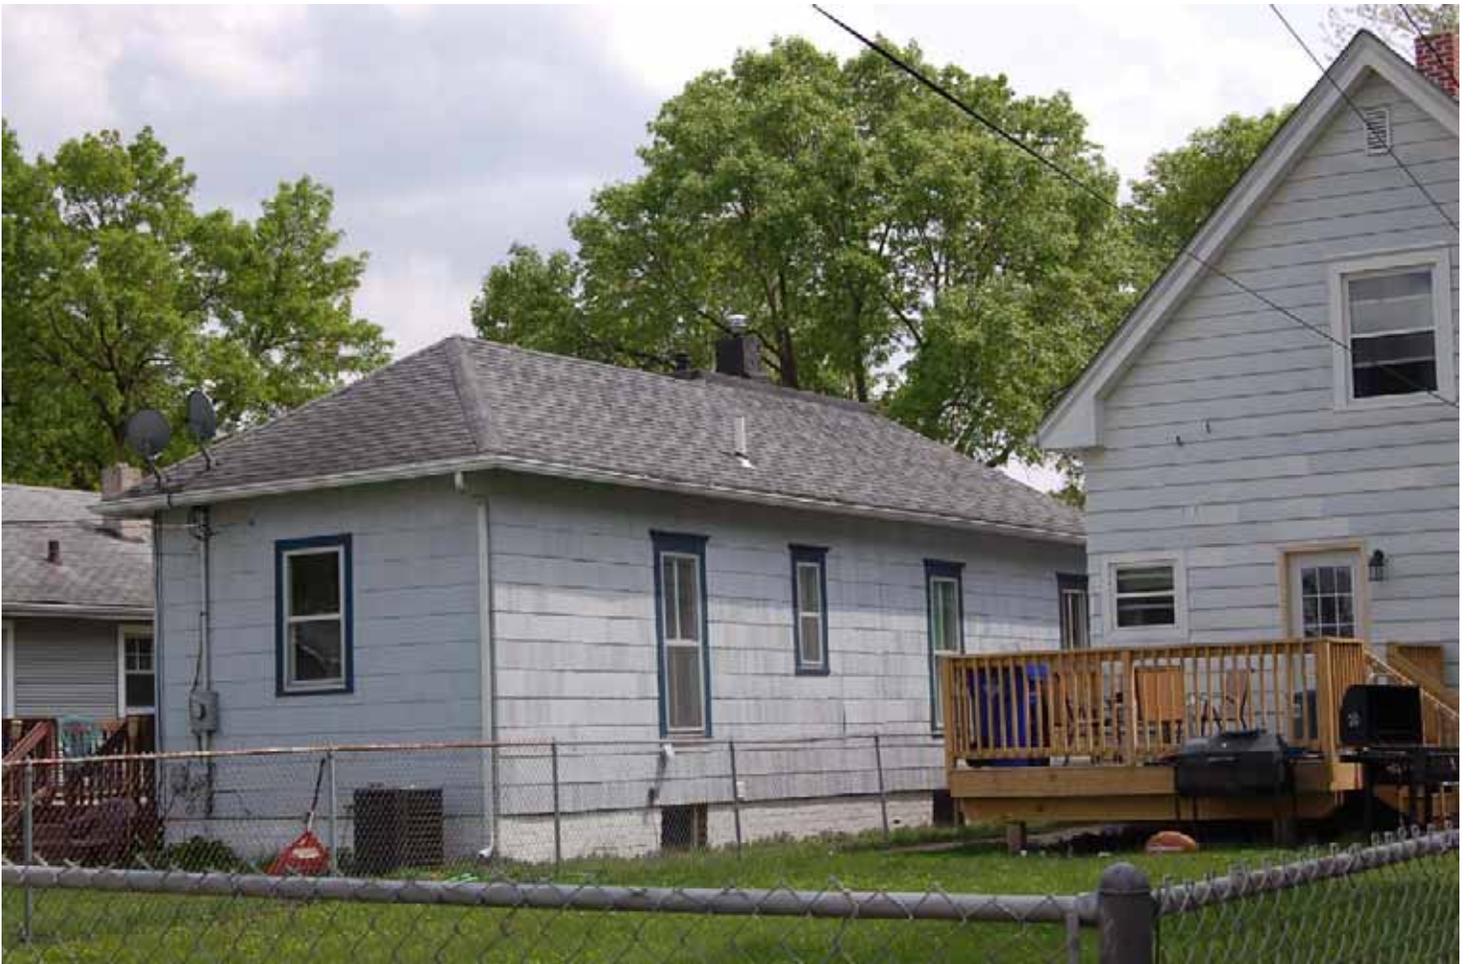
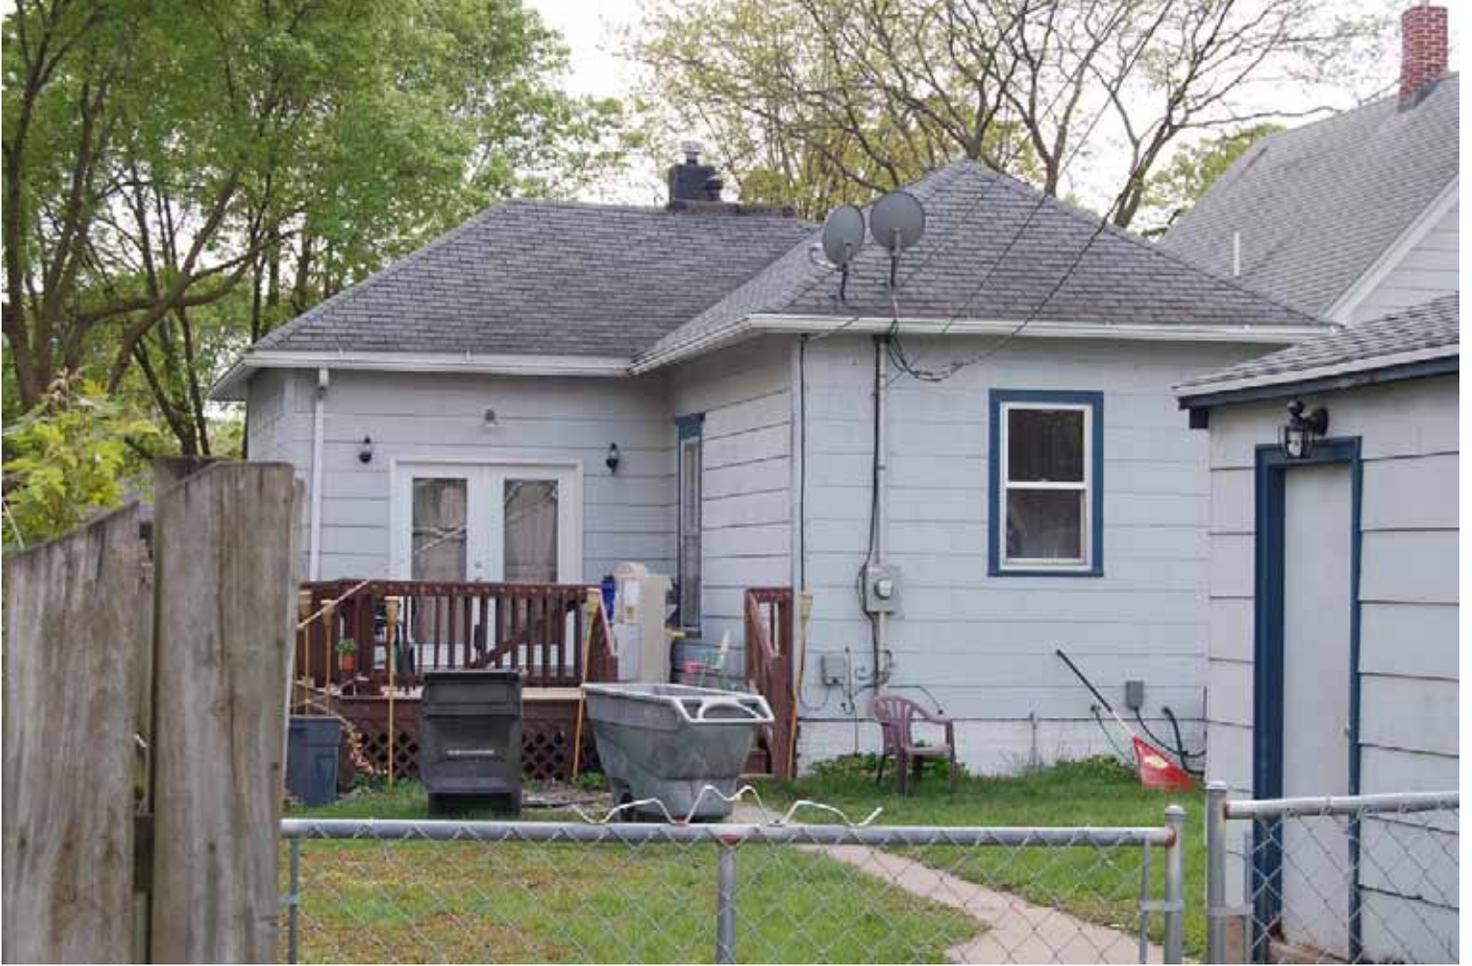
826 G Avenue NW_View NE.JPG

826 G Avenue NW (1910) – Vernacular 1 story, frame dwelling has a hipped roof with a clipped top, asbestos shingle siding, and a painted brick foundation. This type of dwelling, often termed National style, is a rare house type in the Time Check neighborhood, which contains predominantly 1 ½ story gable front, side-gable, and gable front and wing dwellings. As such, Berger recommended the structure as potentially eligible for inclusion in the NRHP under for Criterion A. The IOWA SHPO concurred with that opinion on May 22, 2009.

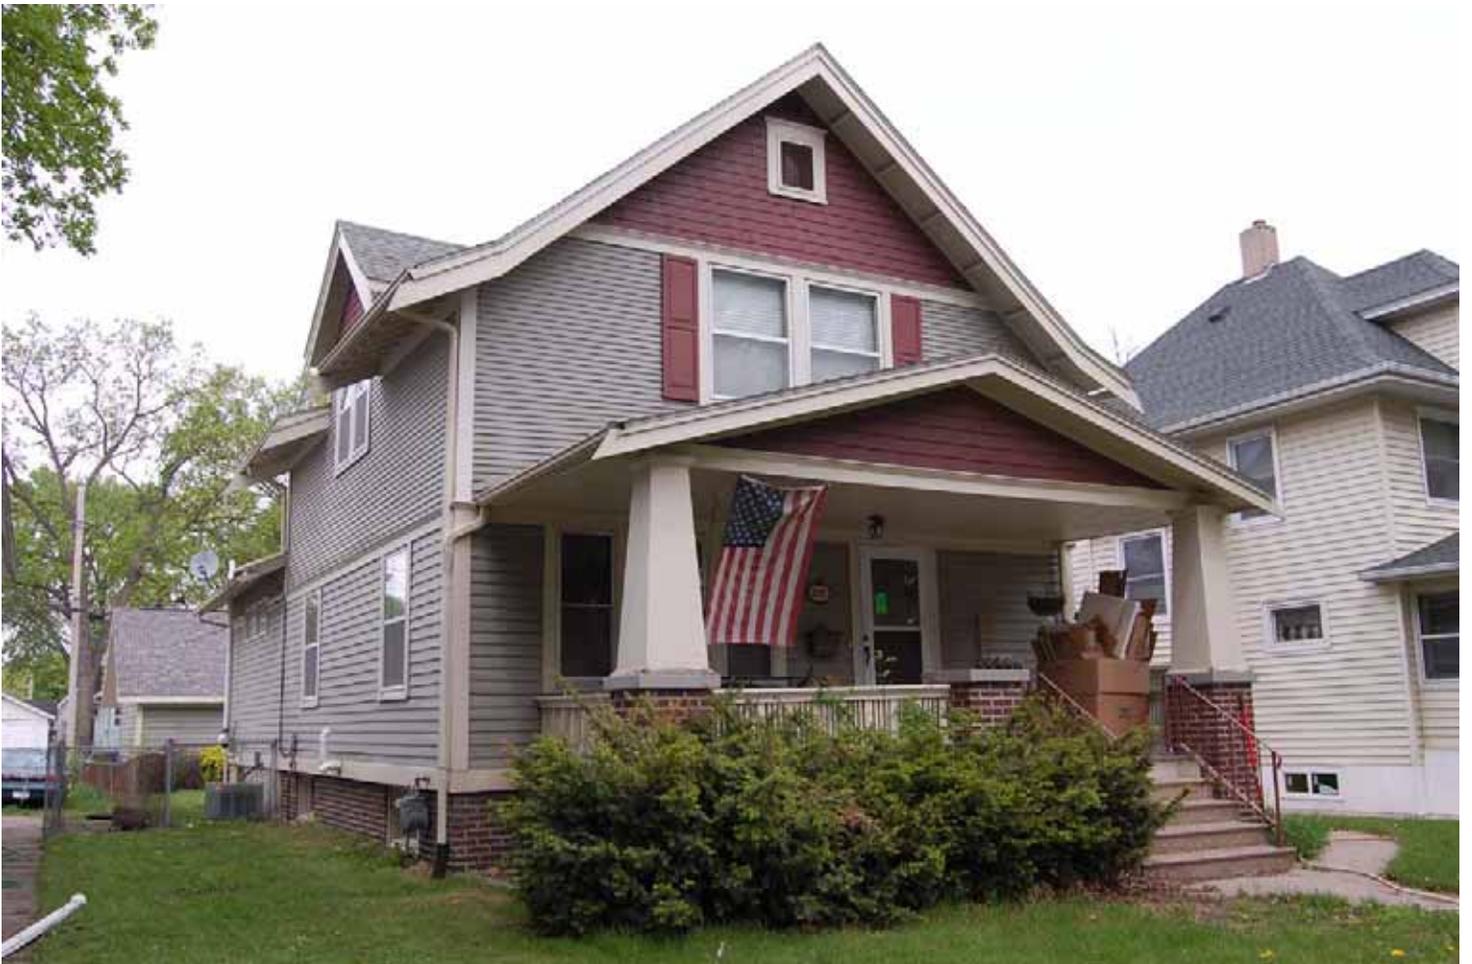
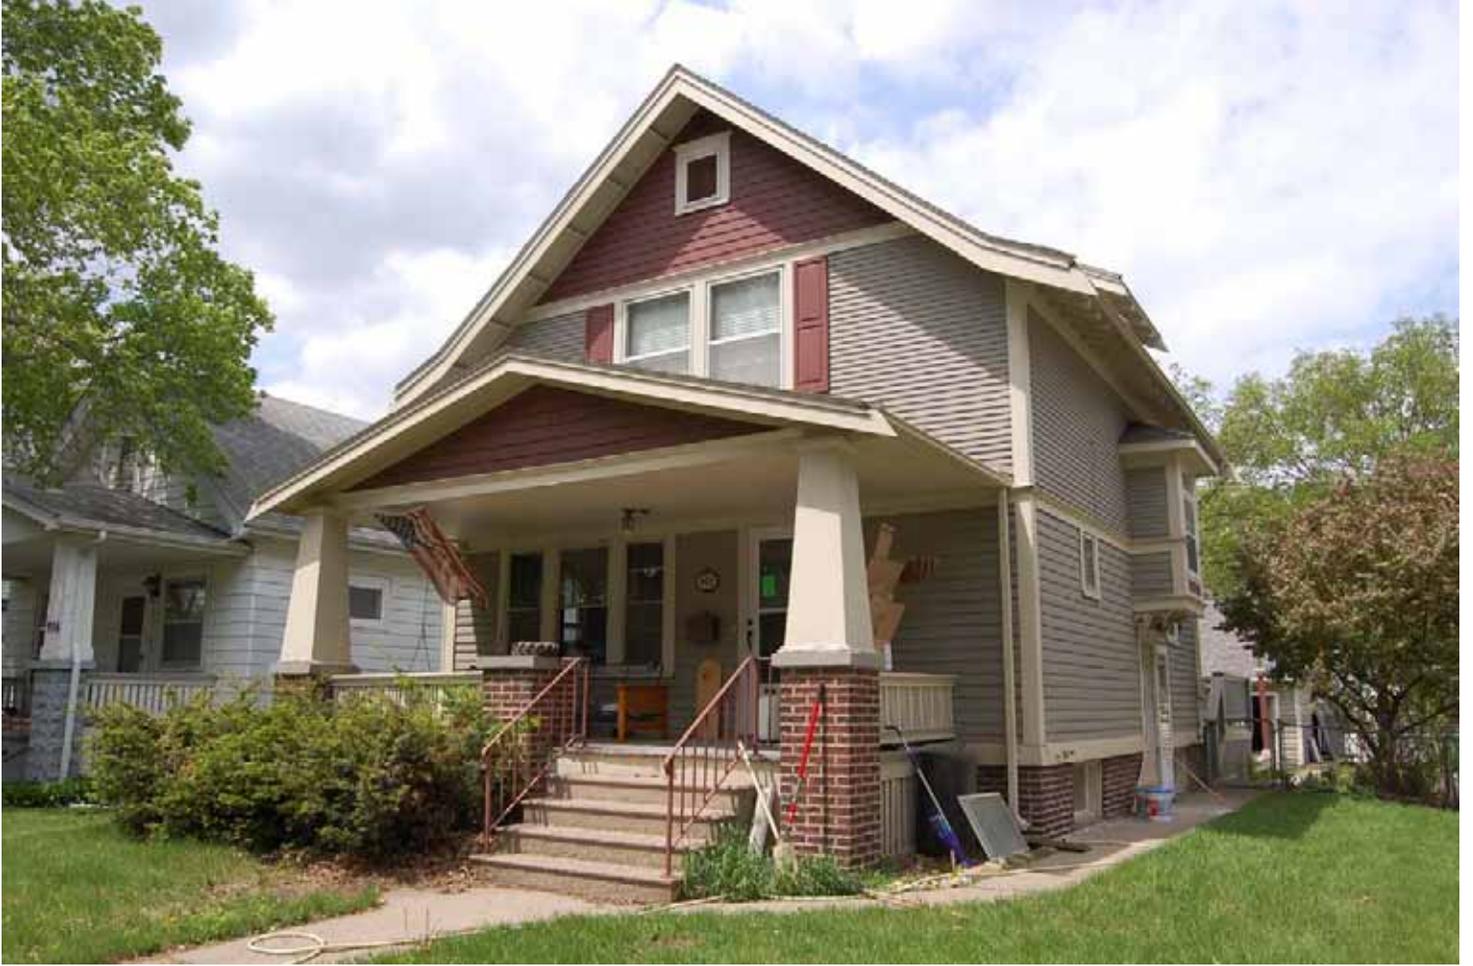
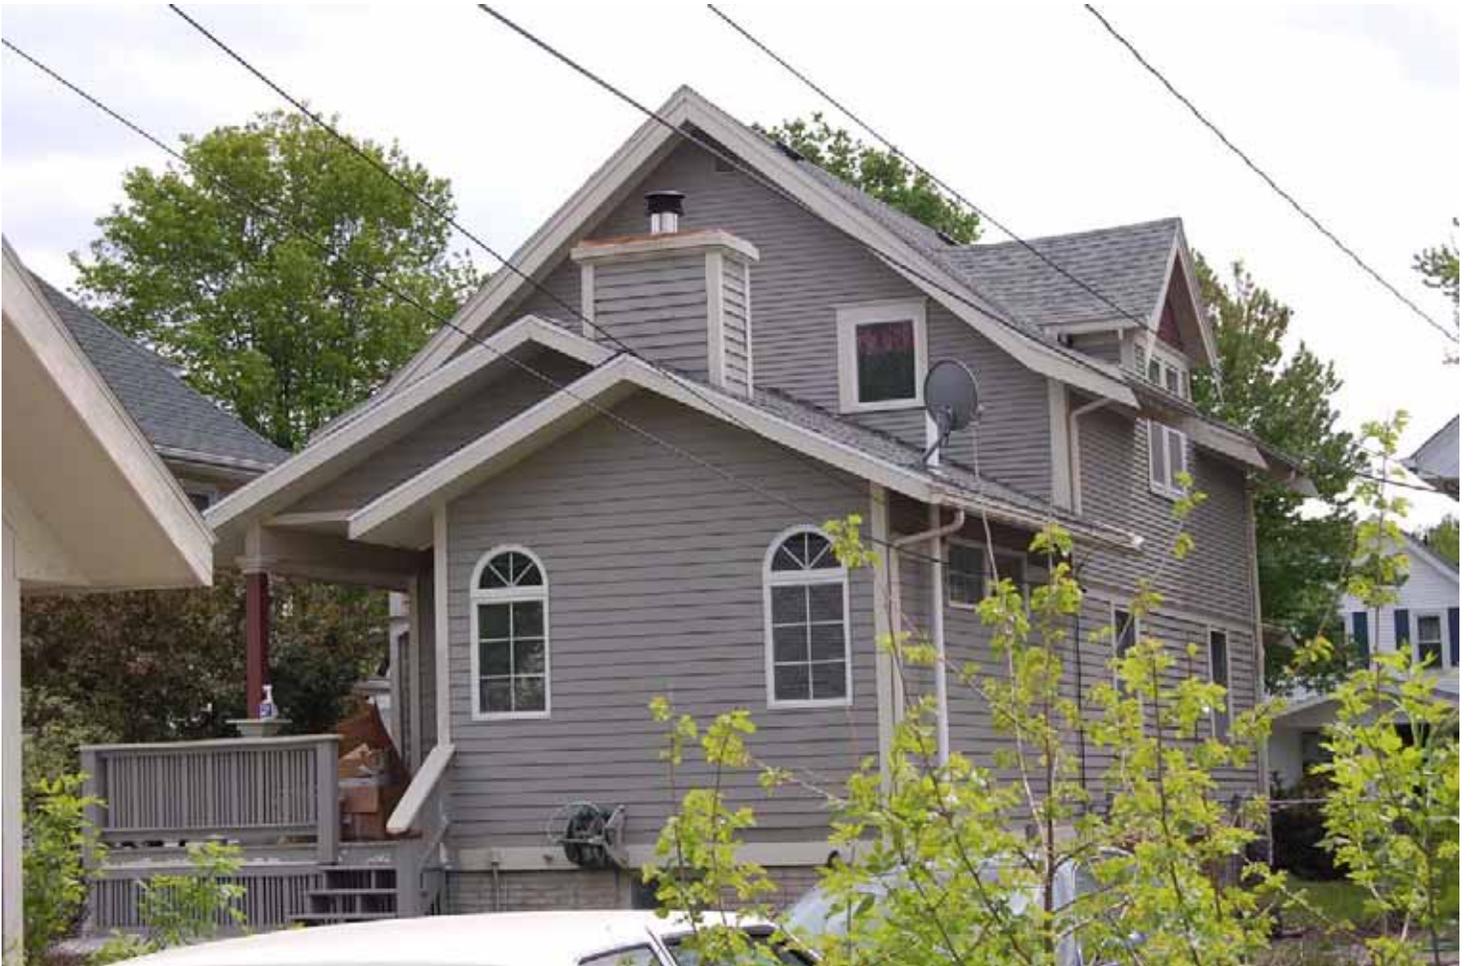
922 G Avenue NW_View NE.JPG

922 G Avenue NW (1912) – Vernacular 2 story gable front frame dwelling with a brick foundation, gable front open porch supported by brick piers, wide siding on the first level, narrow siding on the second level, an upper story bay window supported by scrolled brackets, cedar shingles in the gable ends and exposed rafter tails. Although a modern addition has been constructed on the rear façade and some windows have been replaced, the house remains eligible under Criterion C as an important example of the vernacular gable front dwelling that is commonly found in the working class neighborhoods of the city.
