**Architectural Reconnaissance Survey
for Brown's Additions
to Cedar Rapids
(57-085)**

Linn County, Iowa

**June 2, 2009
Revised March 10, 2010**

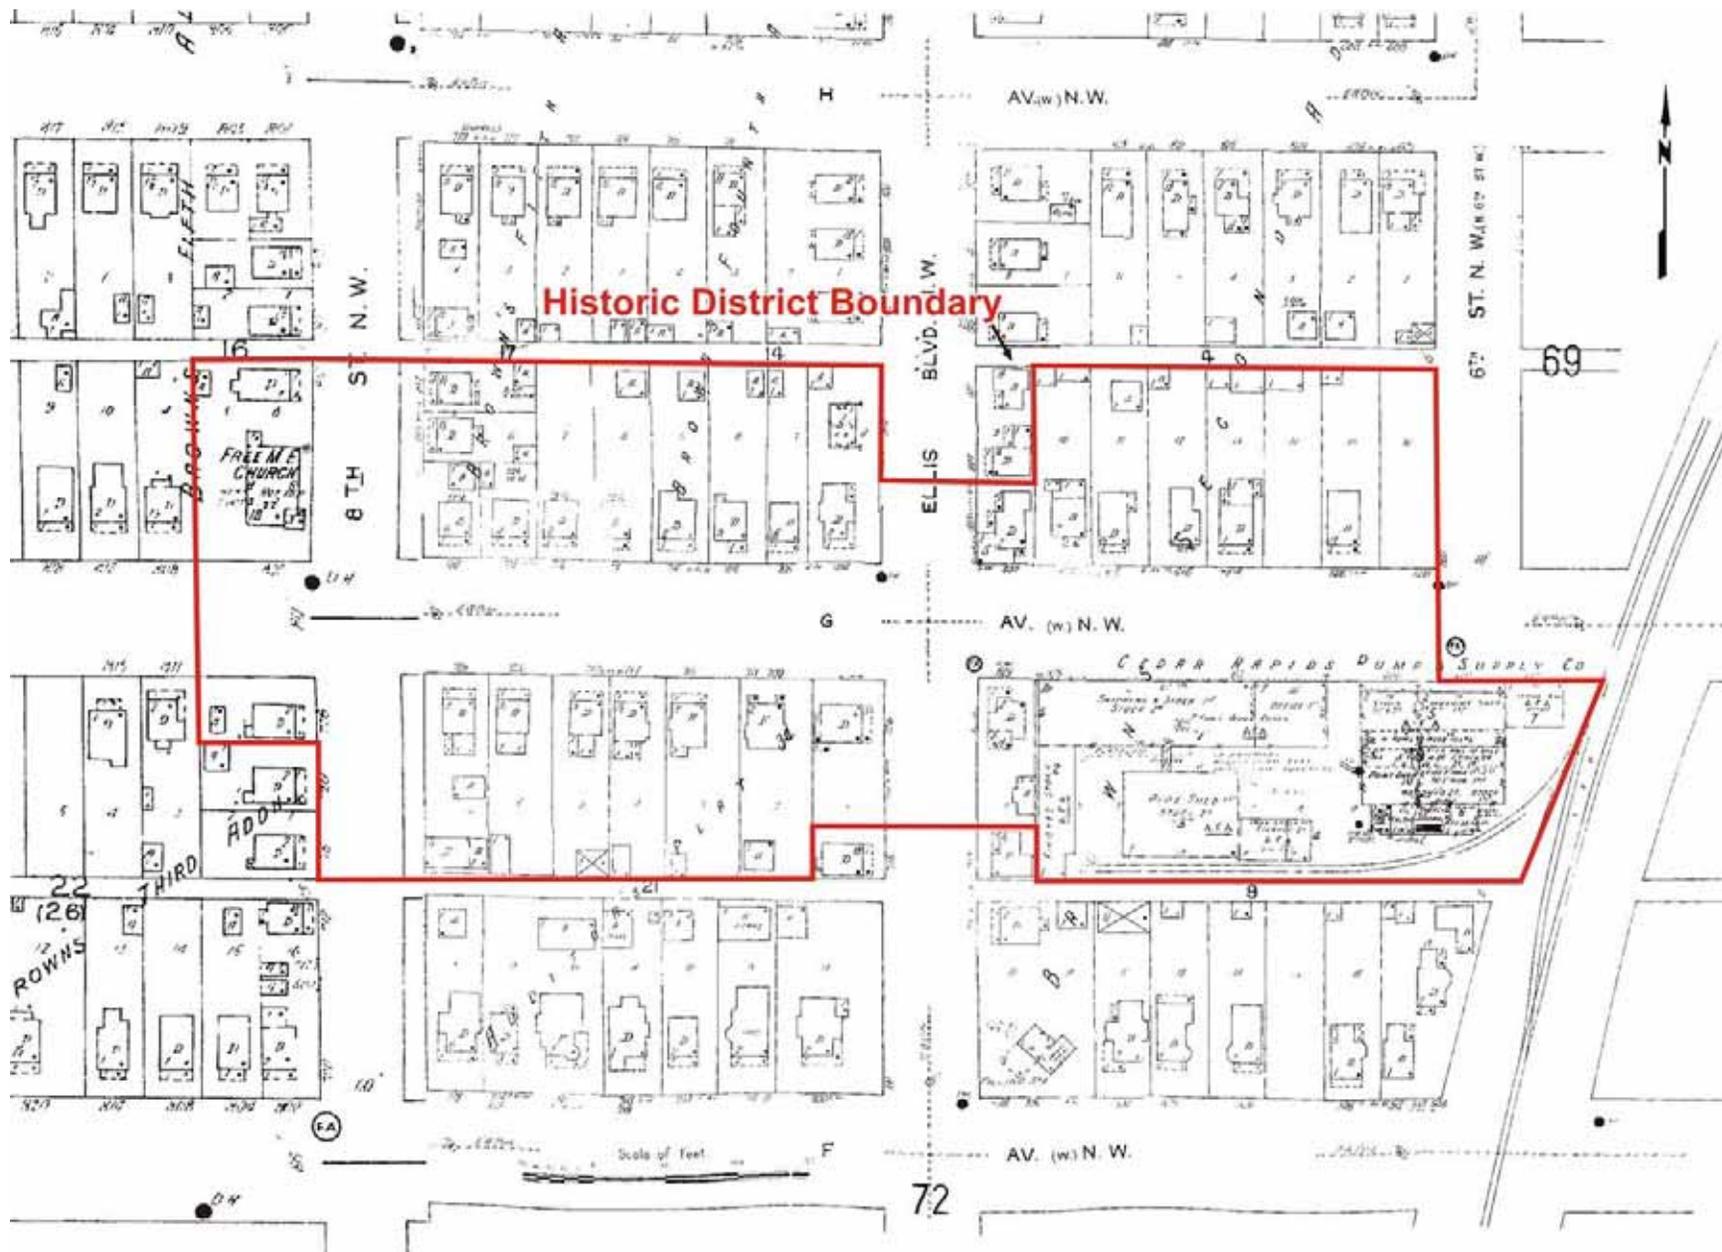
Review of Sanborn Fire Insurance maps of the district indicates that several houses were not present in the area until after 1949 including 600 G Avenue NW and 610 G Avenue NW (Figure 2). Sanborn maps from as early as 1895 to 1949 show vacant lots at both of these locations. The house at 610 G Avenue NW was constructed in 1965, according to Cedar Rapids Assessor's data. This date appears to be correct given the concrete block foundation and lower pitched gable-front roof of the house. The house at 600 G Avenue NW was likely moved to the site sometime after 1949.

Figure 2: Sanborn Fire Insurance Company Map of G Avenue Historic District, 1913-1949

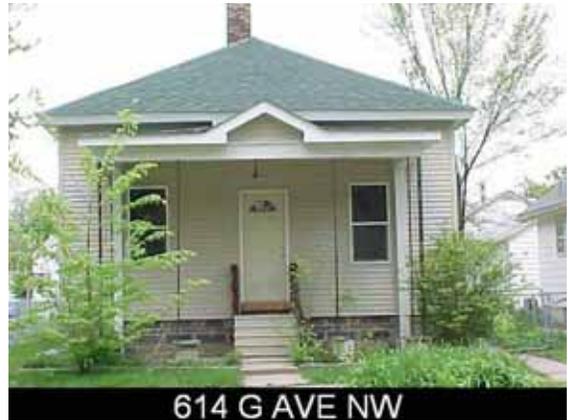
Property Address 614 G AVE NW

PRE RVAL:FLRS=SAGGING. CEILINGS= SAGGING. INT=POOR SHAPE.1/09/02 DWLG PLACARDED BY HOUSING-IN VP CONDITION, CARPORT-NV,C-02.TH.12/18/02 COMP TO PS,

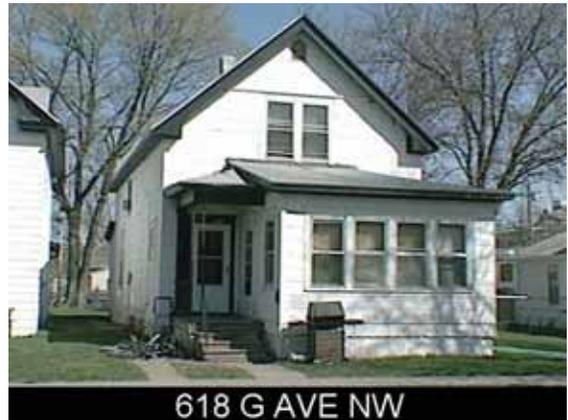
Property Address 618 G AVE NW

PRE RVAL:X-PLMB=1BT.
 01/29/2003-WORN FLR & WALL COVERINGS. NEWER ROOF.
