**Architectural Reconnaissance Survey  
for Kingston  
in Cedar Rapids  
(57-088)**

**Linn County, Iowa**

**The Louis Berger Group, Inc.  
950 50<sup>th</sup> Street  
Marion, Iowa 52302**

**July 14, 2009**

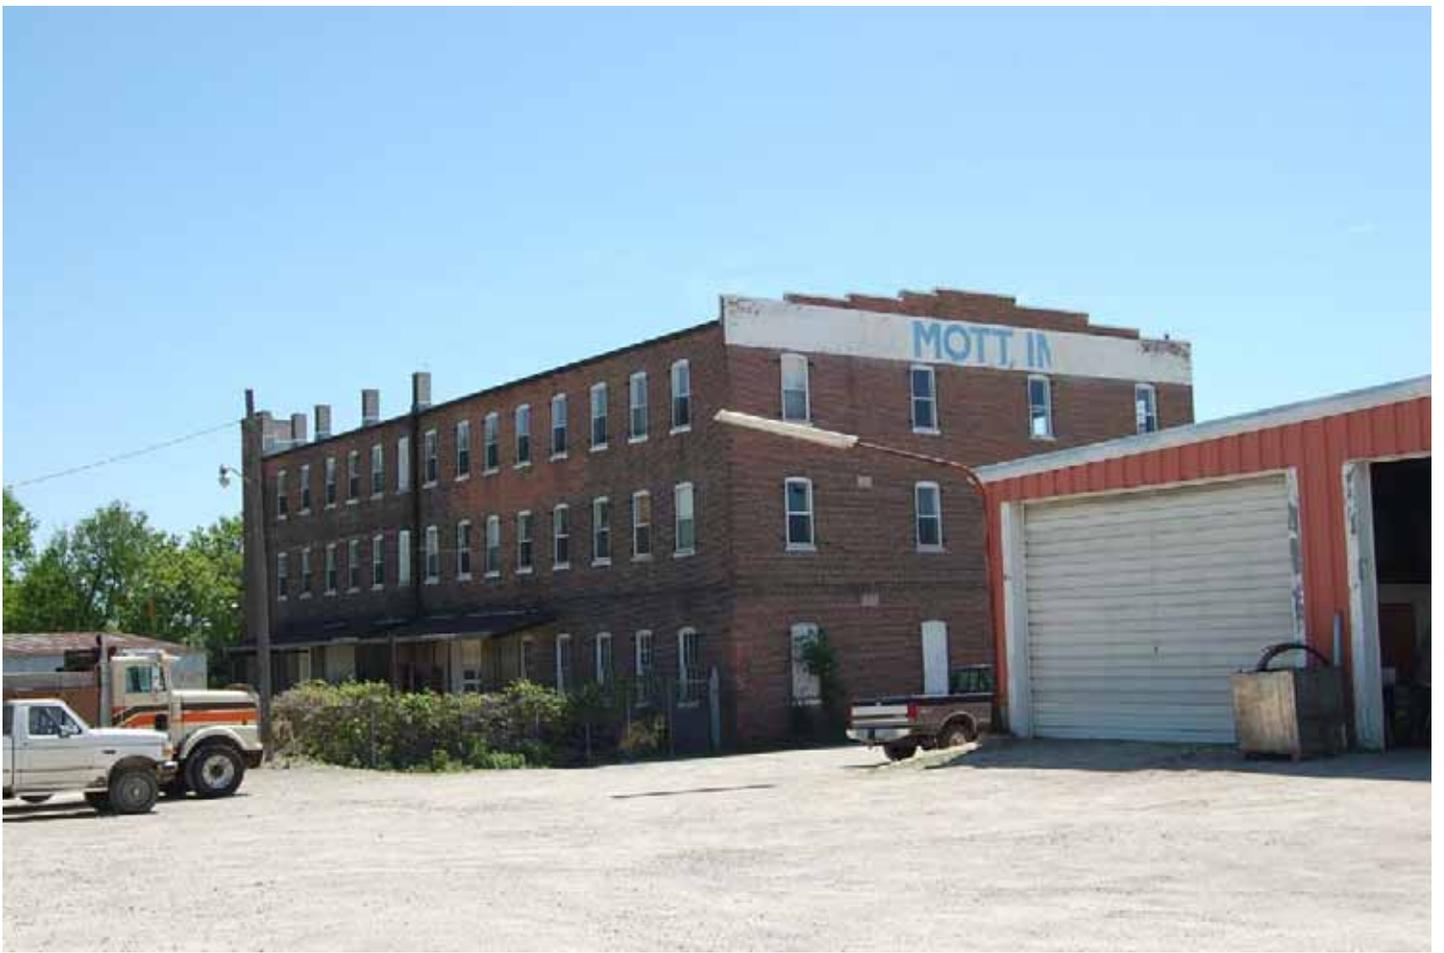
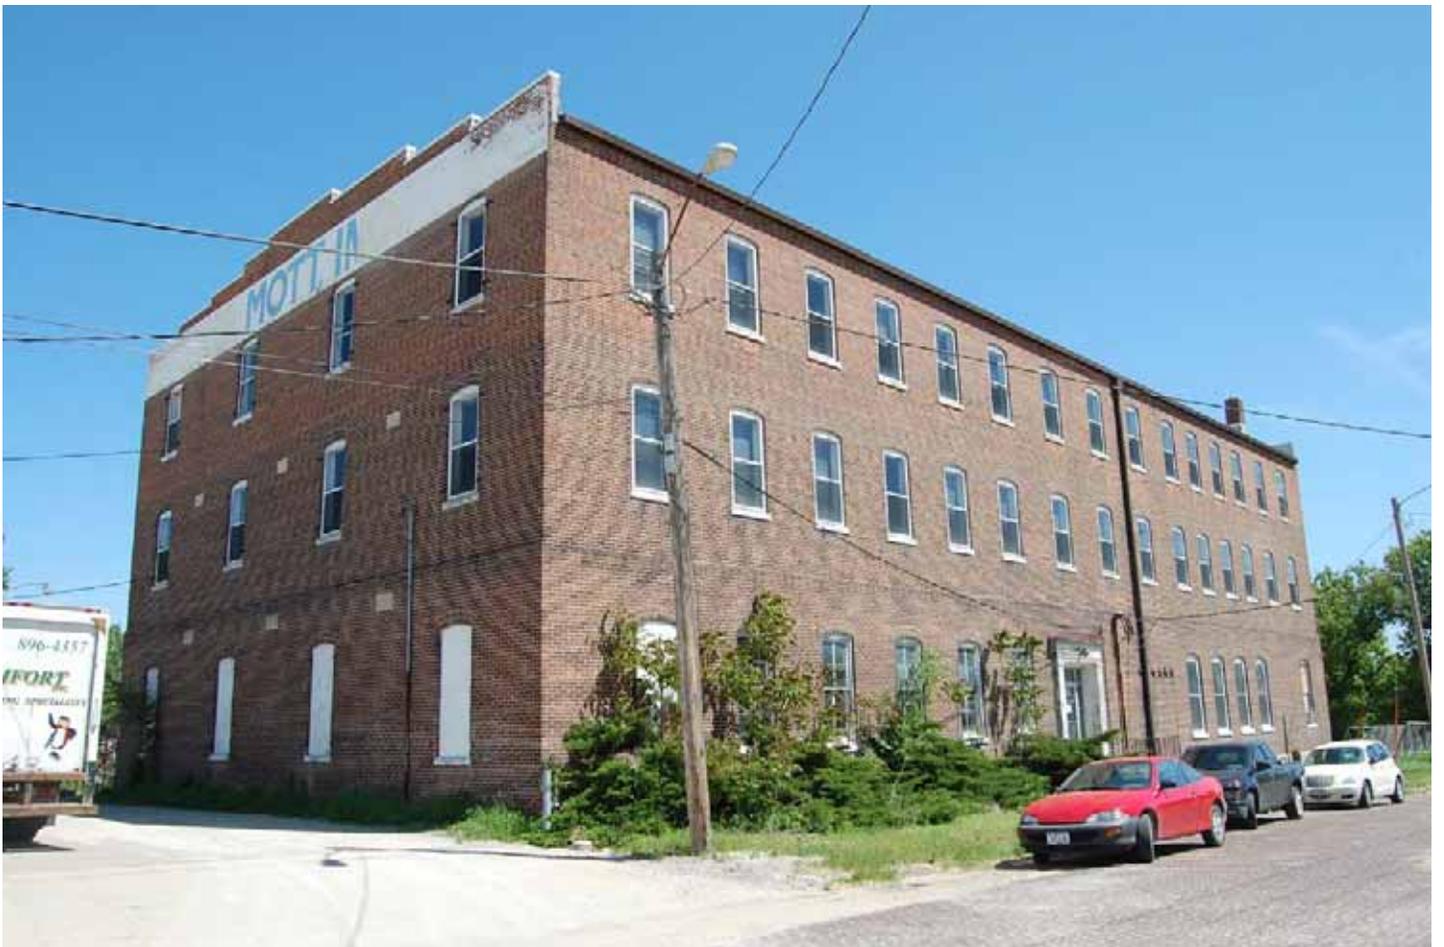
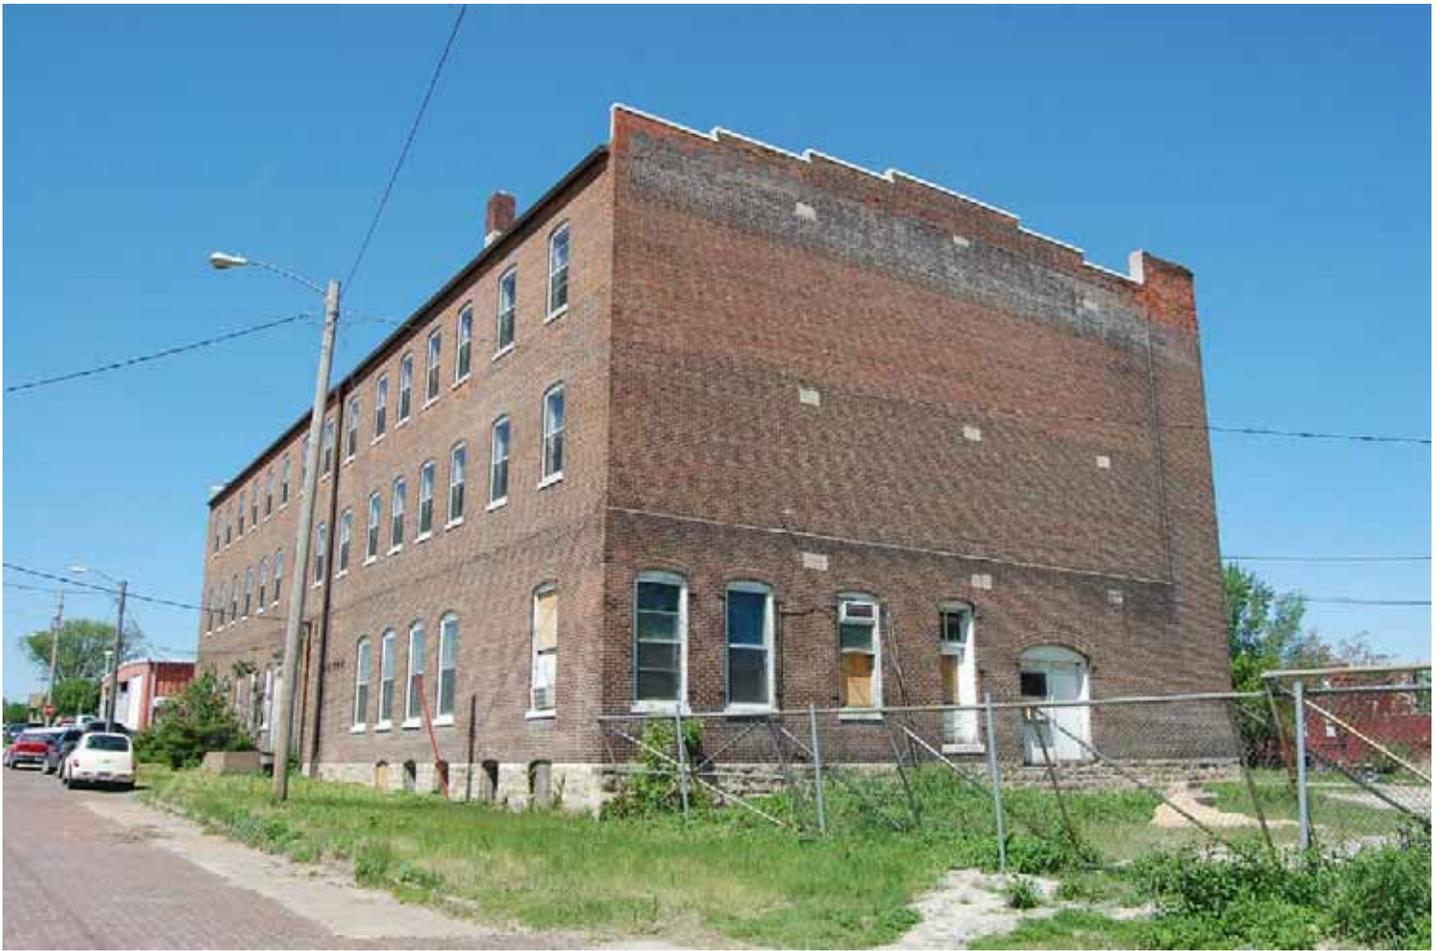
42 7th Avenue SW\_View E.JPG

*42 7<sup>th</sup> Avenue SW (ca. 1900)* – Three story brick industrial building has a limestone foundation, segmental arch windows, and a stepped parapet roof. Sanborn fire insurance maps indicate that the building housed the Iowa Wind Mill and Pump Company from its construction around 1900 to at least 1949. Most of the windows have been replaced, though several 4/4 wood sash can be found on the first floor. Cited as the Iowa Pipe & Supply Company by Marlys Svendsen in her MPD, *Commercial and Industrial Development of Cedar Rapids, c. 1865-c. 1945*, the building is eligible under Criteria A and C as an important example of an early twentieth century industrial building that was associated with development on the west side of the Cedar River.

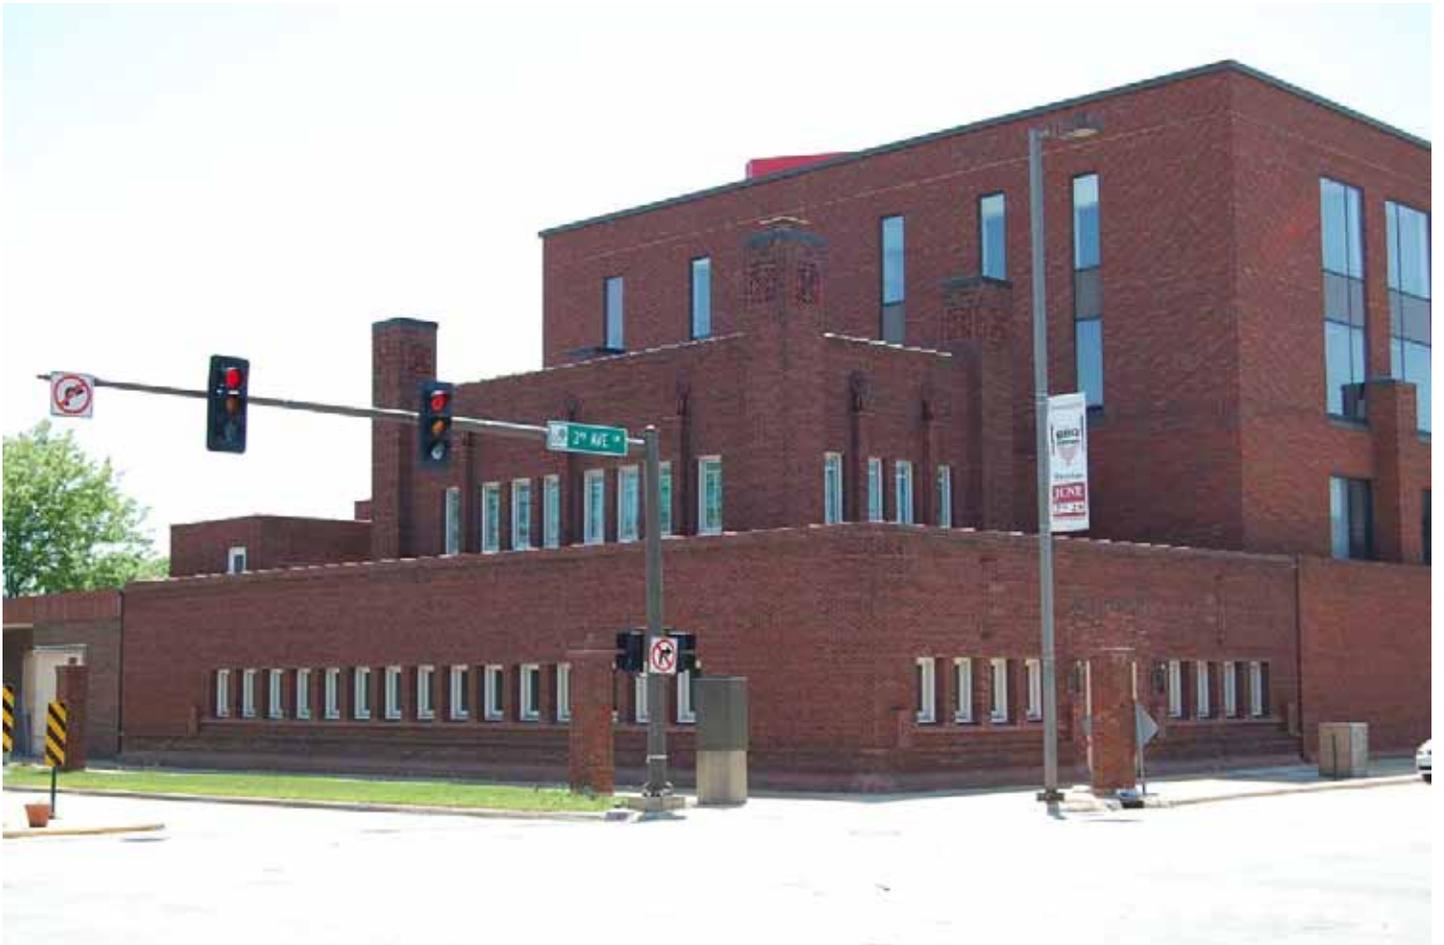
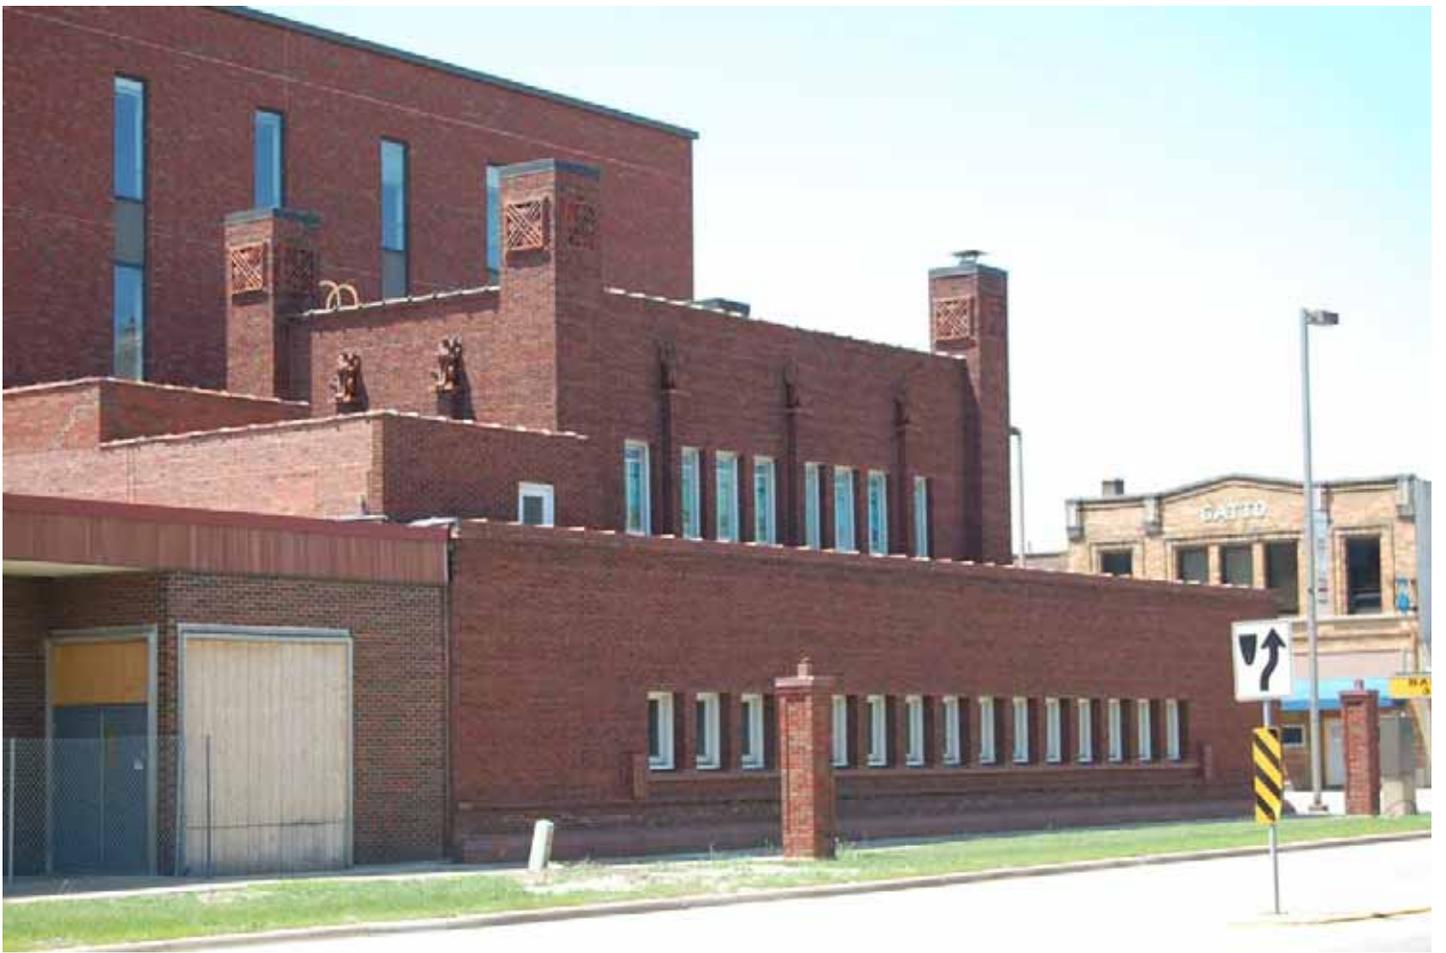
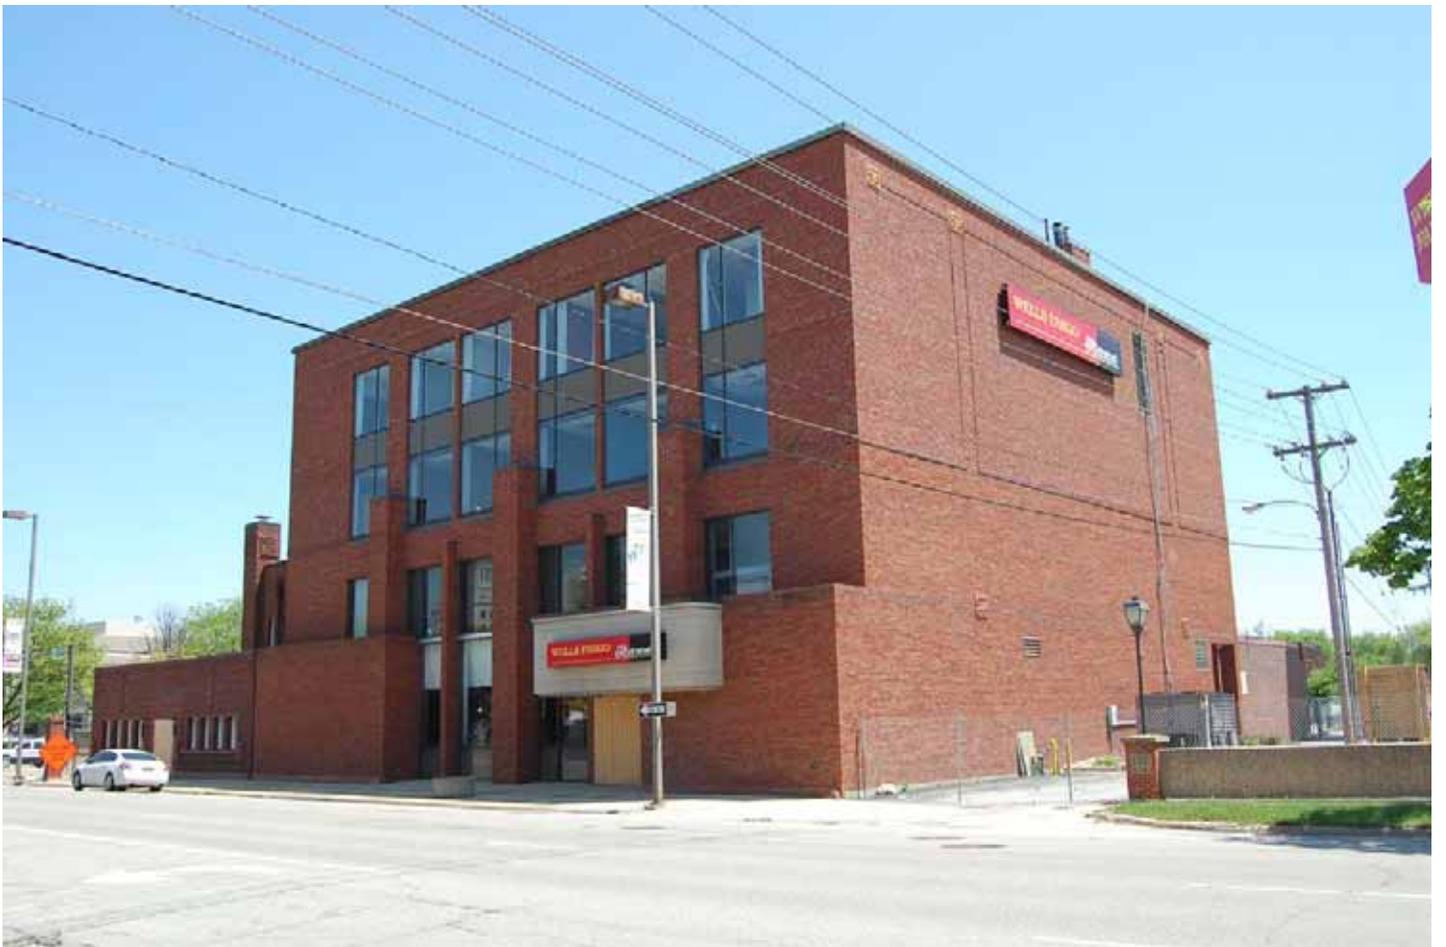
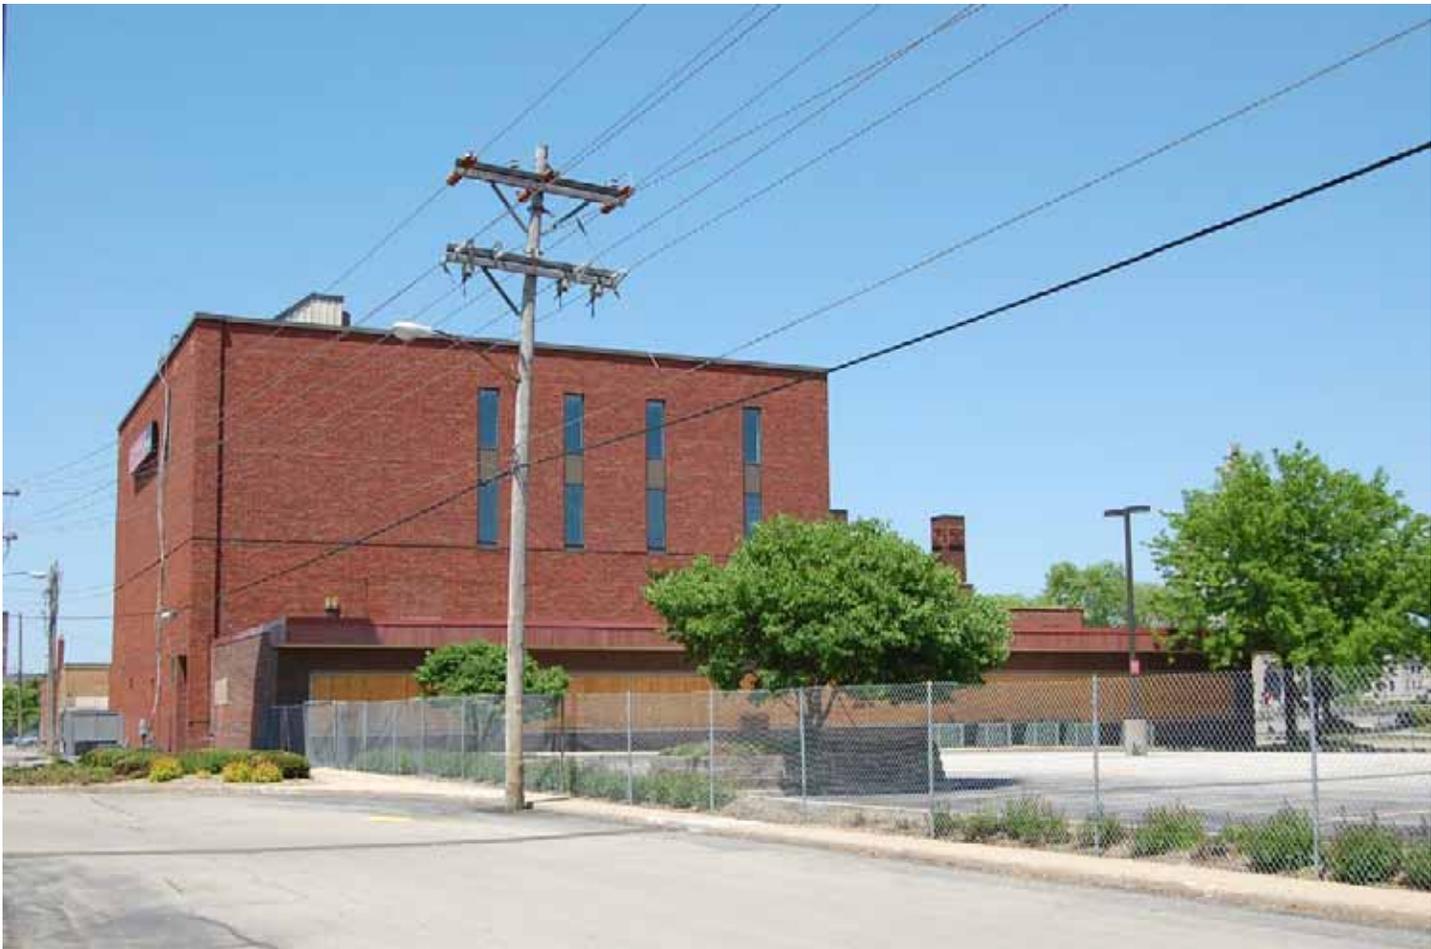
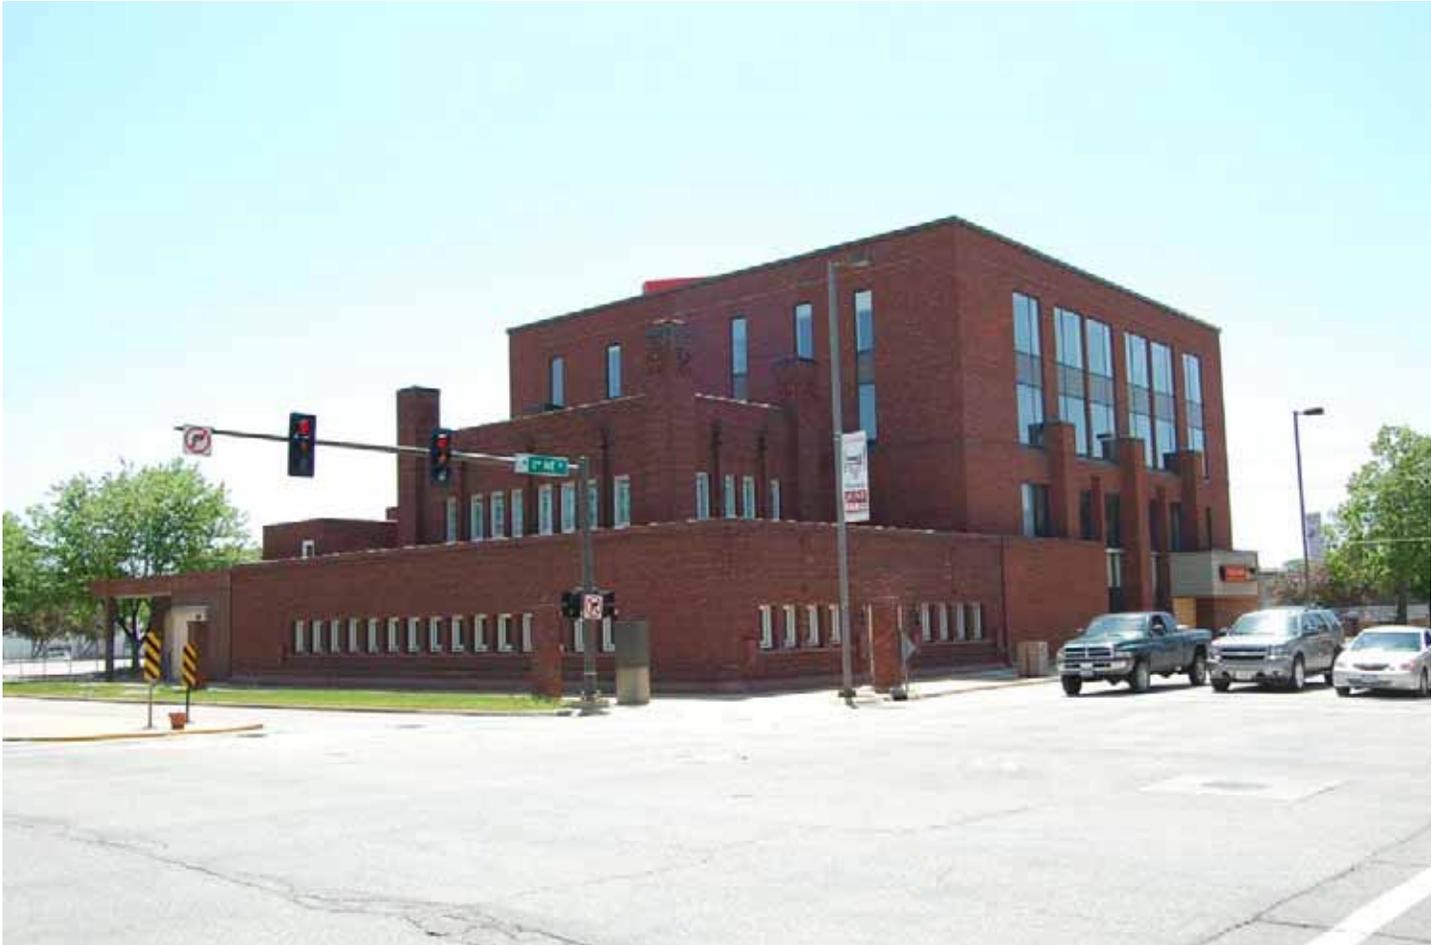
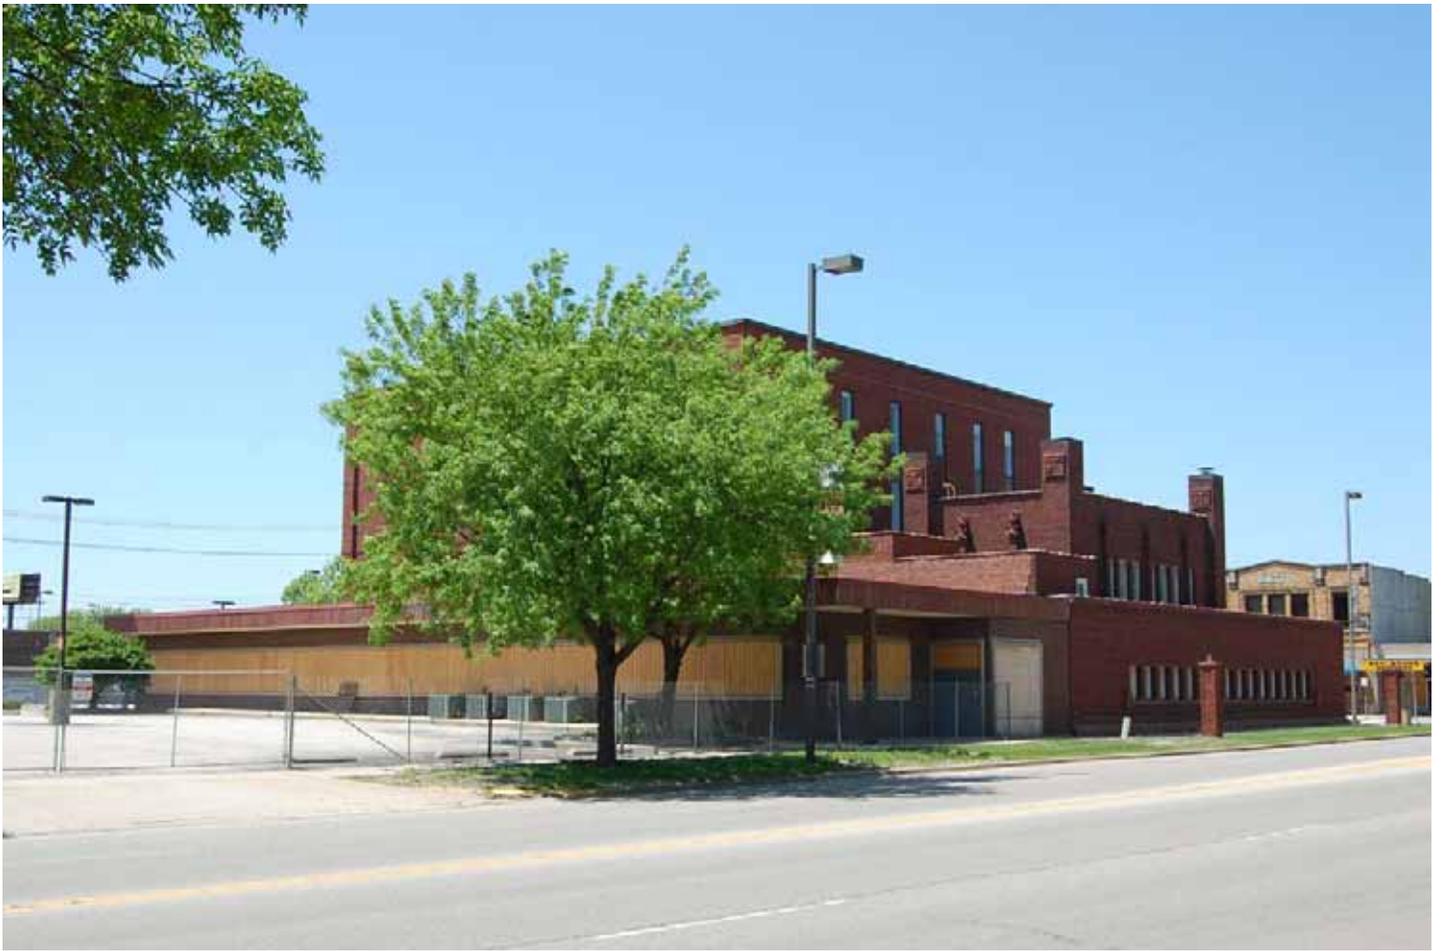
101 3rd Ave SW\_View E.JPG

*101 3<sup>rd</sup> Avenue SW (1910)* – The People’s Savings Bank building was listed in the National Register of Historic Places in 1978 under Criterion C as an important example of a small Midwestern bank designed by nationally renowned architect Louis Sullivan. First few floors of large addition on the west side of the bank were constructed in 1966. Sometime after 1978, several additional stories were added to this addition. Despite this addition, the bank retains sufficient integrity of design, workmanship, materials, feeling, association, location and setting to be listed in the National Register.

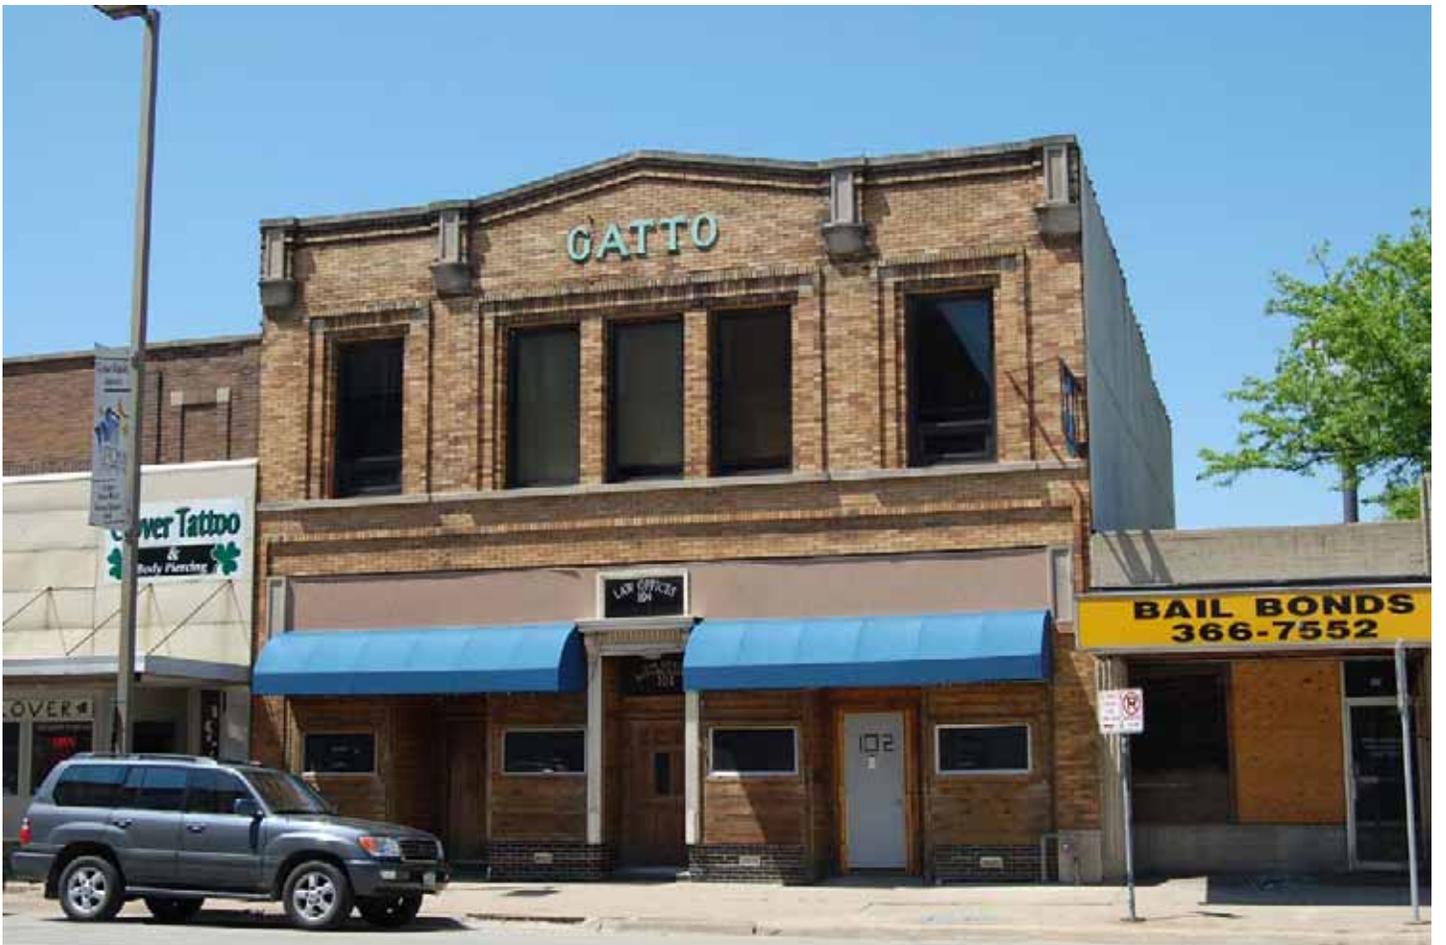
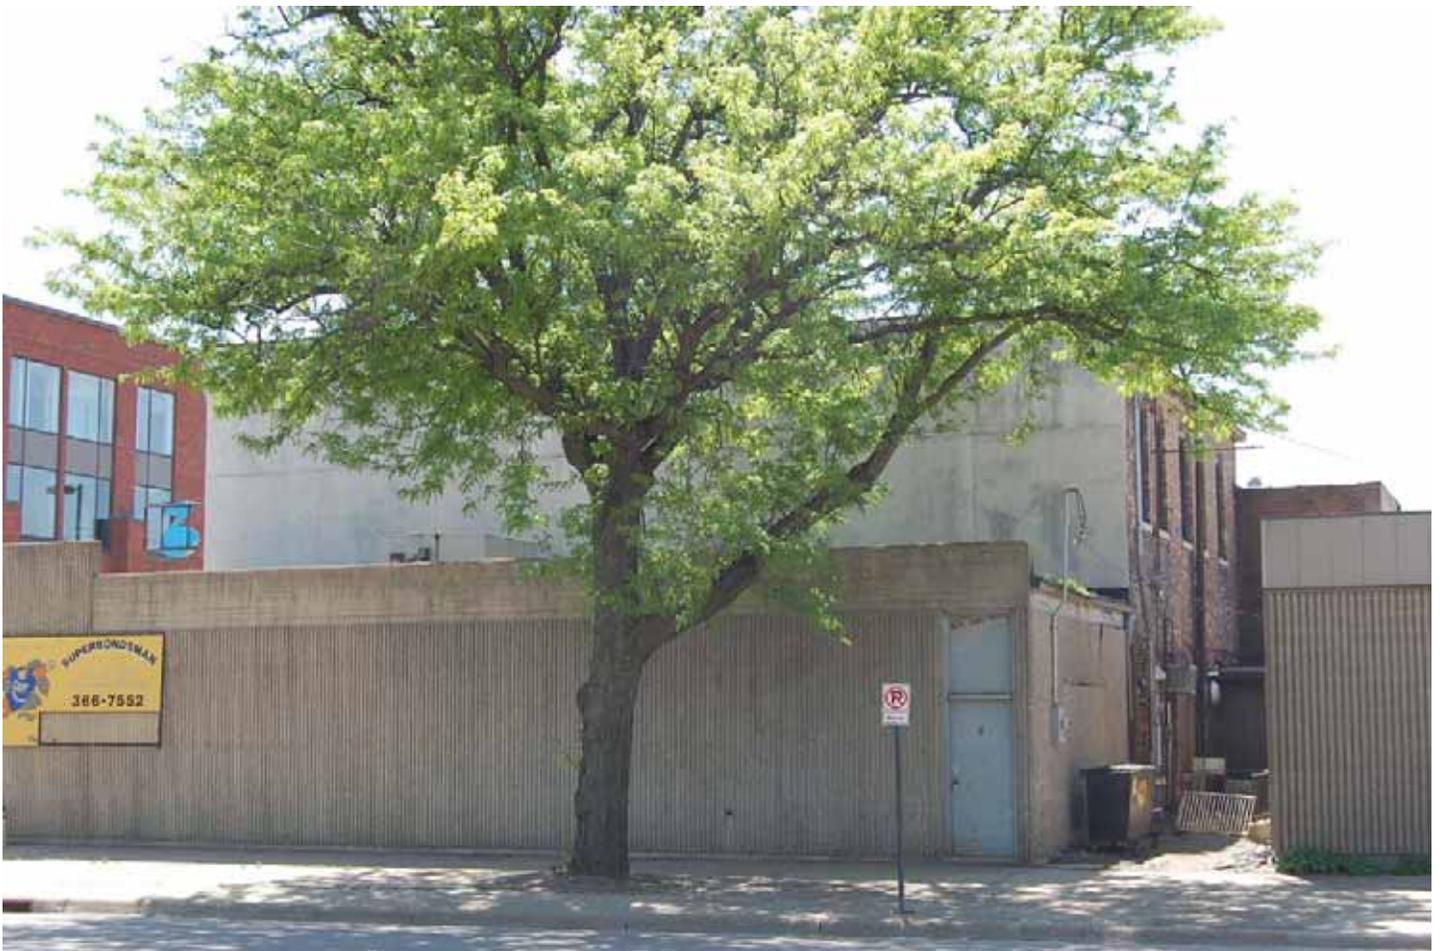
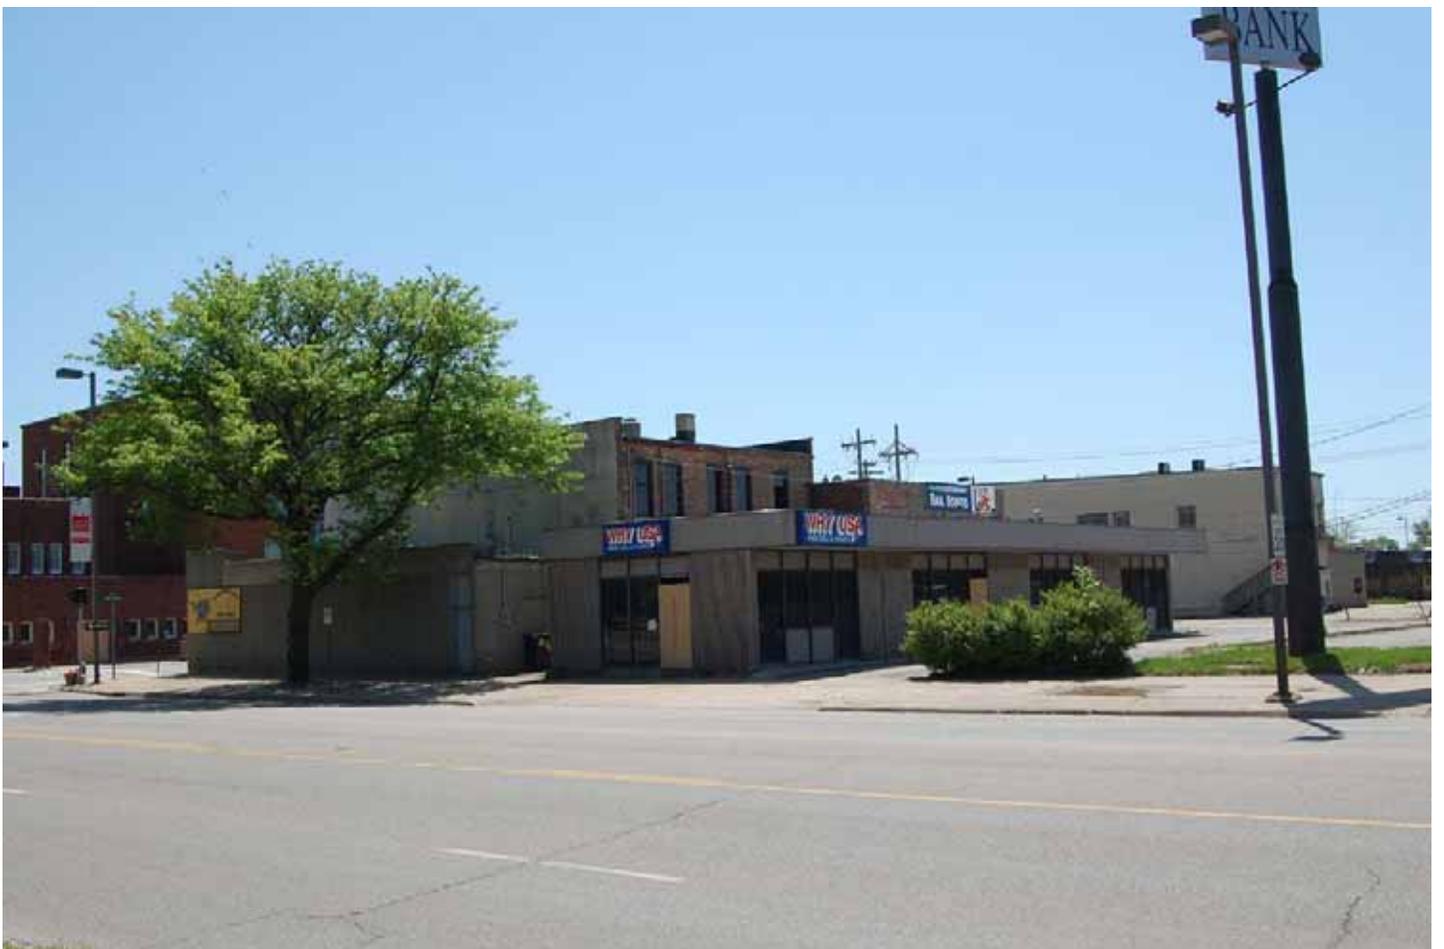
102 3rd Ave SW\_View NW.JPG

*102-104 3<sup>rd</sup> Avenue SW (1912)* – The Gatto Building is a two story commercial building that features buff colored brick walls, corbelling around the upper story windows, concrete window sills/beltcourse, and a pedimented false parapet on the main façade. The first floor has two storefronts with modern wood siding and fixed windows separated by a recessed entrance that retains its original trim surmounted by a deep frieze and cornice. The transoms have been covered by paneling. The upper story has three paired windows in the center flanked by single windows. The center windows are fixed modern steel sash. The outer windows are comprised of steel hopper windows surmounted by fixed steel sash. The building was designed by the Cedar Rapids' architectural firm of Deiman and Fiske. The Gatto Building was identified as potentially eligible for listing in the NRHP by Marlys Svendsen in her MPD, *Commercial and Industrial Development of Cedar Rapids, c. 1865-c. 1945*. The building is eligible under Criteria A and C for its association with the commercial development on the west side of the Cedar River.

The next year in 1912, the Gatto Building (102-104 3rd Avenue, SW) was completed across the street from the Peoples Savings Bank. It was designed by the Cedar Rapids' architectural firm of

Deiman and Fiske and like the other buildings along 3rd Avenue, SW contained a geometric patterned parapet and brick corbelling. Gatto's produce store was located in one shop space and Pohorsky Clothing next door. A meat market, grocery store, cafe and tavern variously occupied the building in later years. The 3rd Avenue, SW building boom continued two years later when the Colonial Theater opened next door at 108 3rd Avenue, SW. The theater's geometric brick and terra cotta decoration imitated the exterior treatments of neighboring buildings. The theater closed during the 1930s and subsequently housed a variety of retail businesses and offices.

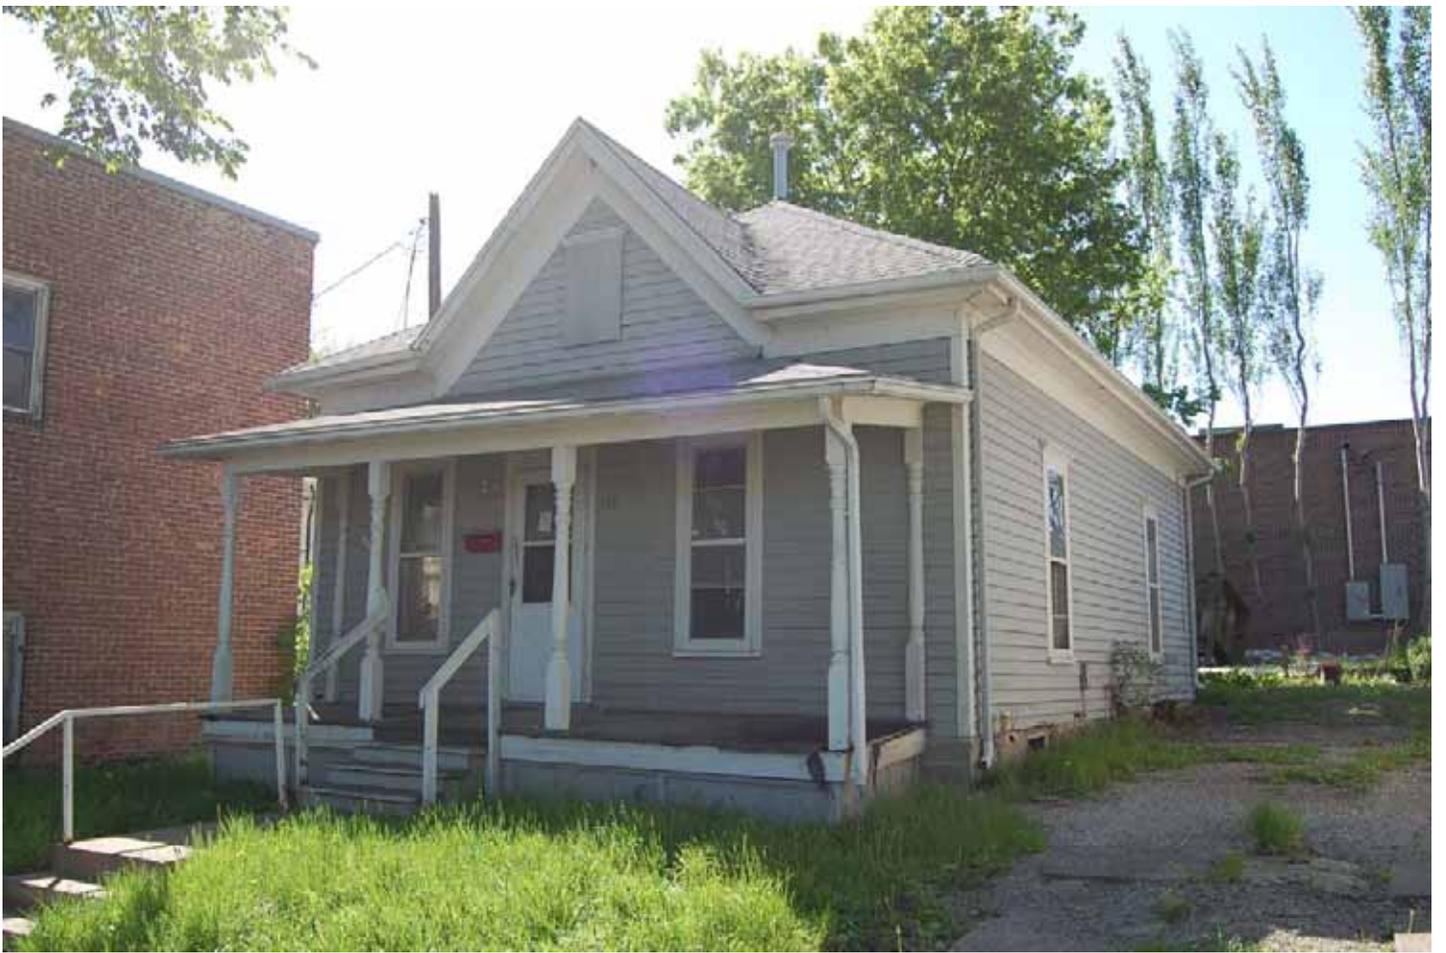
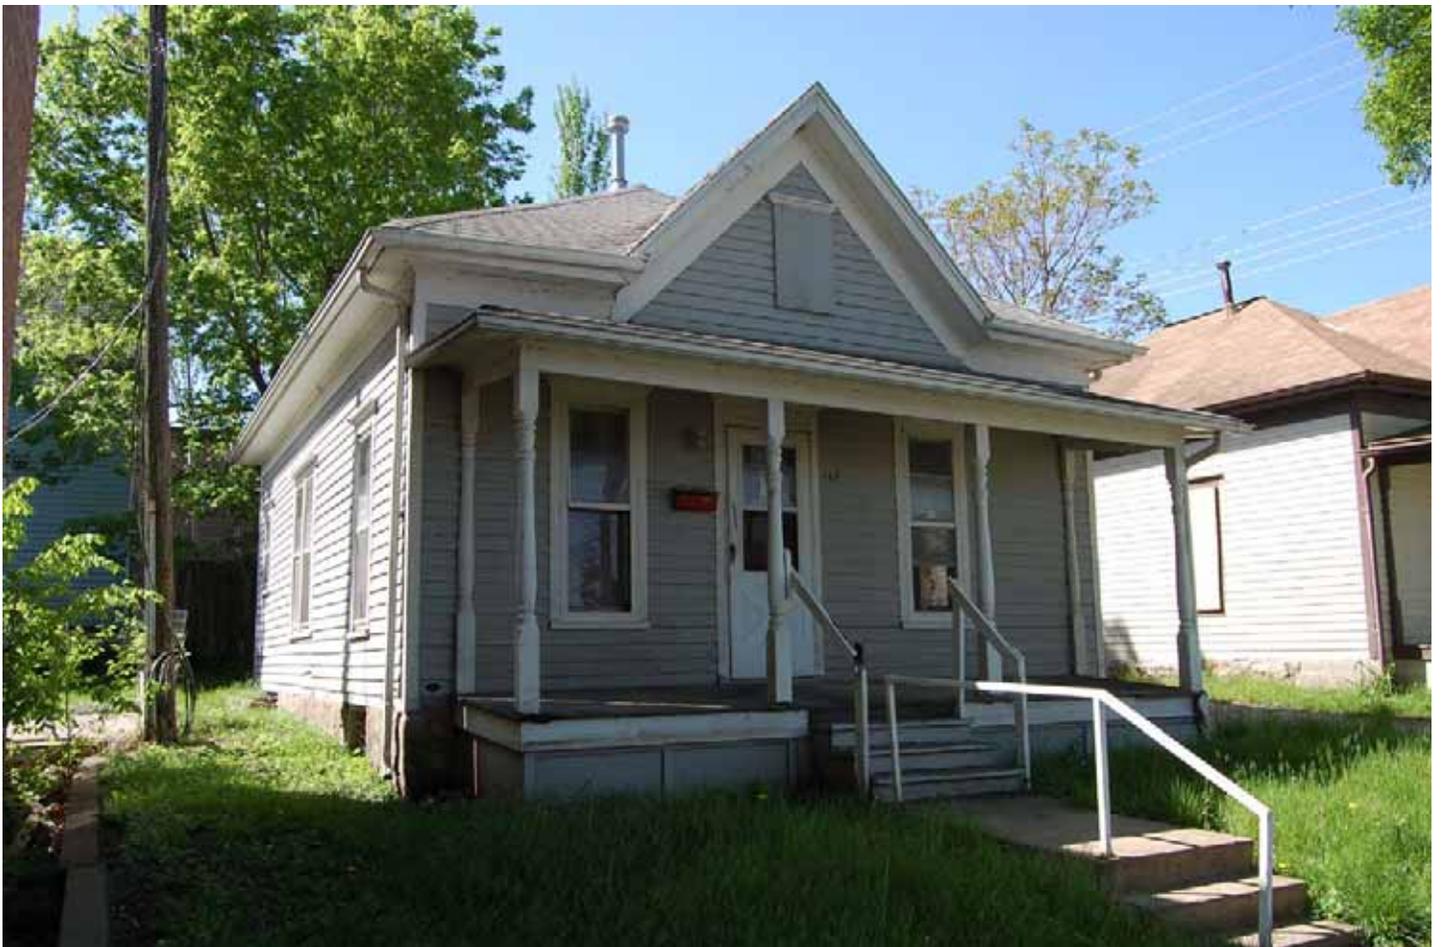
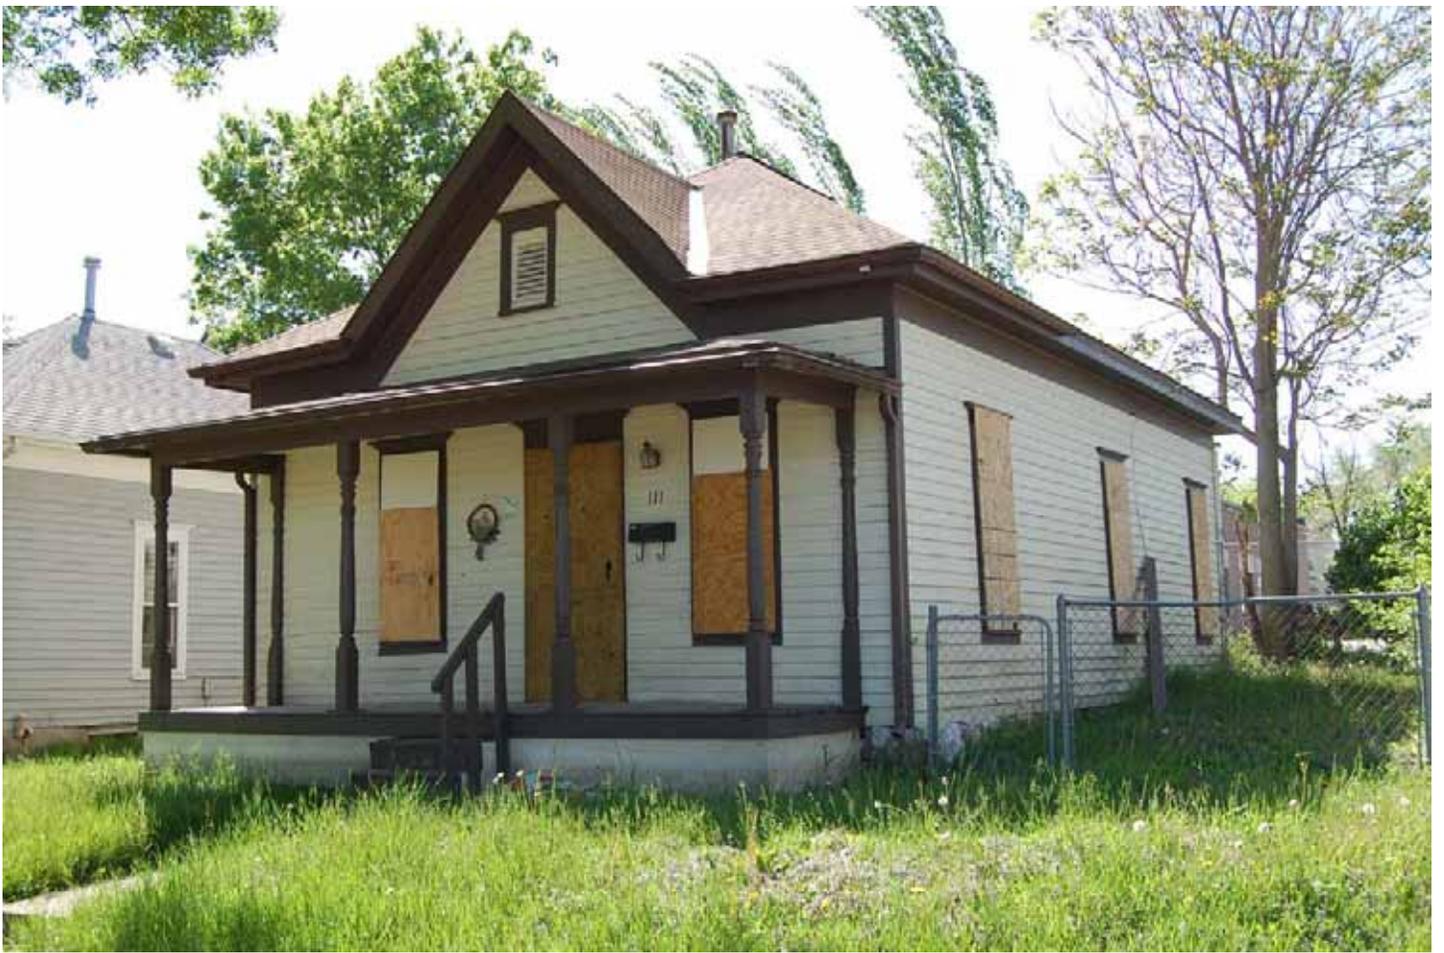
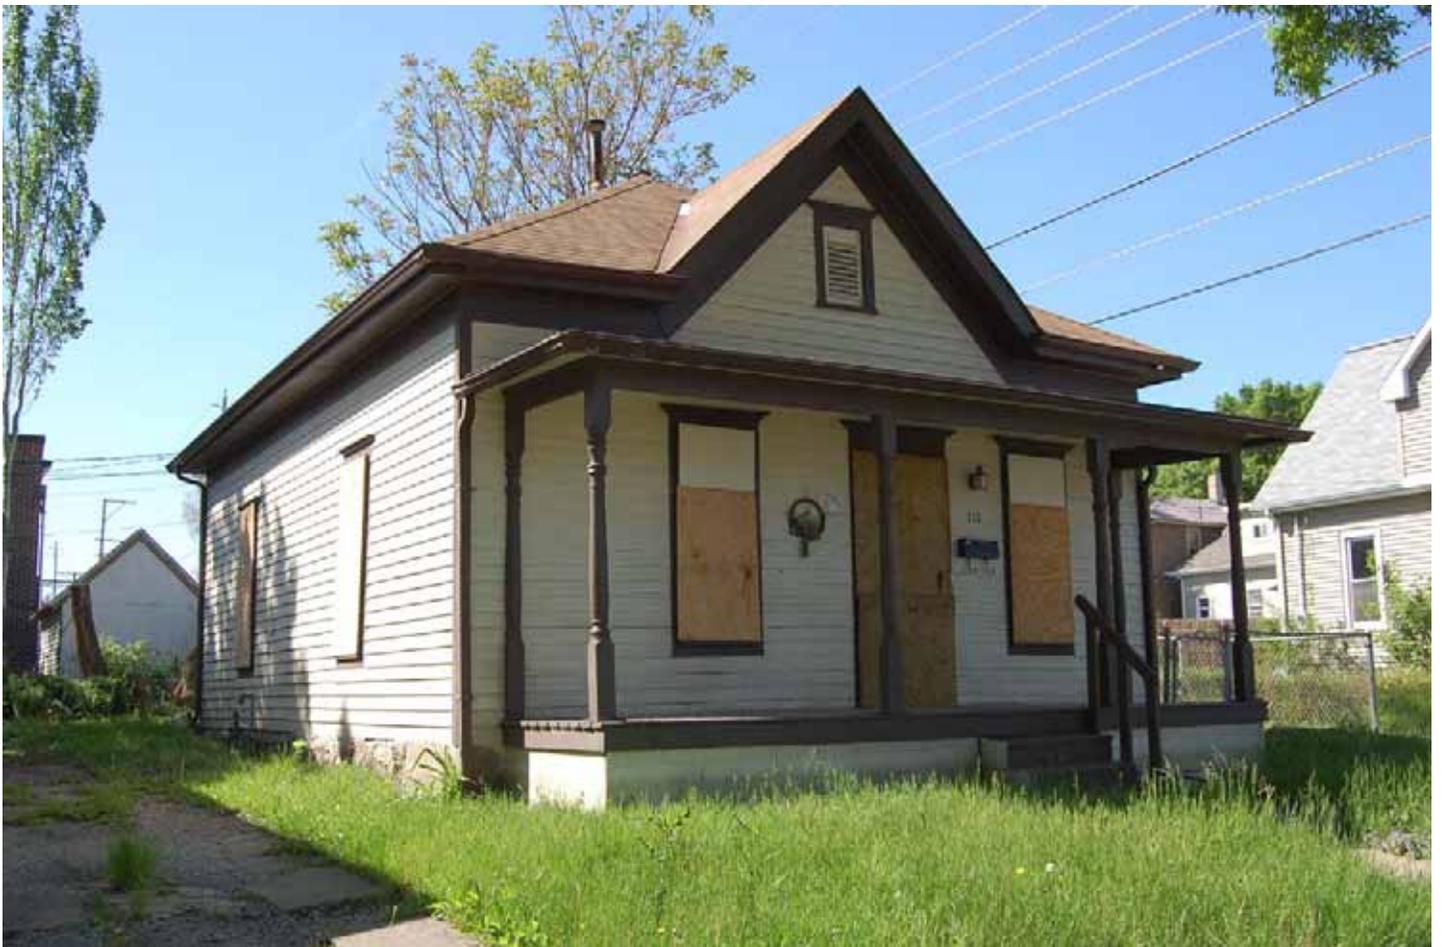
107 5th Avenue SW\_View E.JPG

*107 and 111 5<sup>th</sup> Avenue SW (1895)* – These two residences are presented together as they are nearly identical structures that may have been built at the same time by a local contractor. These one-story vernacular frame structures each feature a hipped roof open porch with turned posts, a gable front wall dormer on the main façade, 1/1 windows with simple wood hood moldings, and deep eaves with wide fascia. The one-story hipped roof form is a rare form in working class neighborhoods, with the gable front form being far more prevalent. Sanborn Fire Insurance maps confirm that these structures date to the late 19<sup>th</sup> century. While the house at 107 was determined as not eligible by SHPO in 1993, reconnaissance survey of Kingston and surrounding neighborhoods indicates that these are significant examples of late 19<sup>th</sup> century vernacular residential architecture and thus should both be considered eligible under Criterion C.
