**Architectural Reconnaissance Survey  
for Kingston  
in Cedar Rapids  
(57-088)**

**Linn County, Iowa**

**The Louis Berger Group, Inc.  
950 50<sup>th</sup> Street  
Marion, Iowa 52302**

**July 14, 2009**

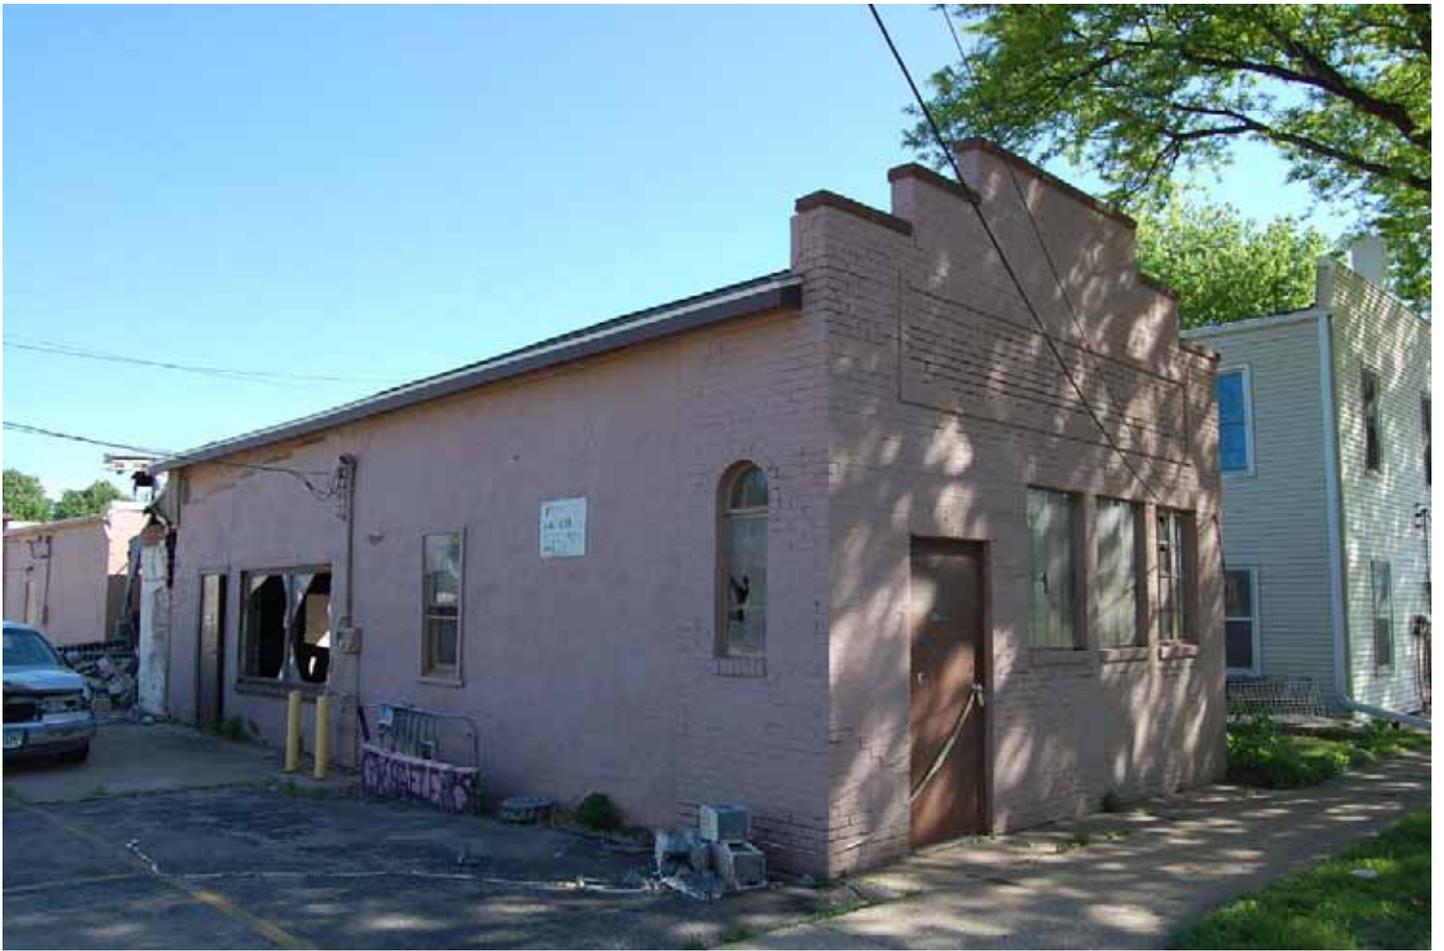
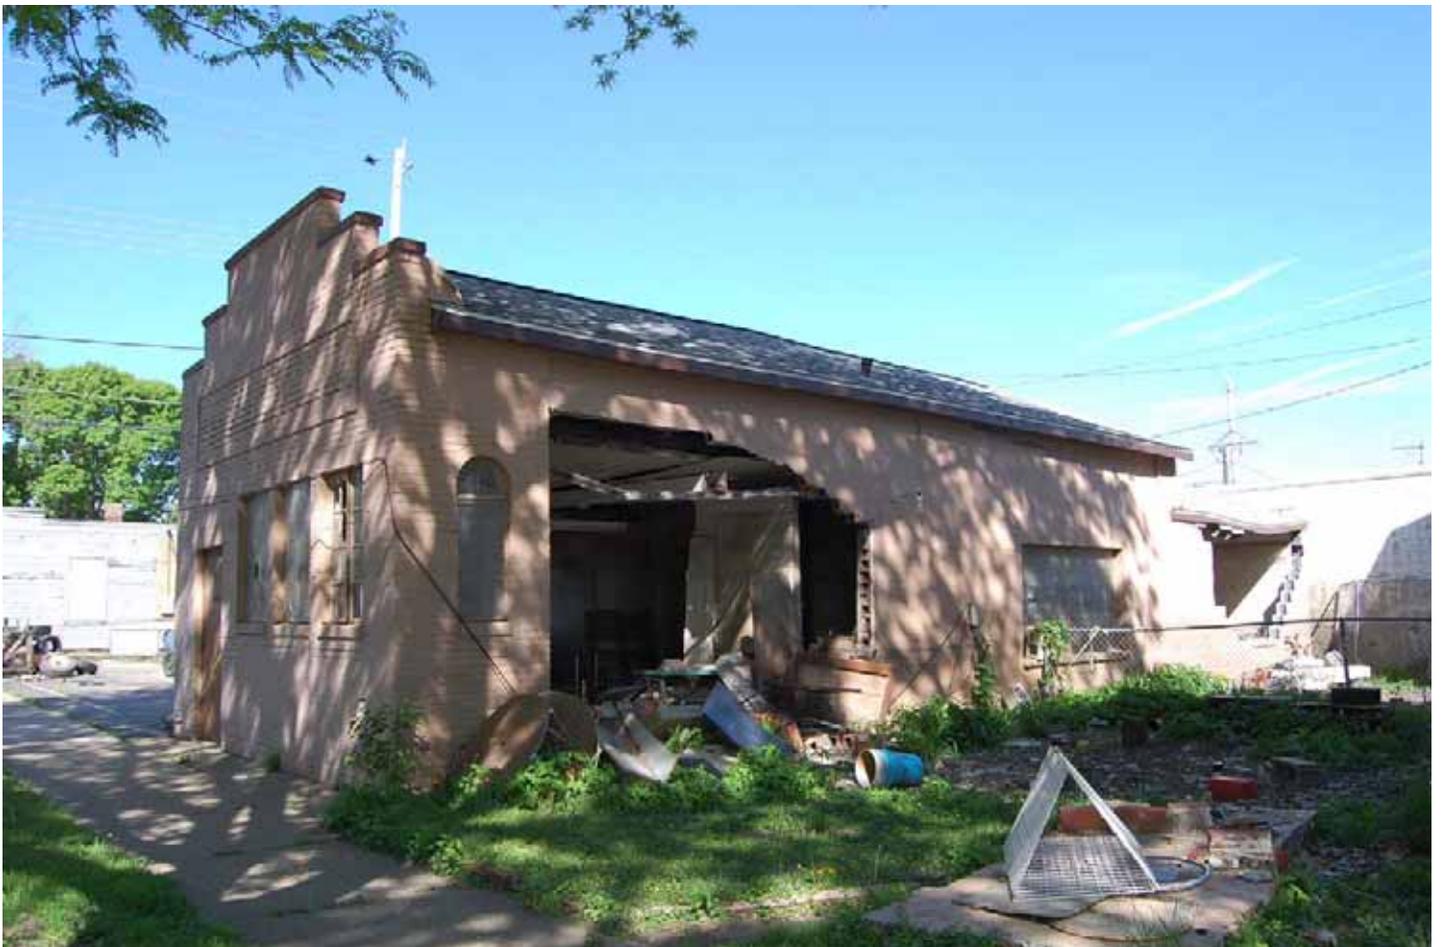
108 5th Avenue SW\_View N.JPG

*108 5<sup>th</sup> Avenue SW (1930)* – Falsefront brick commercial structure that features steel multi-pane windows, a gable-front roof with stepped parapet, small round arch windows on the secondary façade, and a rear addition. This structure is a highly intact example of an early 20<sup>th</sup> century neighborhood business, although the flood did severely damage the walls of one façade. Sanborn Fire Insurance maps indicate that it was originally a dry cleaning business. As such, the structure is eligible under Criteria A for its association with the development of small businesses in the early 20<sup>th</sup> century in the predominantly residential neighborhoods of Kingston.

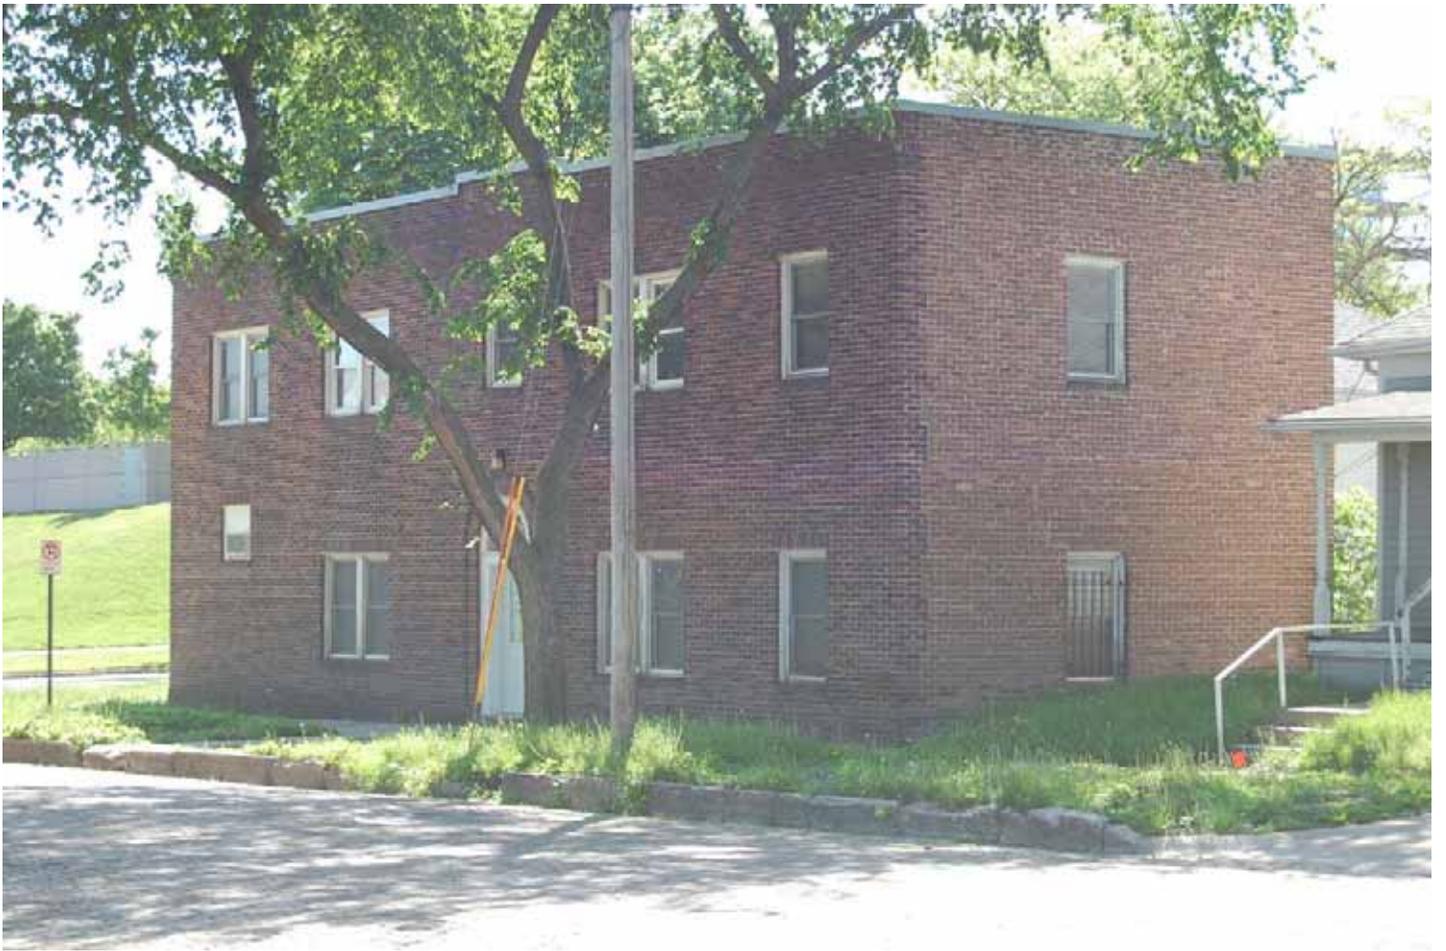
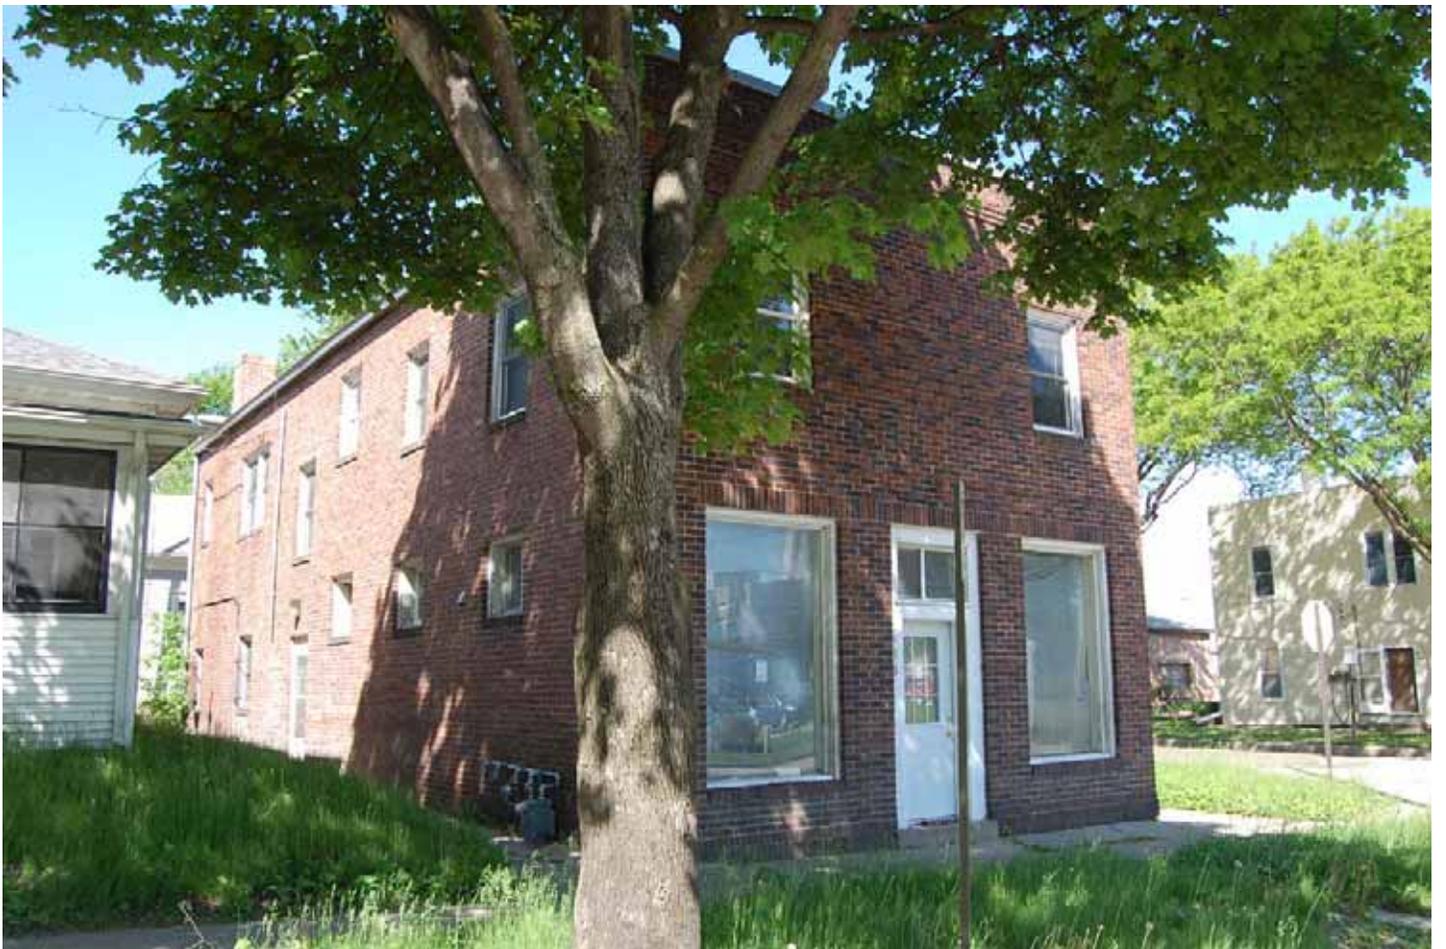
500 1st Street SW\_View E.JPG

*500 1<sup>st</sup> Street SW (1925)* – Two story brick commercial building that has a central entrance flanked by large display windows. The building is five bays deep with a round arch entrance located on the secondary façade facing 5<sup>th</sup> Avenue SW. The 1925 building has a high degree of integrity of design, workmanship, materials, feeling, association, location and setting. As such, the structure is eligible under Criteria A and C as a rare example of an intact commercial structure in a primarily residential setting in the neighborhood of Kingston.

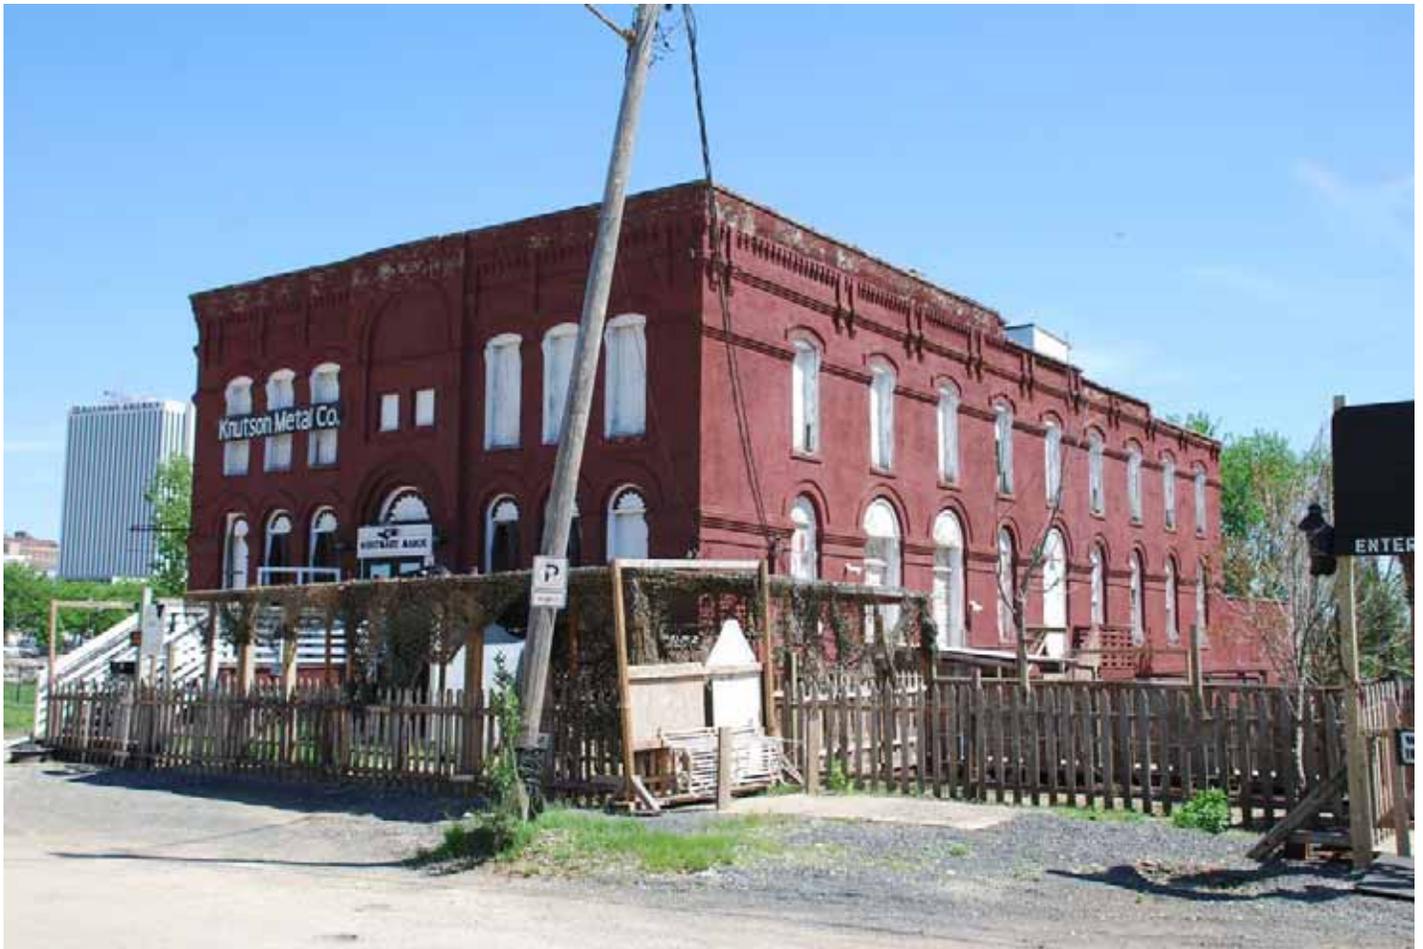
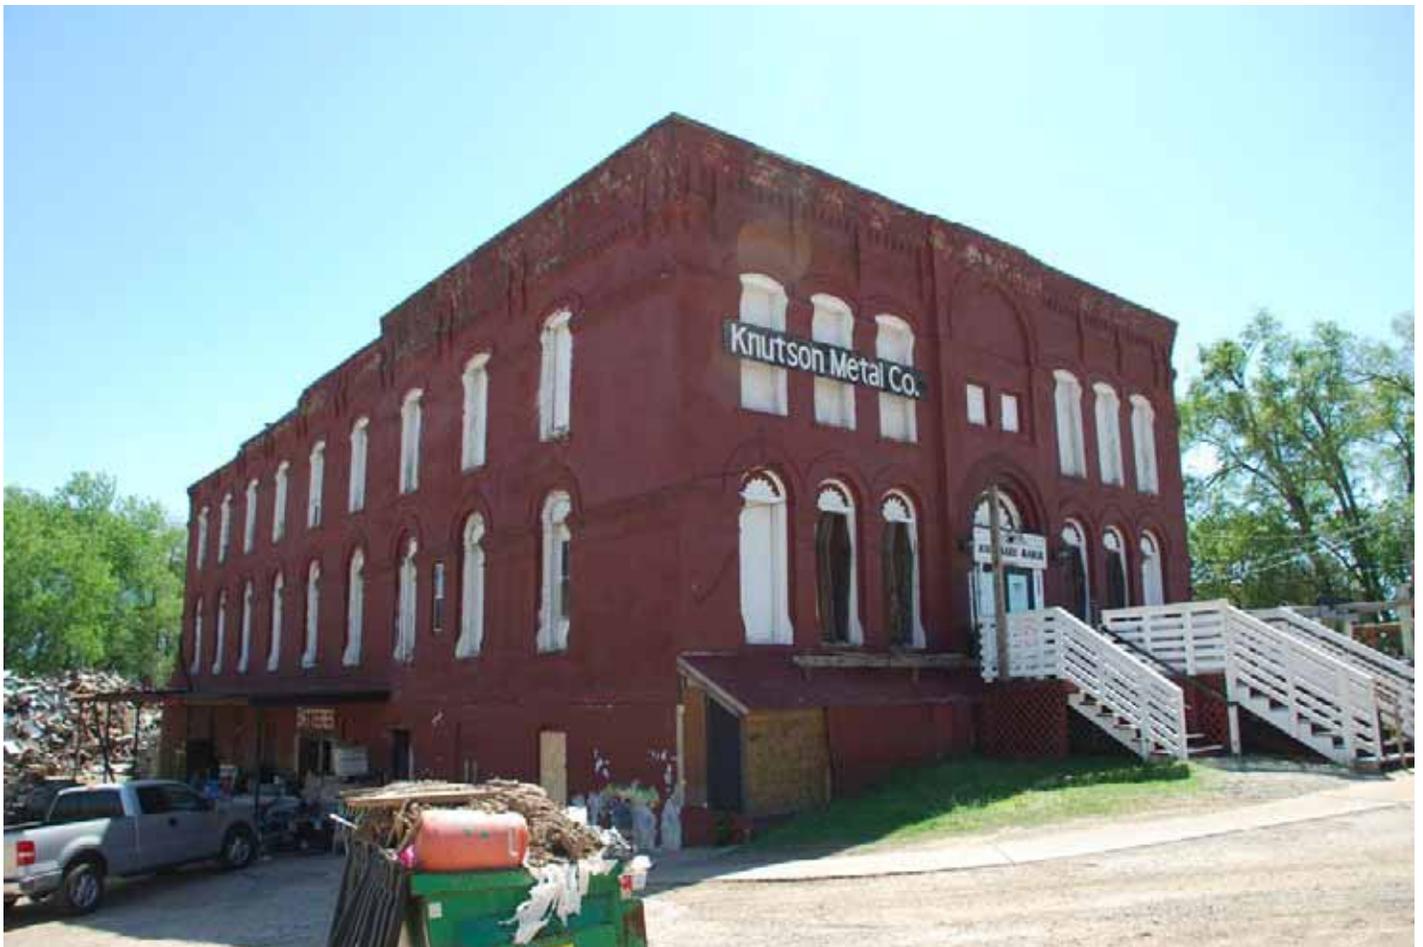
525 H Street SW\_View NE.jpg

*525 H Street SW (ca. 1900)* – Two story brick industrial building that was identified by Marlys Svendsen as the Cedar Rapids Candy Company under the address 519 H Street SW. The building (now known as the Knutson Metal Co.) has round arch windows on the first floor, segmental arch windows on the second floor and a cornice of corbelled brick. Though the windows have for the most part been boarded up, this structure retains a great deal of its significant architectural features and retains a high degree of integrity of design, workmanship, feeling and association. As such, the structure is eligible under Criteria A and C as a significant example of an early twentieth century light industrial building that is associated with the growth of industries on the west side of the Cedar River.

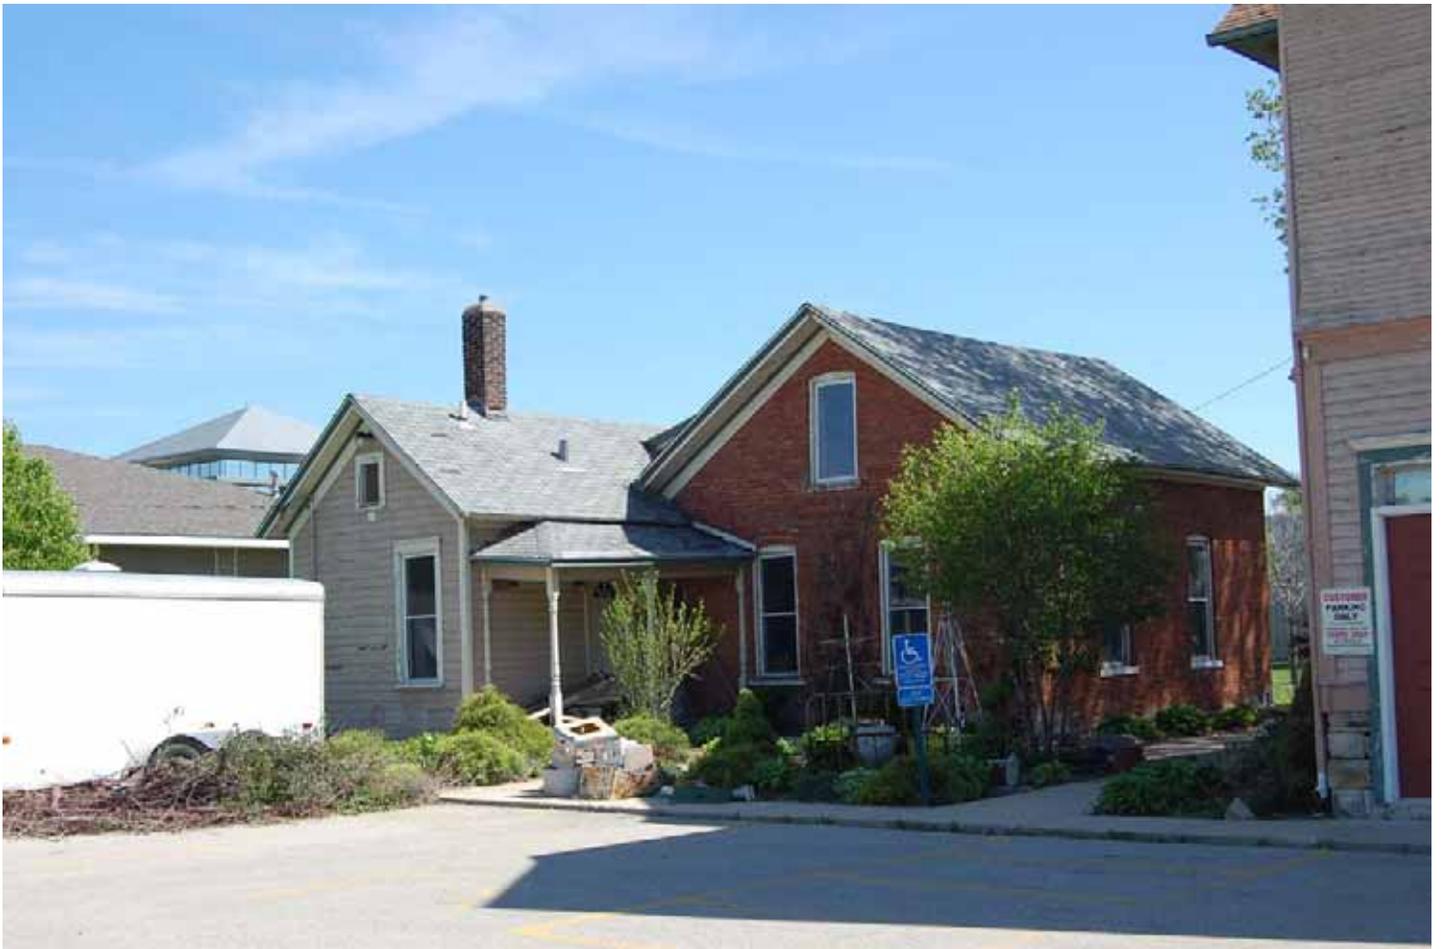
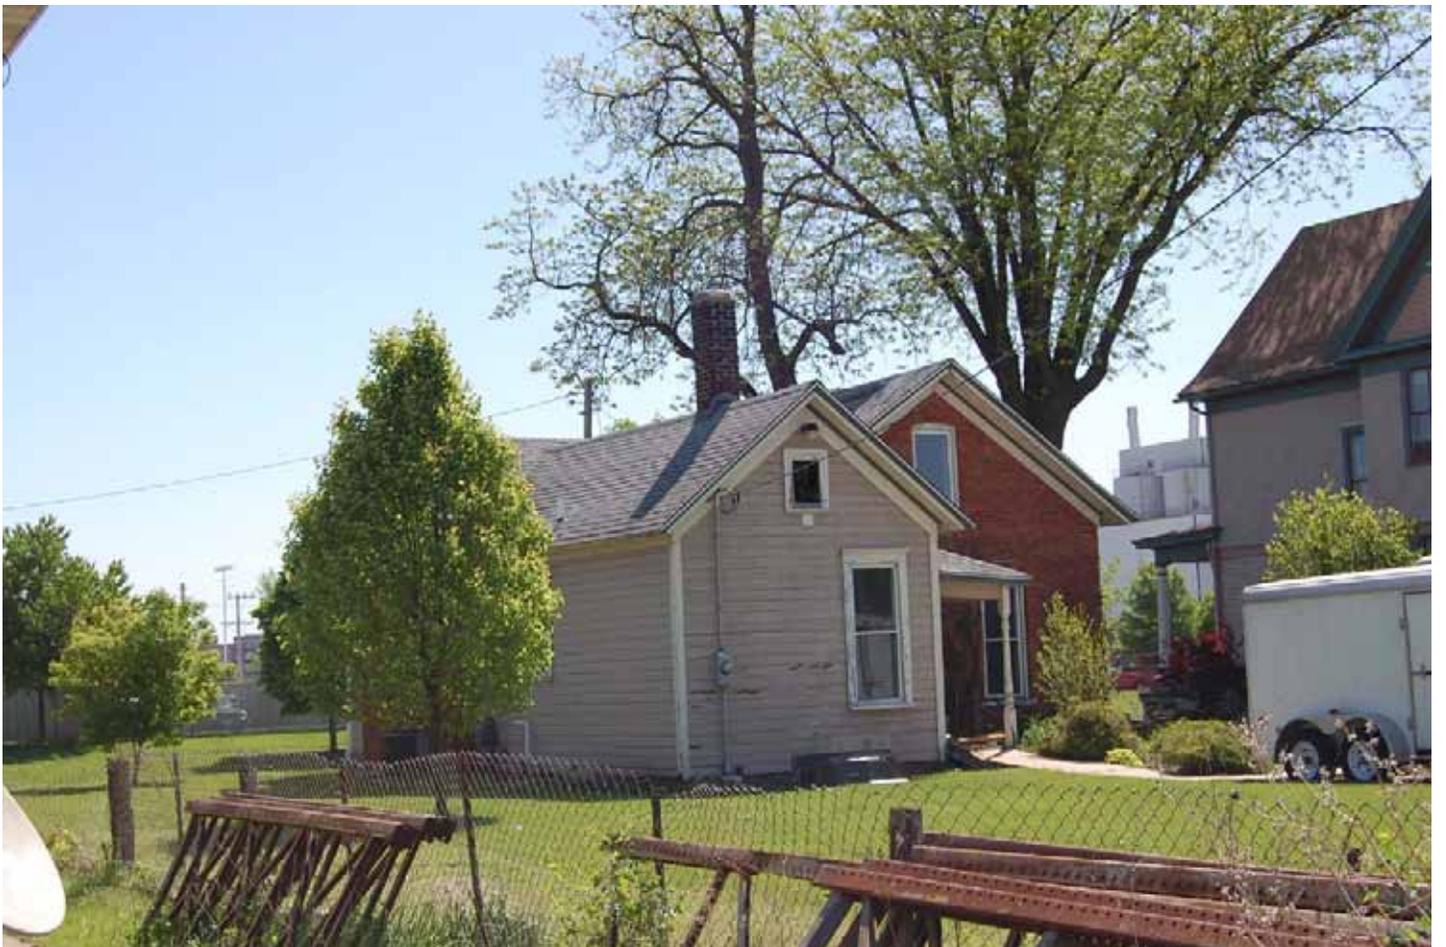
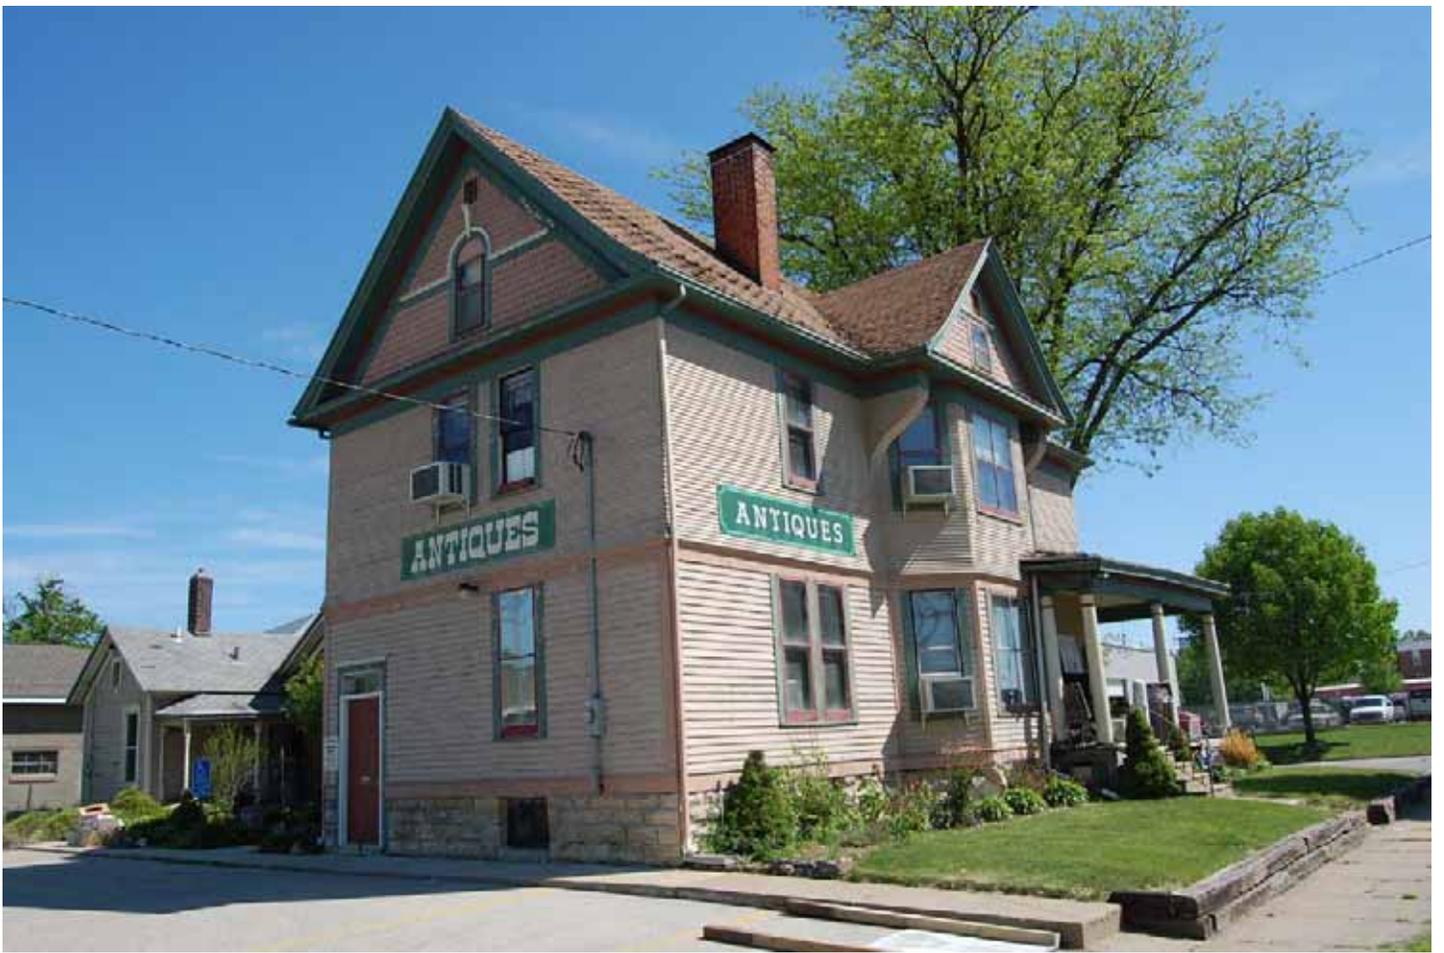
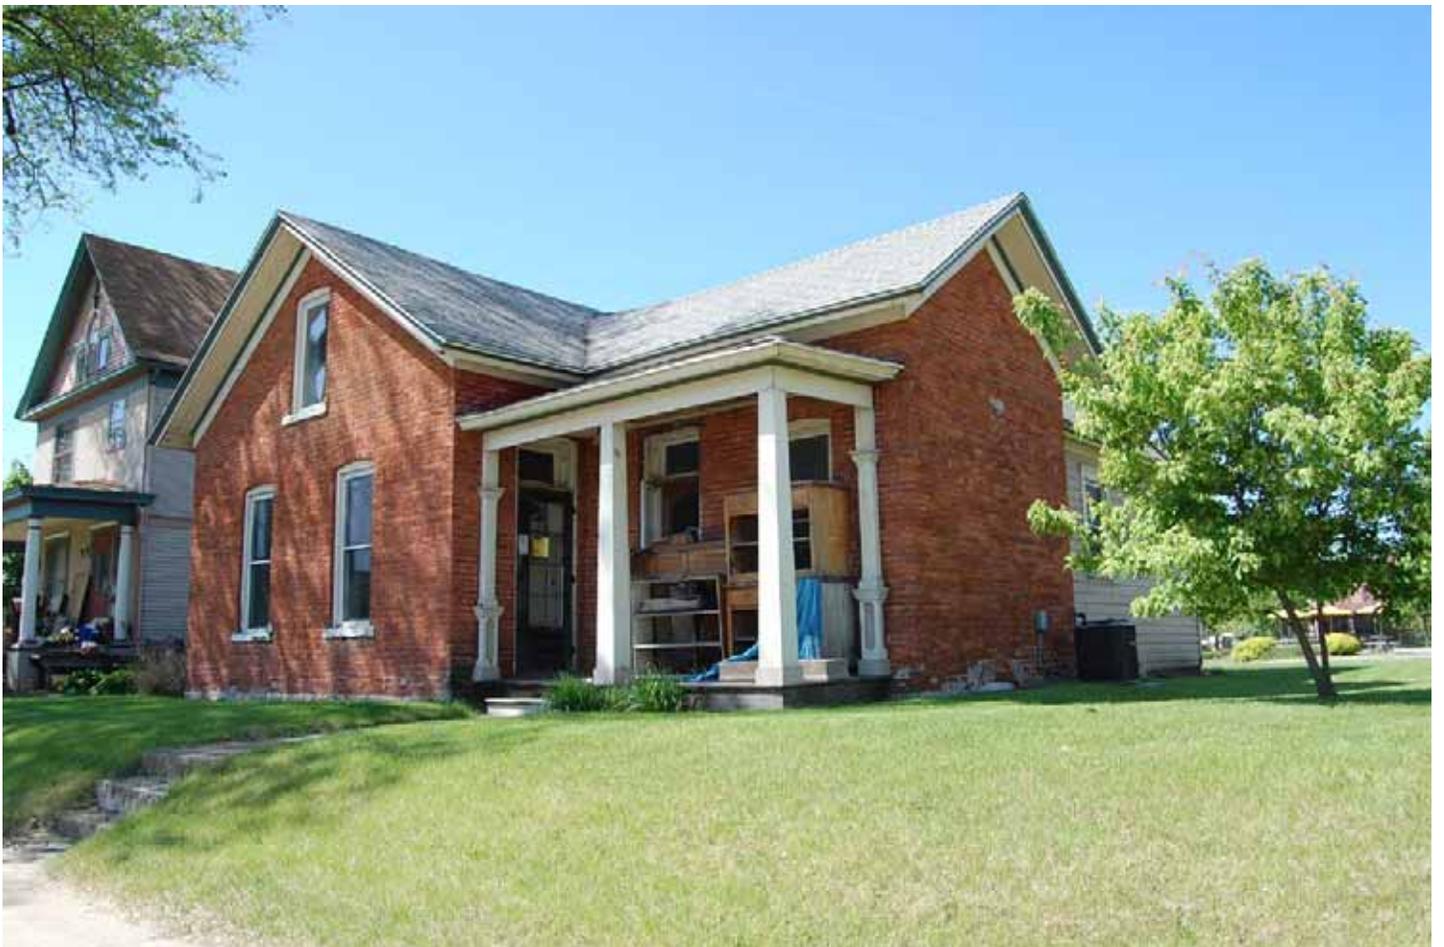
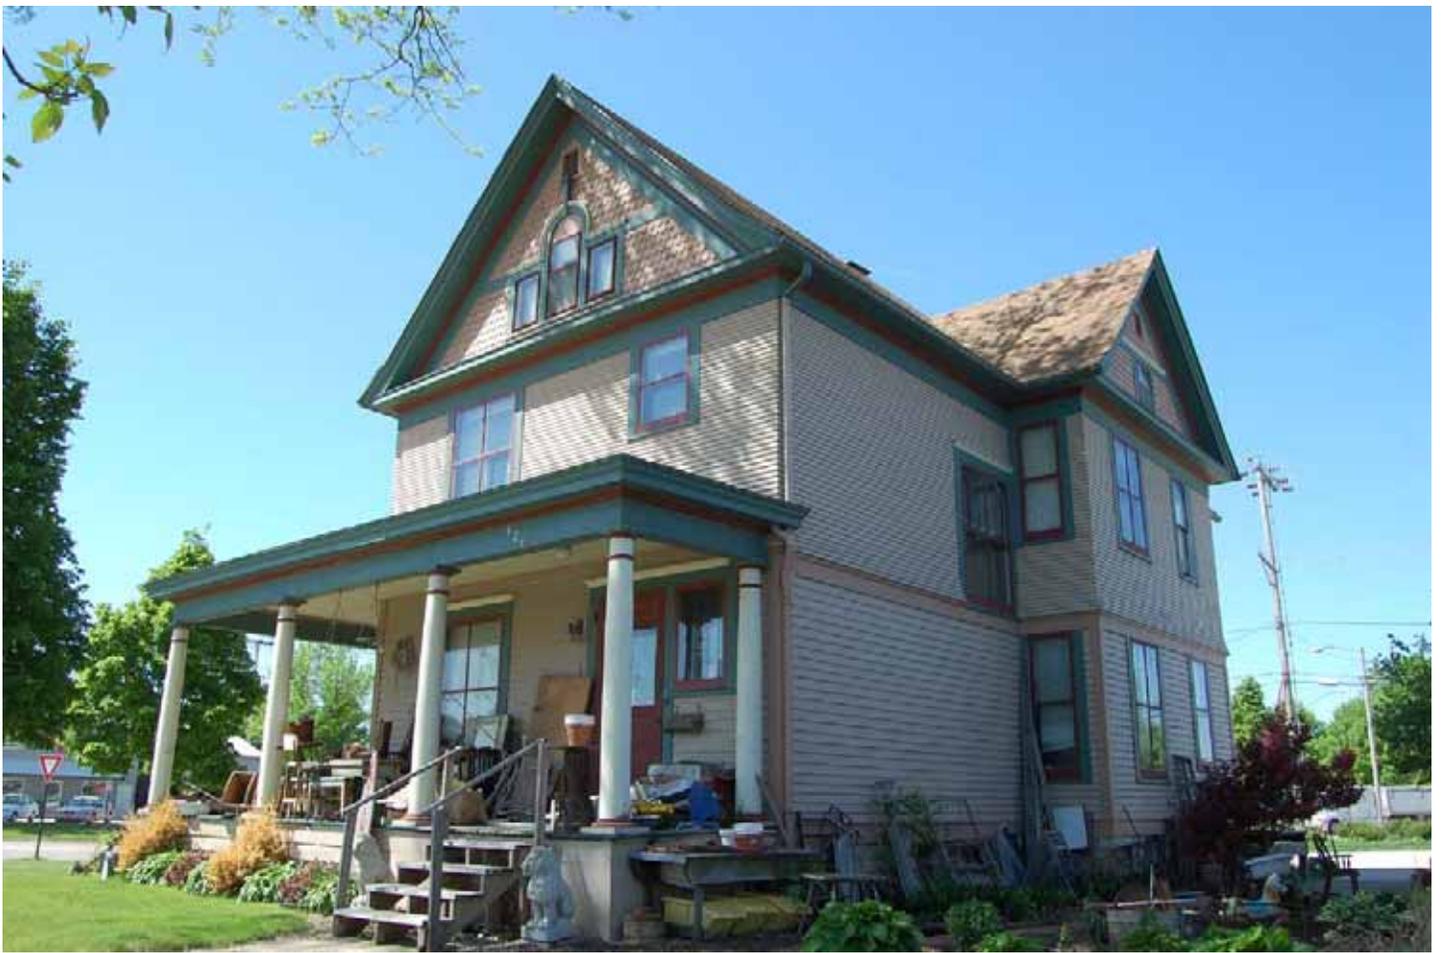
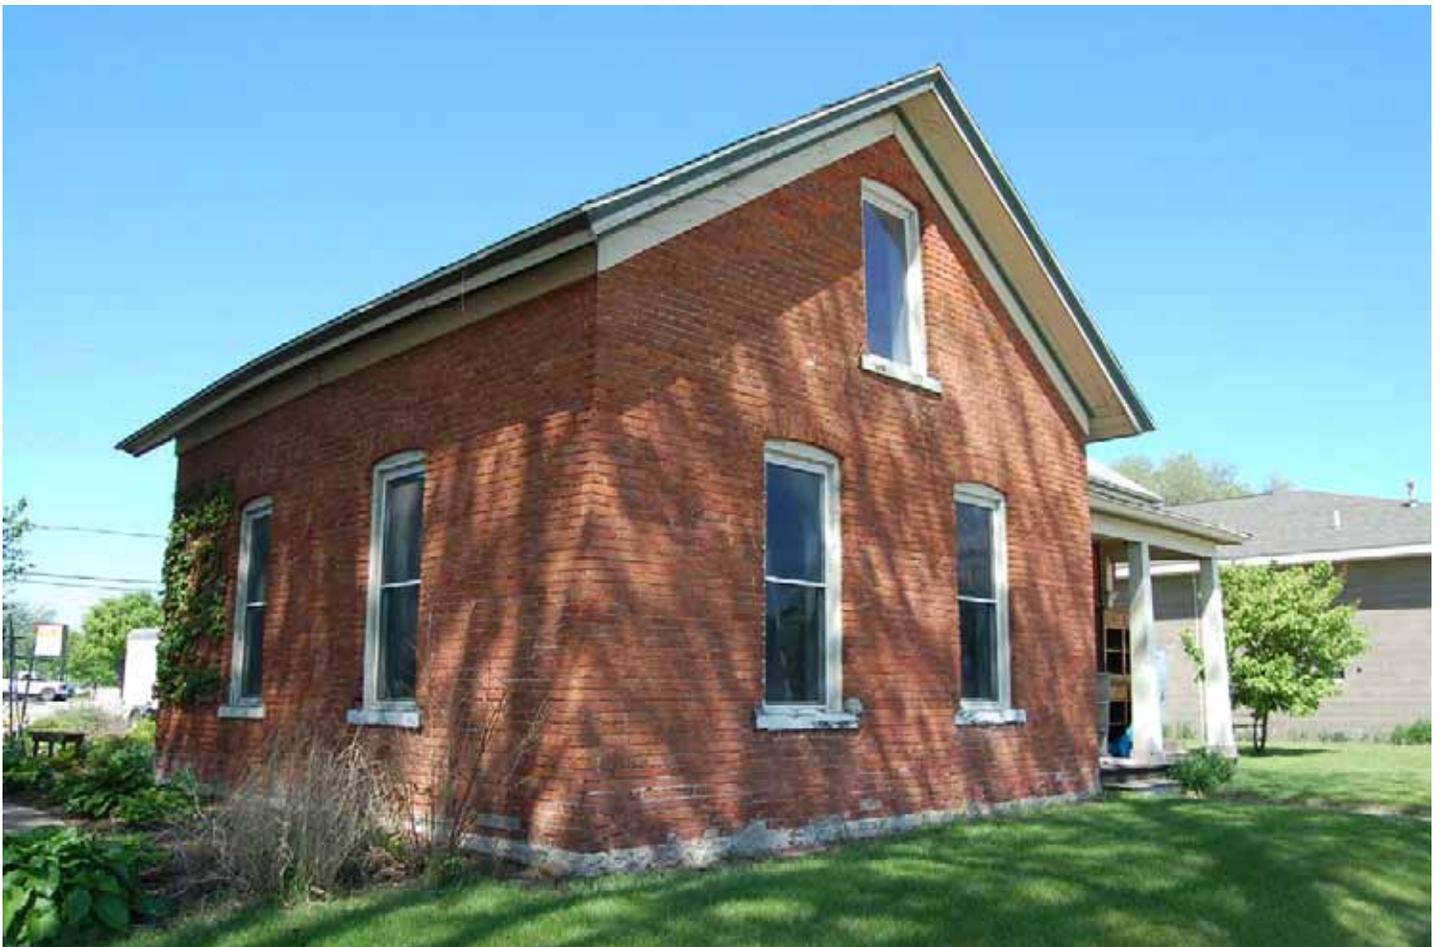
626 1st Street SW\_View E.JPG

*626 1<sup>st</sup> Street SW (ca. 1870 and 1900)* – The property contains two residences including a two and a half story Queen Anne style frame dwelling and a one-and-a-half story brick dwelling. The Queen Anne style dwelling has a cross-gable roof, clapboard siding, limestone foundation, an L-shaped porch with tapered Ionic columns, and pedimented gable ends with shingle siding and pseudo Palladian style windows. The brick house is considerably older, perhaps dating to the founding of Kingston according to neighbors. The gable-front and wing structure has a one-story frame addition on the rear façade, a hipped roof front porch, a hipped roof rear porch, and segmental arch windows with modern 1/1 or fixed sash. Both houses are eligible under Criterion C as significant examples of their type. The houses may be eligible under other criteria with background research.

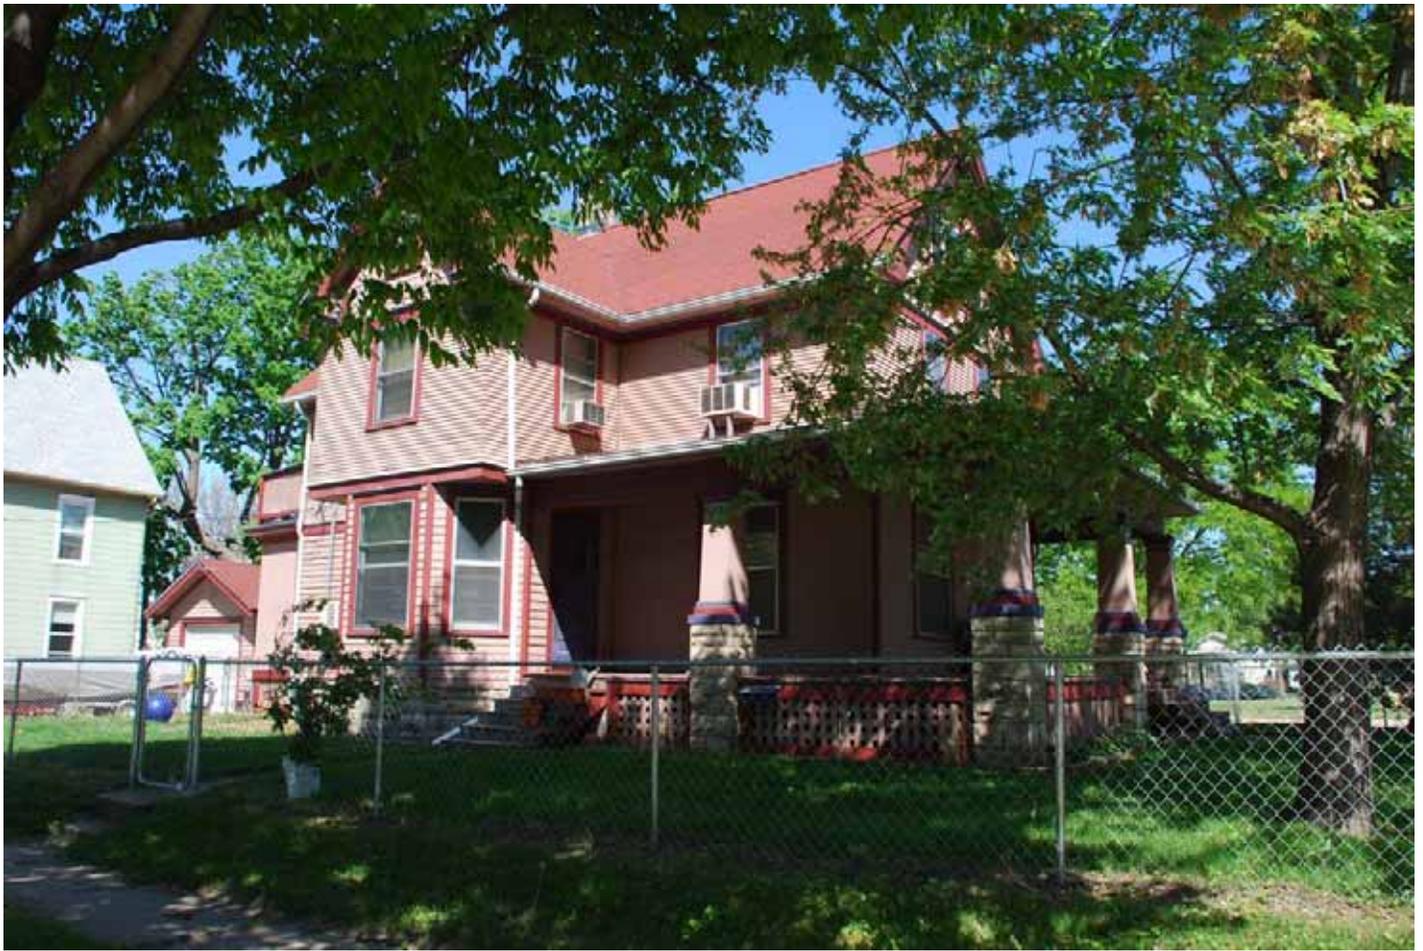
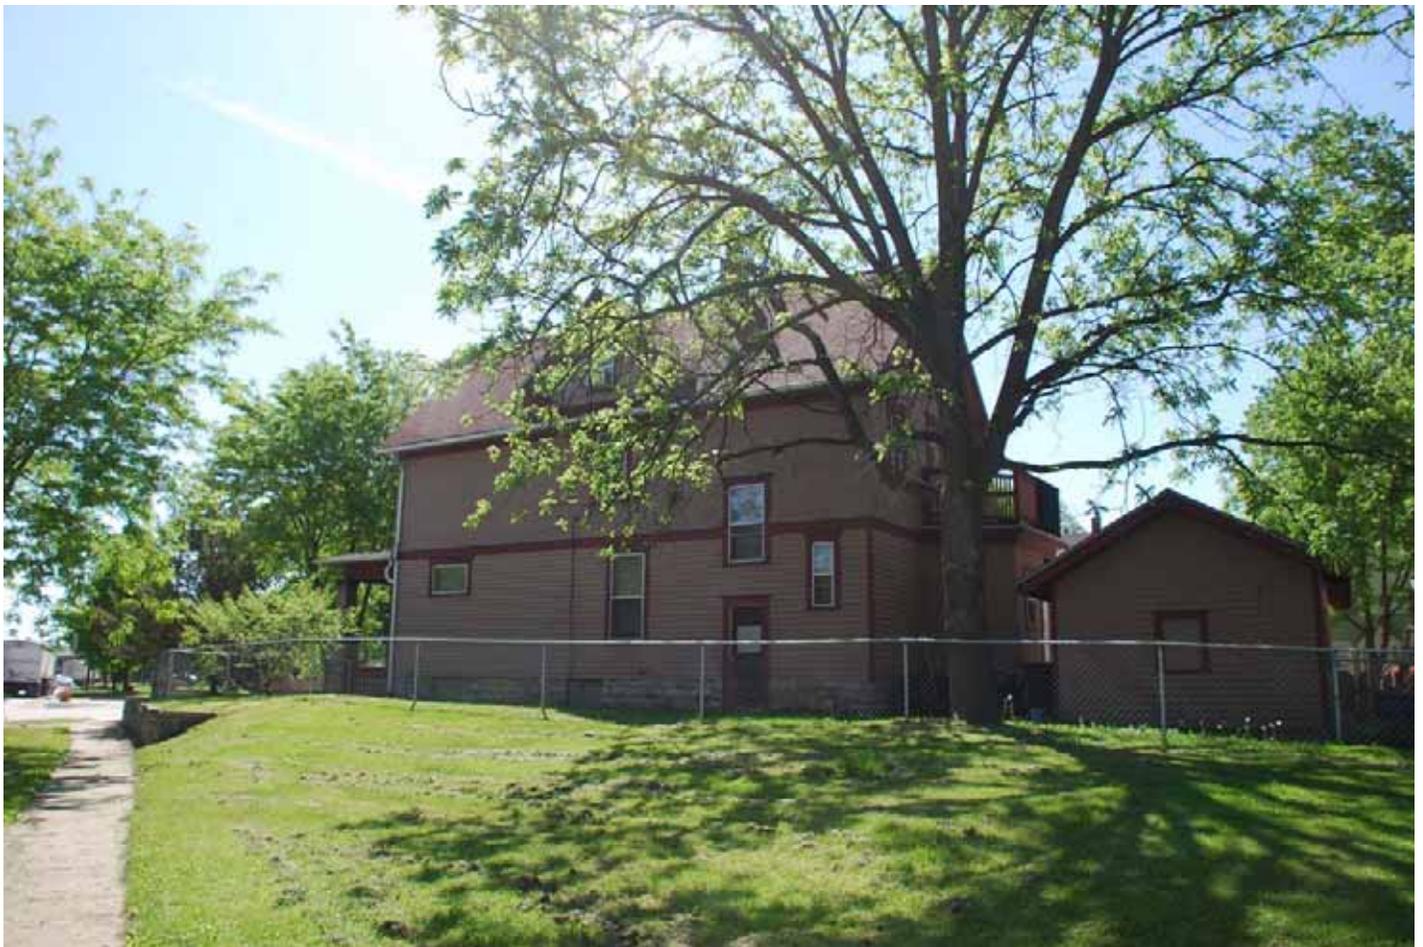
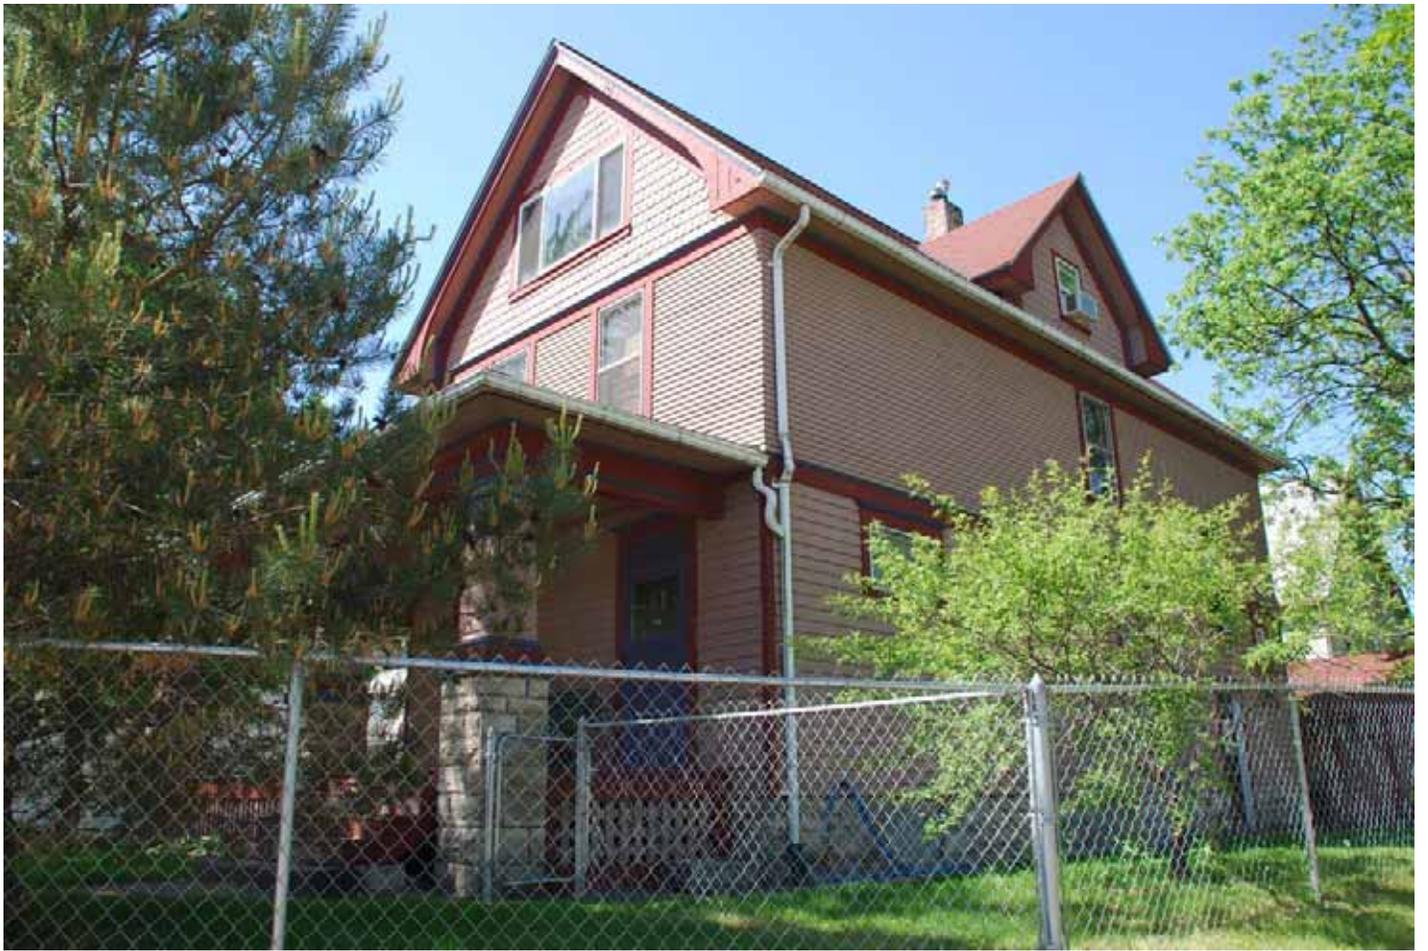
626 2nd Street SW\_View NW.jpg

*626 2<sup>nd</sup> Street SW (1910)* – Queen Anne style, 2 ½ story frame dwelling features an L-shaped open porch with stone piers surmounted by tapered wood posts, a cutaway bay, varying siding width on the first and second levels, keyhole cut shingles in the gable ends, and decorative bargeboards and cornice returns. The large house has had minimal alterations besides a window replacement in the gable end of the main façade. Despite this, the house appears to be eligible for Criterion C as a significant example of a Queen Anne style house. With additional research, the structure may be eligible under other criteria.

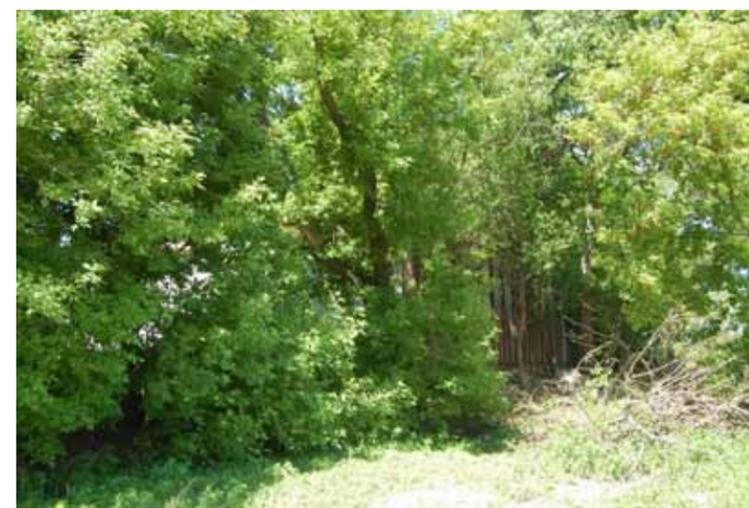
42 7th Avenue SW\_View N (warehouse).JPG

*42 7<sup>th</sup> Avenue SW (ca. 1900)* – Three story brick industrial building has a limestone foundation, segmental arch windows, and a stepped parapet roof. Sanborn fire insurance maps indicate that the building housed the Iowa Wind Mill and Pump Company from its construction around 1900 to at least 1949. Most of the windows have been replaced, though several 4/4 wood sash can be found on the first floor. Cited as the Iowa Pipe & Supply Company by Marlys Svendsen in her MPD, *Commercial and Industrial Development of Cedar Rapids, c. 1865-c. 1945*, the building is eligible under Criteria A and C as an important example of an early twentieth century industrial building that was associated with development on the west side of the Cedar River.
