**Architectural Reconnaissance Survey
for St. Patrick's Neighborhood
in Cedar Rapids
(57-086)**

Linn County, Iowa

June 8, 2009

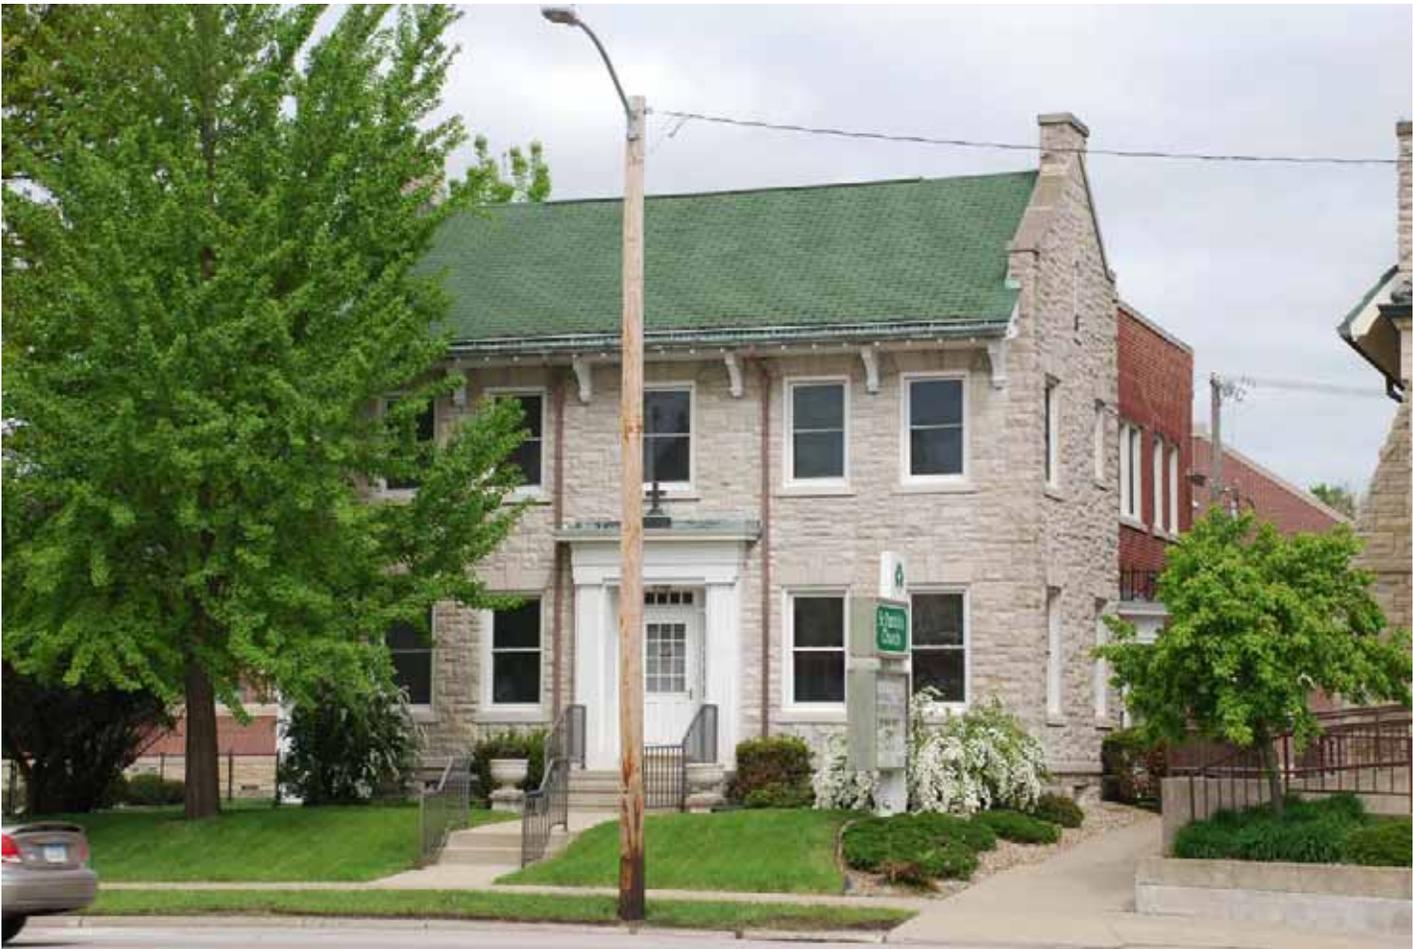
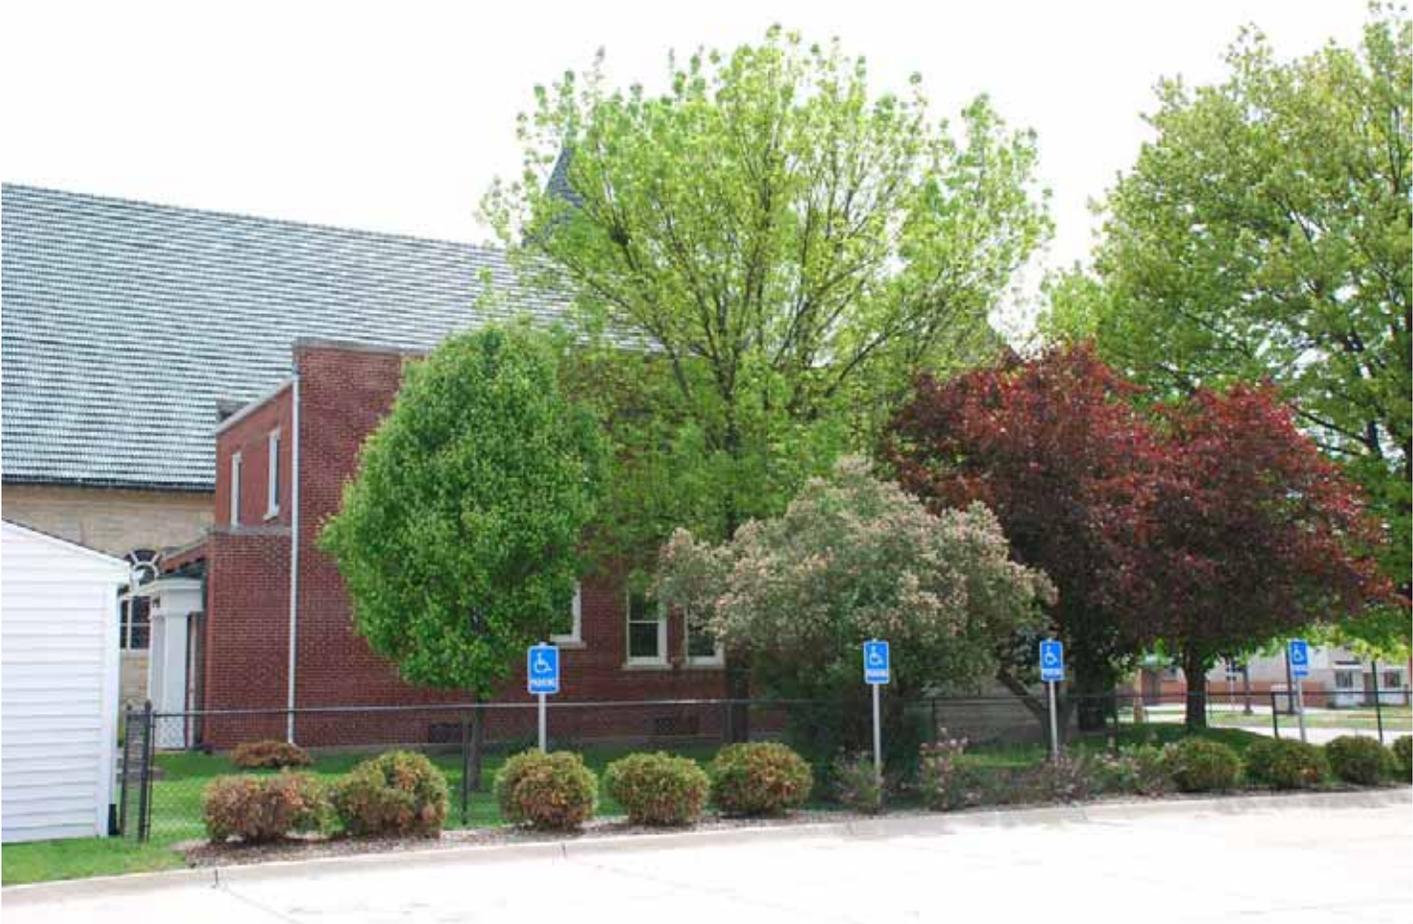
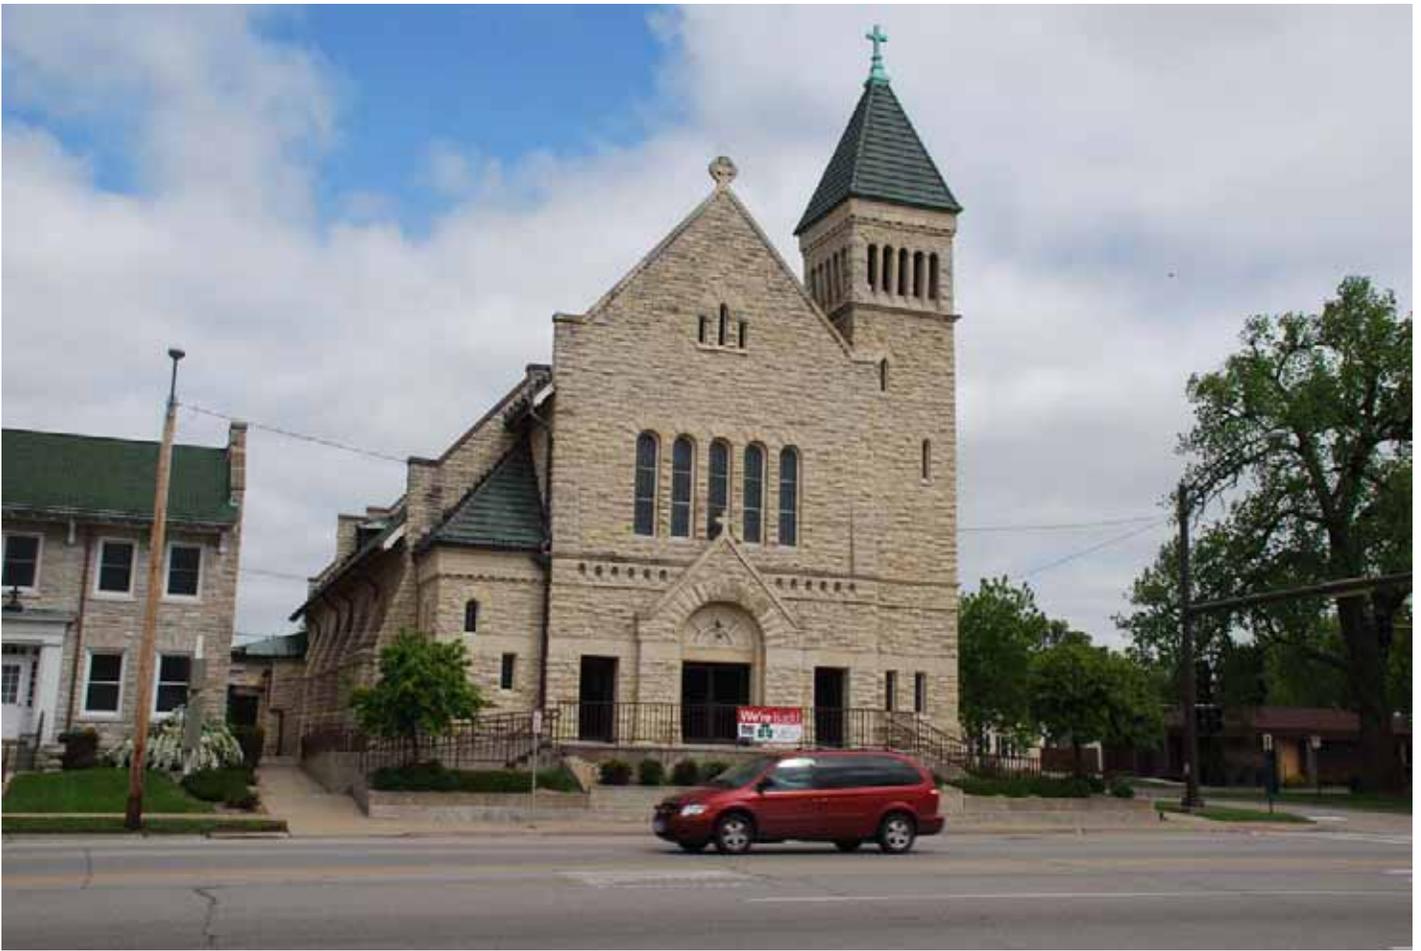
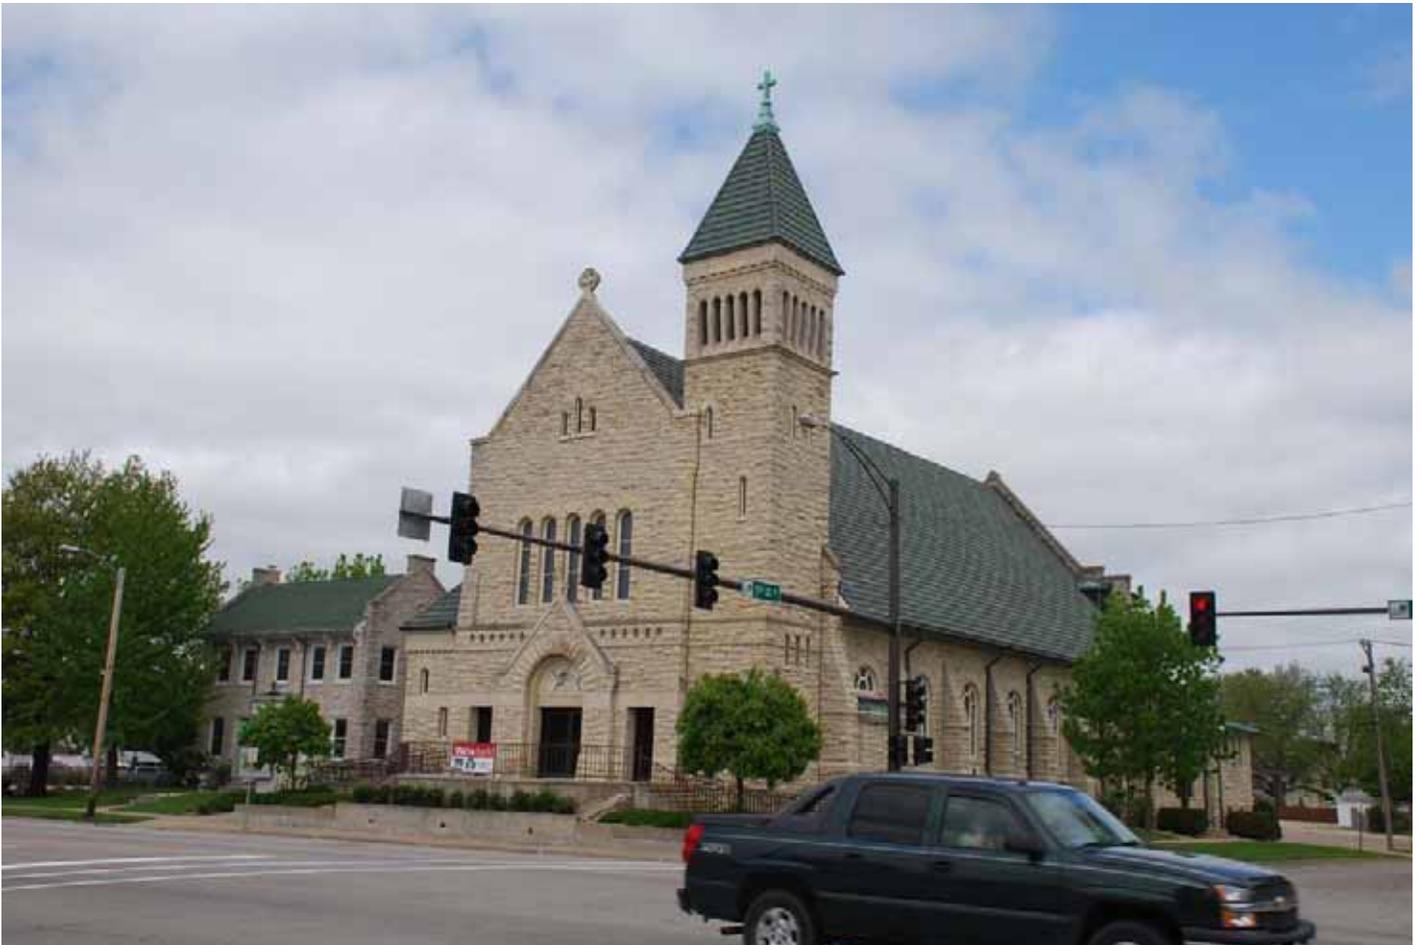
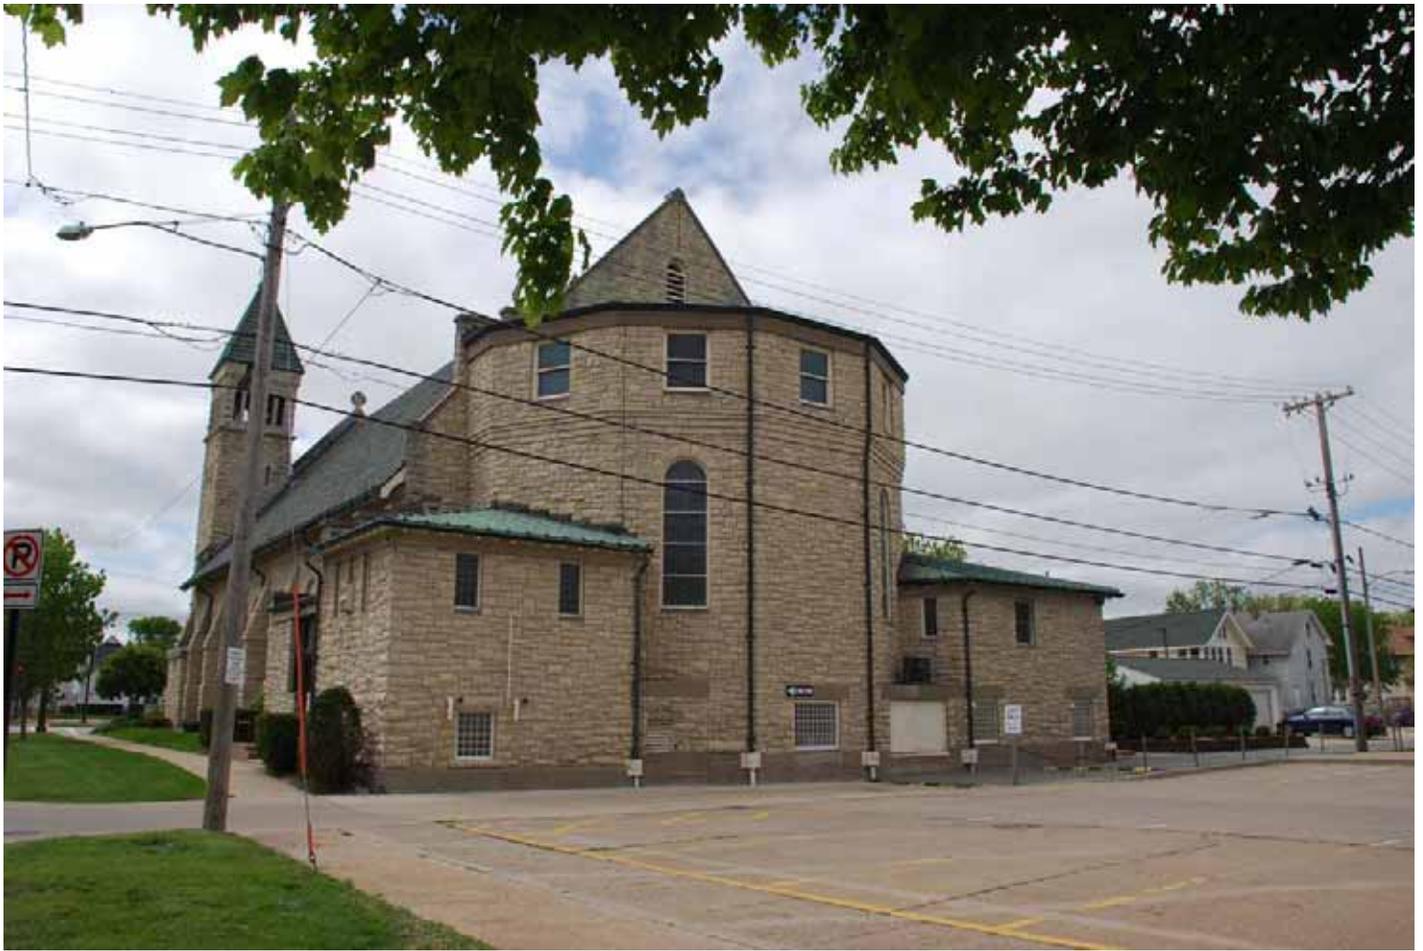
120 5th Street NW (Rectory)_View NW.jpg

120 5th Street NW (A.K.A. 500 1st Avenue NW) (1924) – The St. Patrick’s Church and Rectory complex stretches from 1st Avenue NW to the alley between A and B Avenues NW. The complex is comprised of a stone Gothic Revival Church and a stone side-gable rectory, both built in 1924. The Parish Center, behind the church and rectory was built in 2004. The original school was torn down sometime after 2004. The rectory is a two story, side-gable Colonial Revival style stone structure with a two story brick addition. Most of the windows have been replaced; but the building still retains a high degree of integrity. Both the church and rectory are eligible under Criterion C as excellent examples of early twentieth century Gothic Revival and Colonial Revival style buildings.

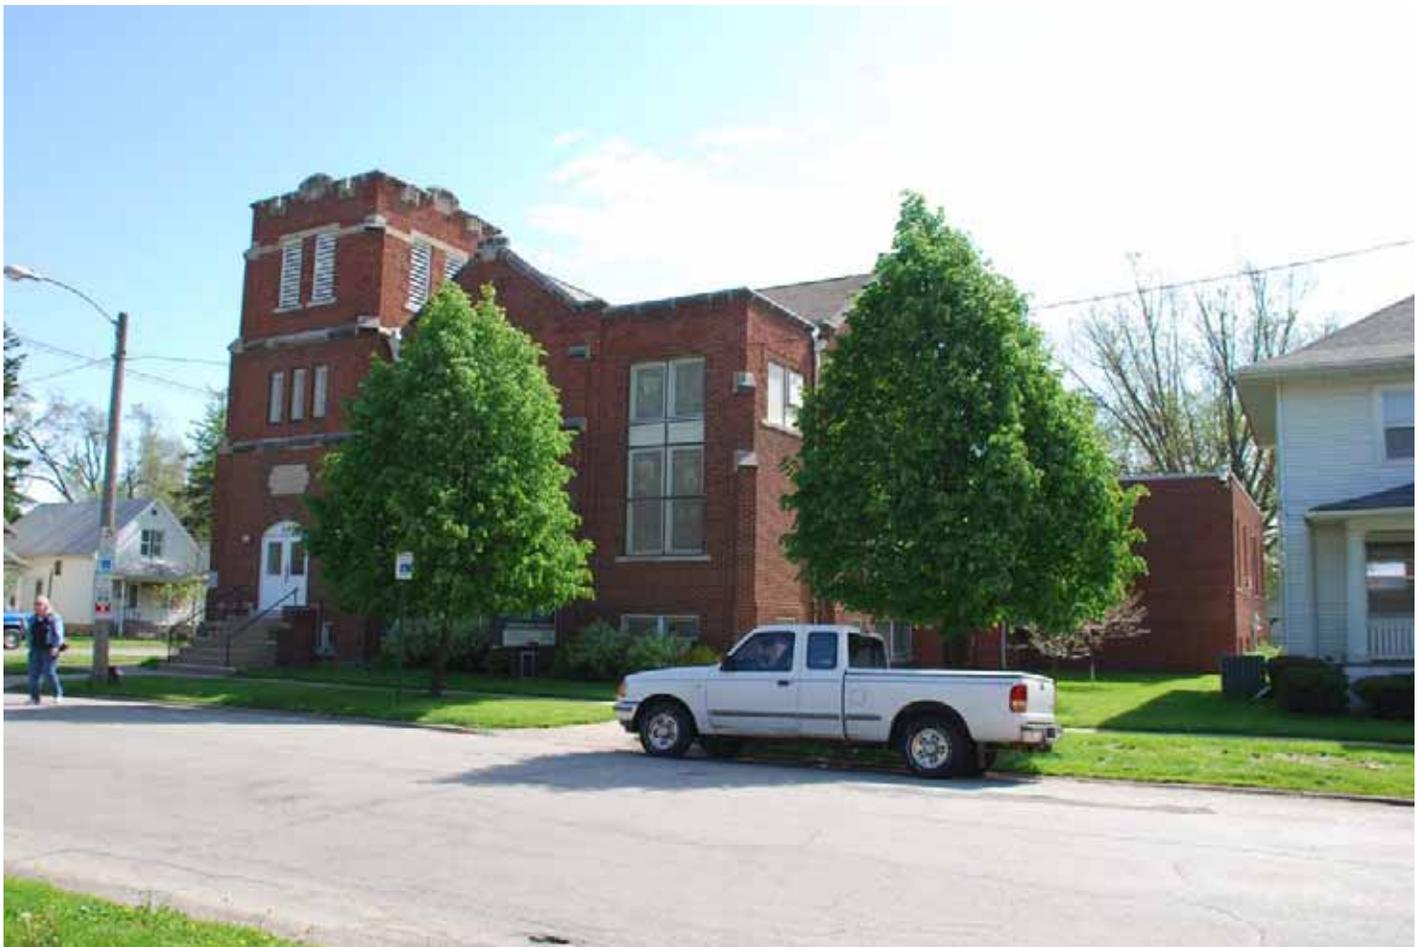
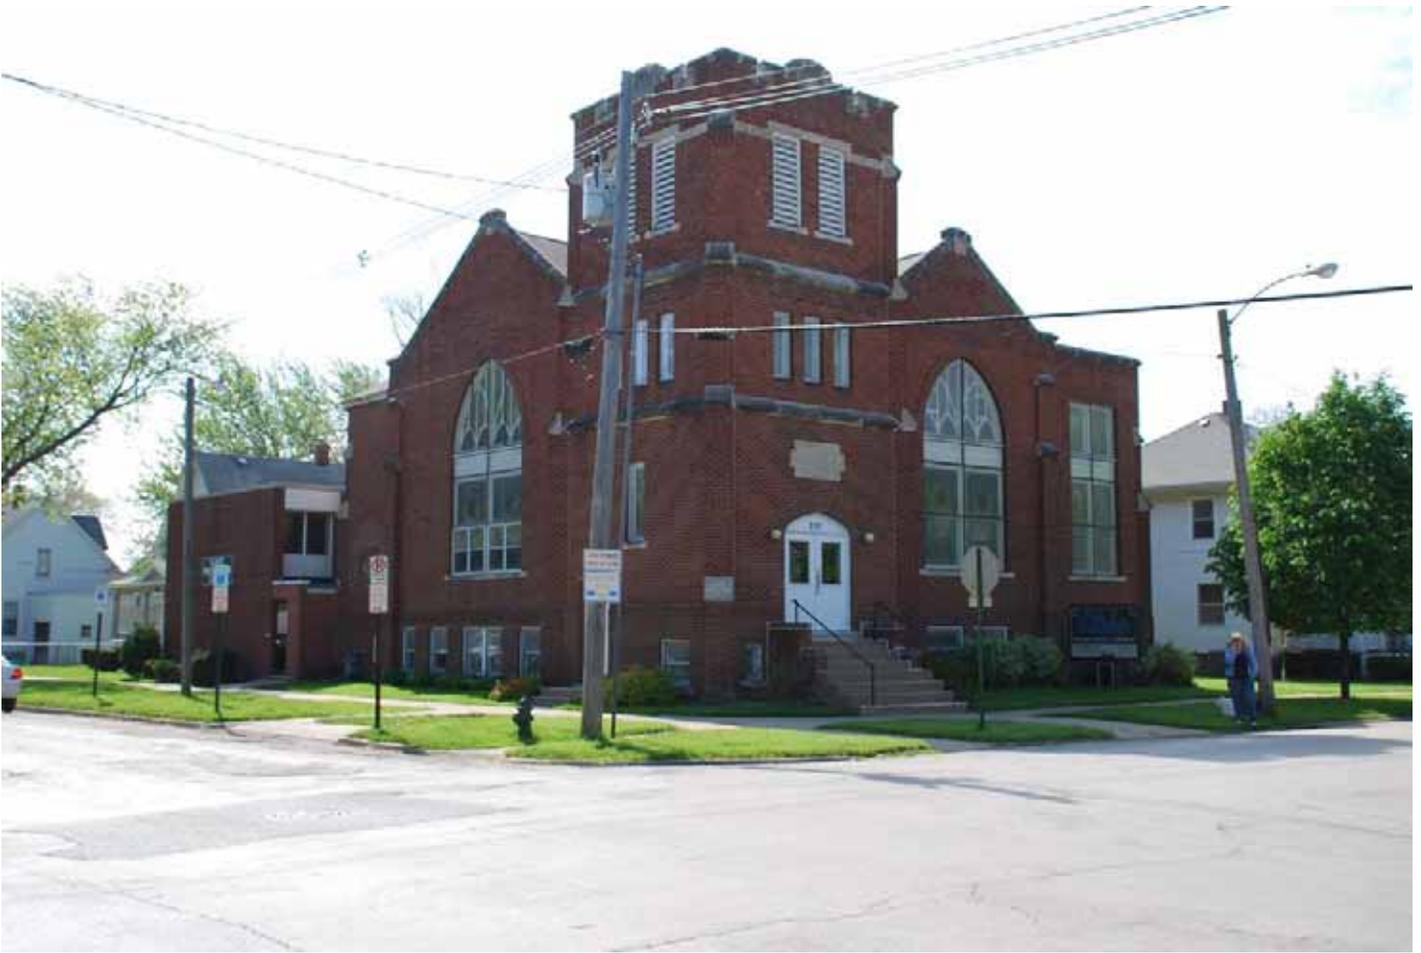
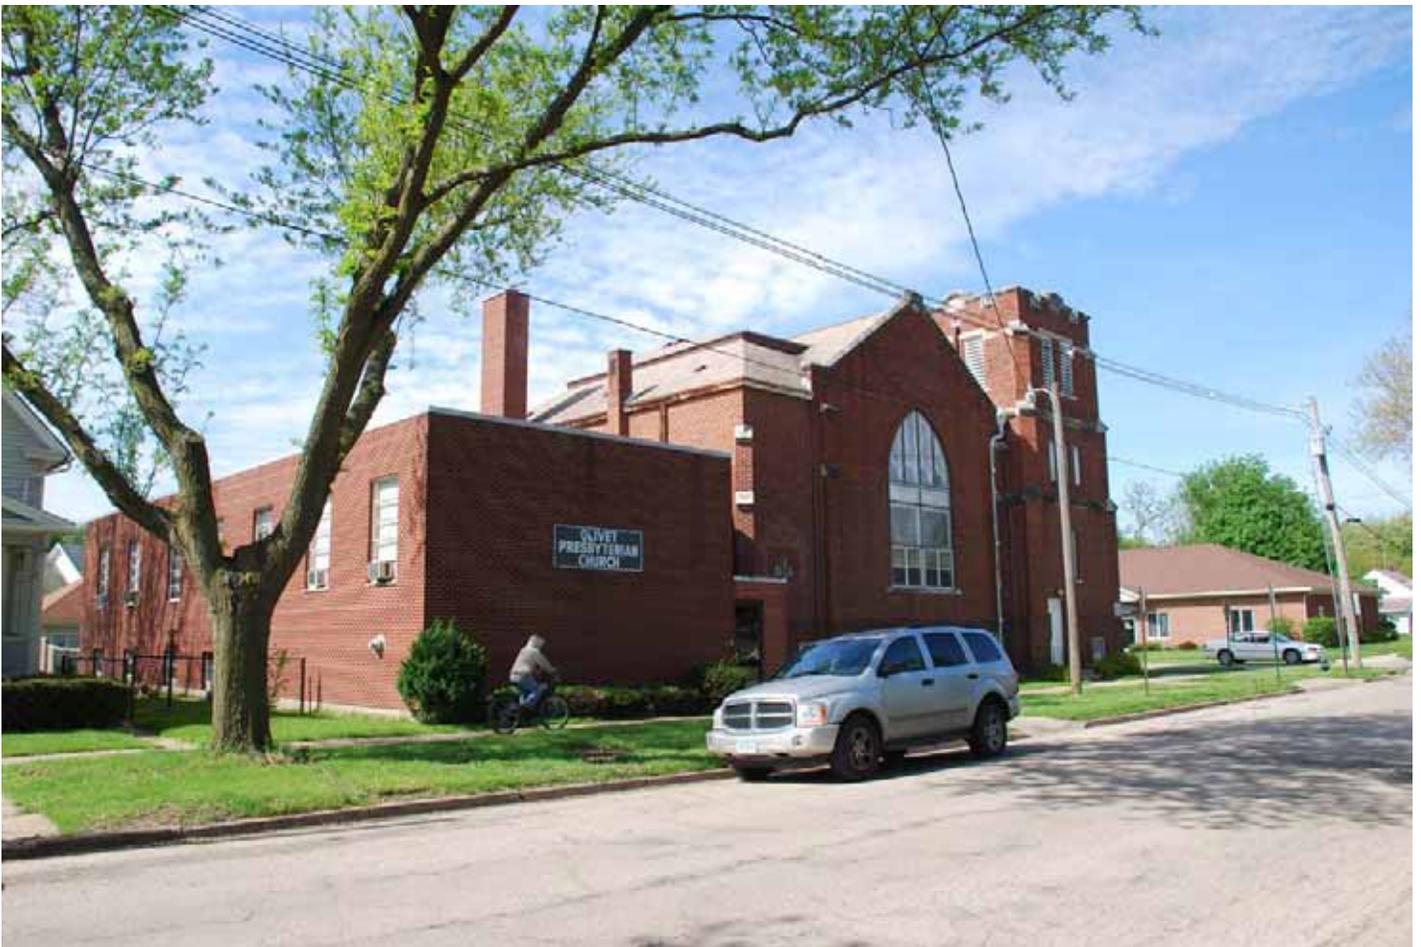
237 (A.K.A. 231) 10th St NW_View NE.jpg

231 10th Street NW (A.K.A. 237 10th Street NW) (1904) – The Gothic Revival style Olivet Presbyterian Church is located on a prominent corner lot with an area of residential and industrial buildings. The church is covered by intersecting gable roofs with a three-level, square entrance tower at the northwest corner. Details include cast stone wall coping and string courses, large arched windows with tracery, and brick buttresses. The exterior brick walls are laid in a running bond pattern and window and door openings are detailed with pointed and segmental arches. A one-story, flat-roofed wing has been constructed at the rear (east) of the church. The church was identified in the 2000 MPD *Architectural and Historical Resources of Cedar Rapids Residential Neighborhoods, 1870 – 1940* as an individually eligible resource located outside of identified historic districts (Svendsen 2000: Section F, Page 76). As with other churches in the area, Olivet Presbyterian was located along a streetcar line for easy access and was located within one of the city’s expanding residential neighborhoods in the Northwest Quadrant. The Olivet Presbyterian Church is eligible for listing in the National Register under Criterion A for its historical association with the development of the neighborhood. The building may also qualify for listing under Criterion C as an example of an early-twentieth-century Gothic Revival-style church executed in brick.

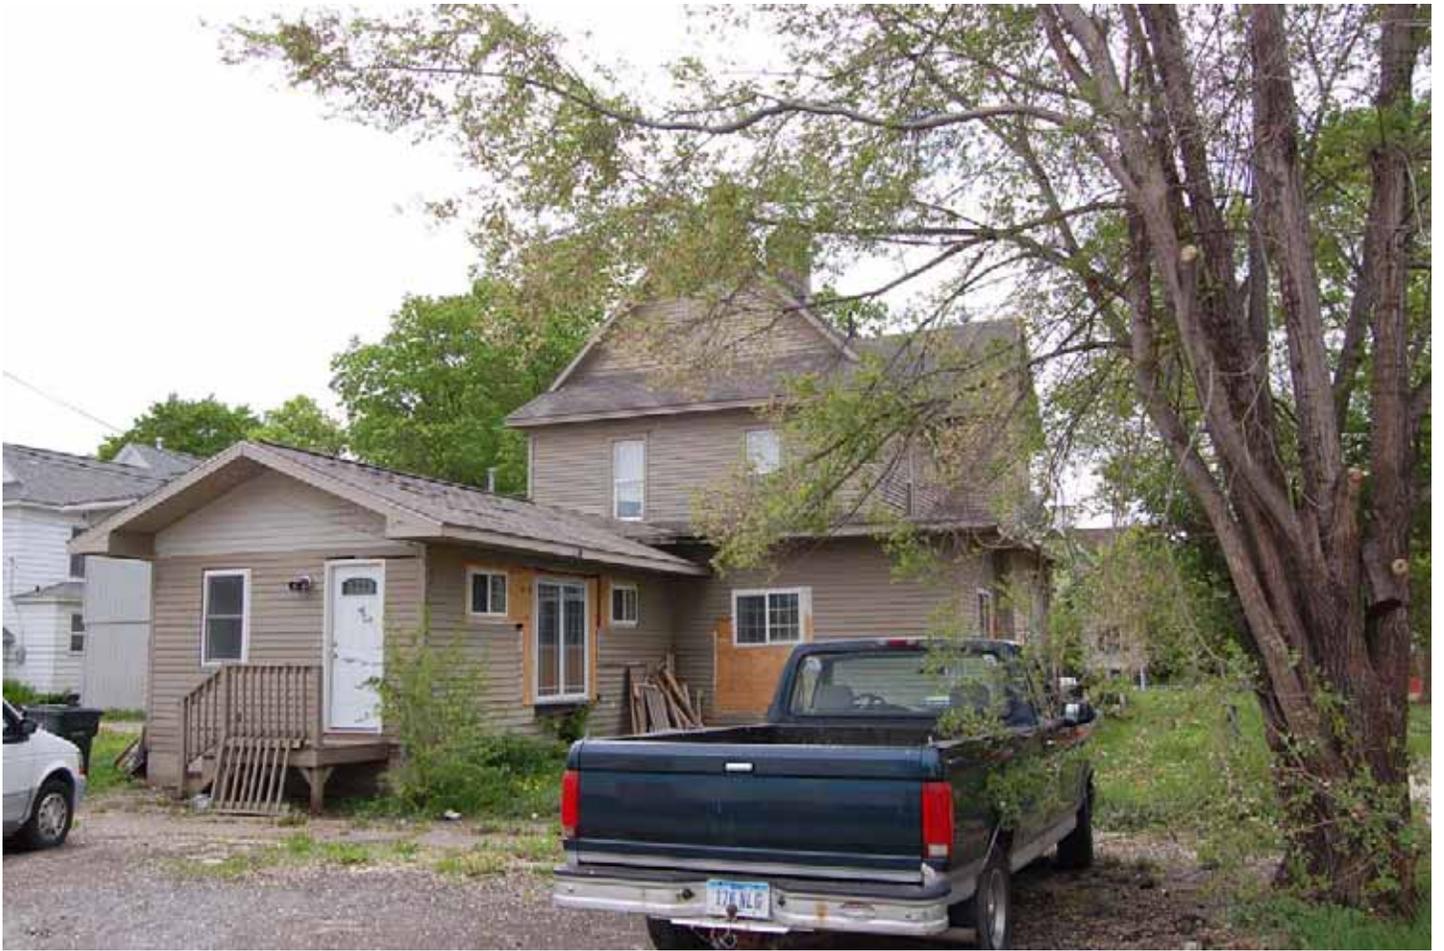
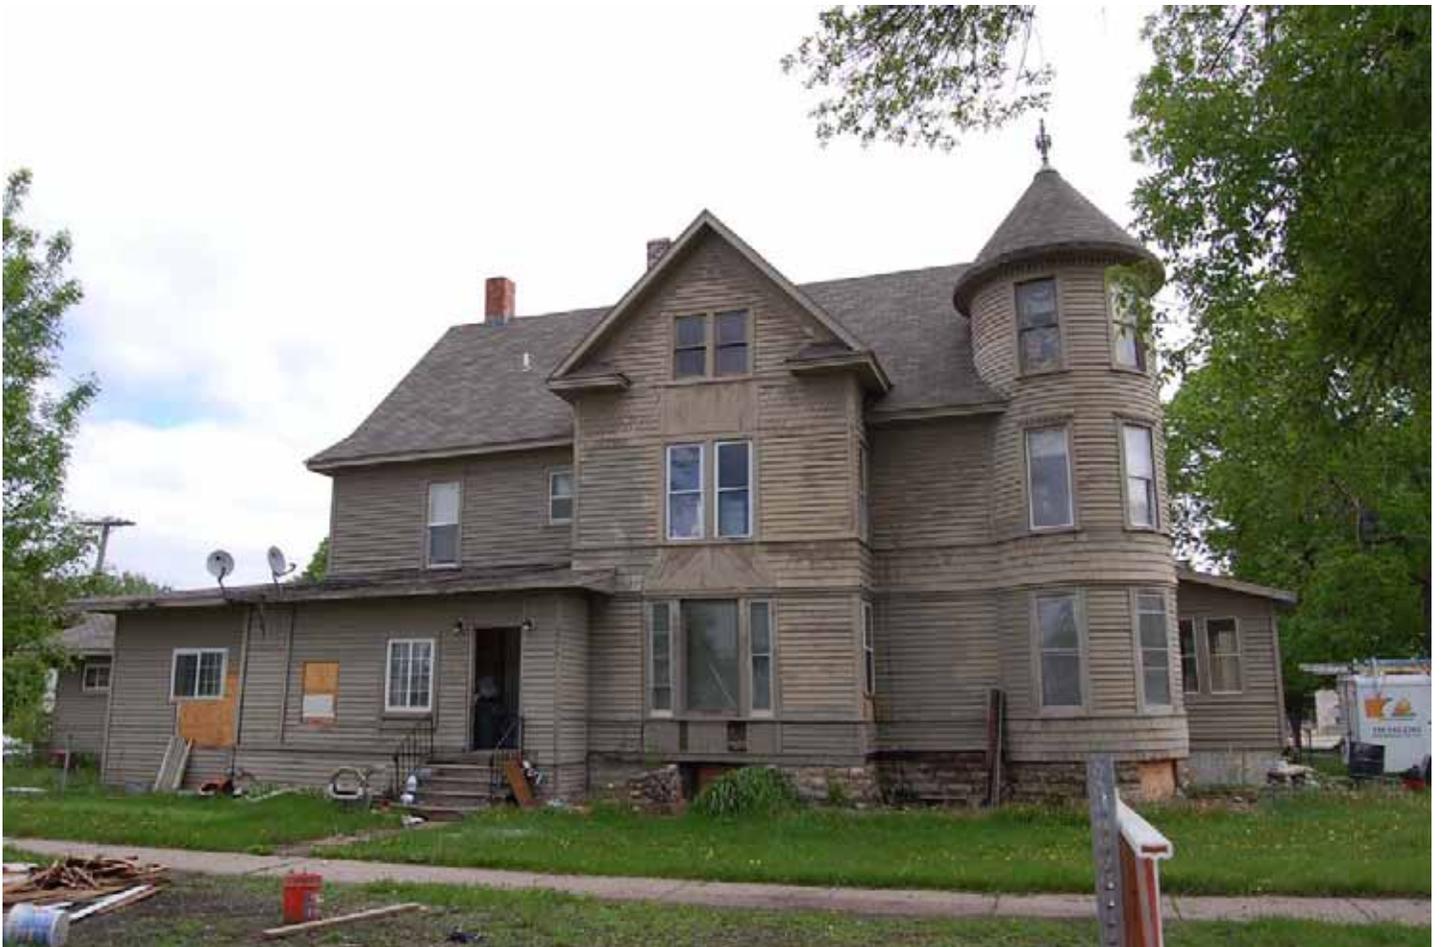
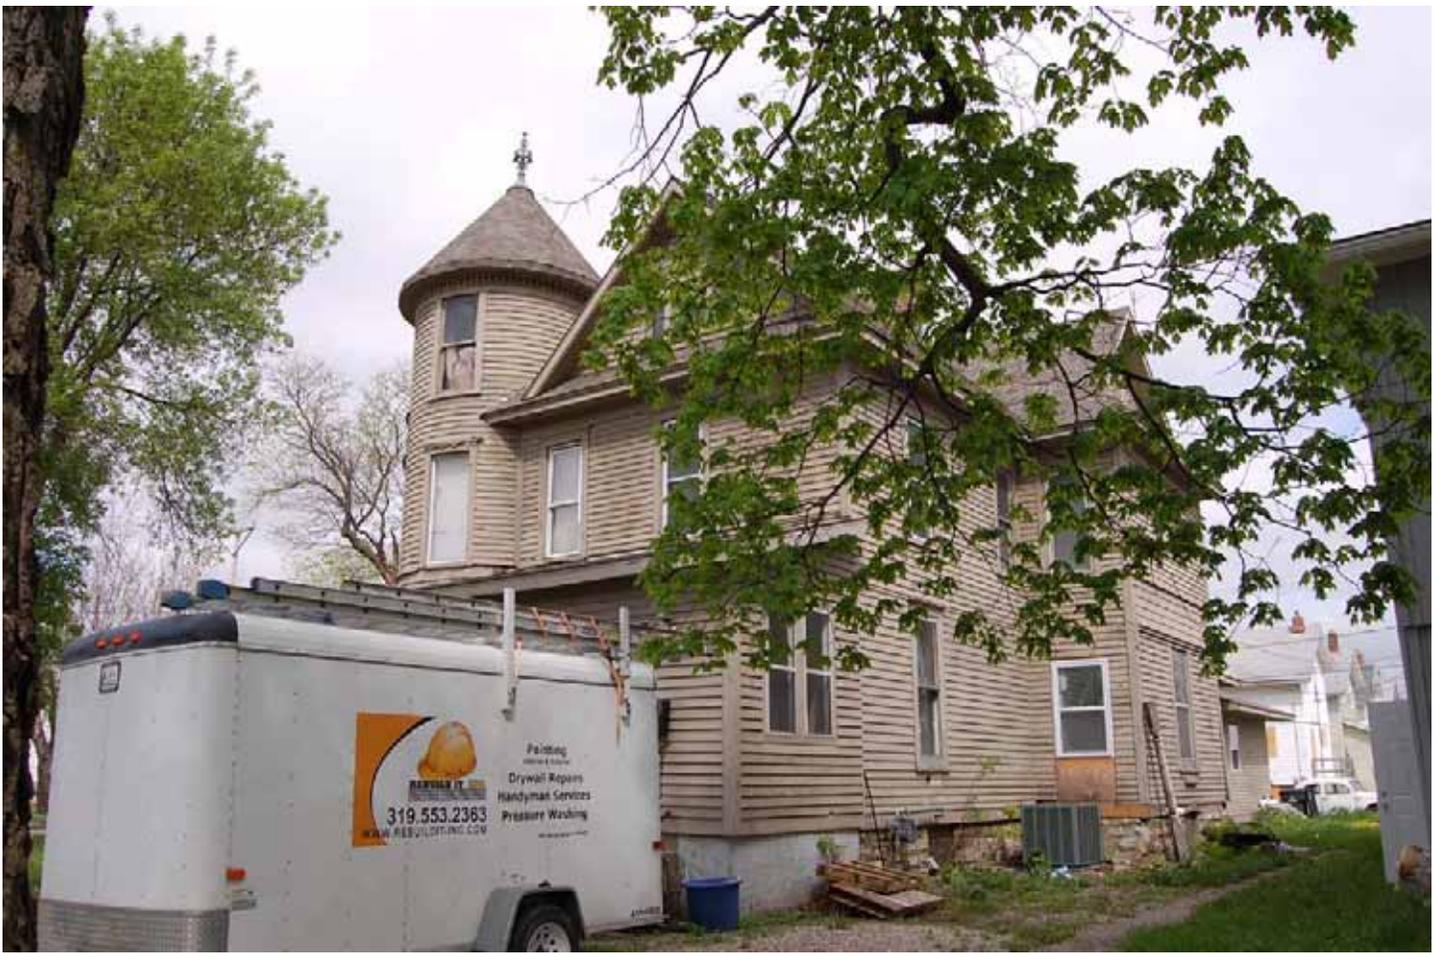
305 5th St NW_View E.JPG

305 5th Street NW (ca. 1890) - This 2 ½-story, frame Queen-Anne style dwelling is covered by an intersecting gable roof, clad with weatherboard siding and shaped and square-end wooden shingles, and set on a limestone foundation. The first- and second-floor levels, which are clad with weatherboard siding, are separated by a wide band of wooden shingles that encompasses each elevation of the house. The 3-story, round tower located at the southwest corner of the façade is capped by a conical roof. Other details on the house include wooden window surrounds, wooden string courses, and corner boards. Historic Sanborn Fire Insurance maps indicate that this one-story porch formerly wrapped around the northeast side of the house. It appears that the existing porch replaced the original porch sometime after 1949 and has since been enclosed with aluminum siding and 1/1 metal-sash windows and the foundation has been modified with a stucco finish. The one-story porch on the southwest side of the rear one-story ell has also been enclosed with aluminum siding and an entrance has been inserted there. A gable-roofed ell has also been built at the northwest (rear) corner of the house. Major alterations include replacement of the front porch and enclosure of the side porches, which is a dominant feature of such Queen Anne examples. Original windows and doors have been replaced and some openings have been modified and

new ones created. Classically inspired detailing, also common to the style, are noted only on the tower with its dentils and modillion blocks. The rear addition also detracts from the original form of the house due to its small scale and lack of architectural detailing. Although this dwelling retains its overall Queen Anne-style form, it has undergone significant alteration, which has diminished its overall integrity. As such, the house is not eligible under Criterion C. However, initial research indicates that the building was the home of Charles H. Swab, part owner of Swab Brothers, a hardware business established in 1881 by his father, Joseph F. Swab. On that basis, the house may be eligible under Criterion B for its association with a significant person.

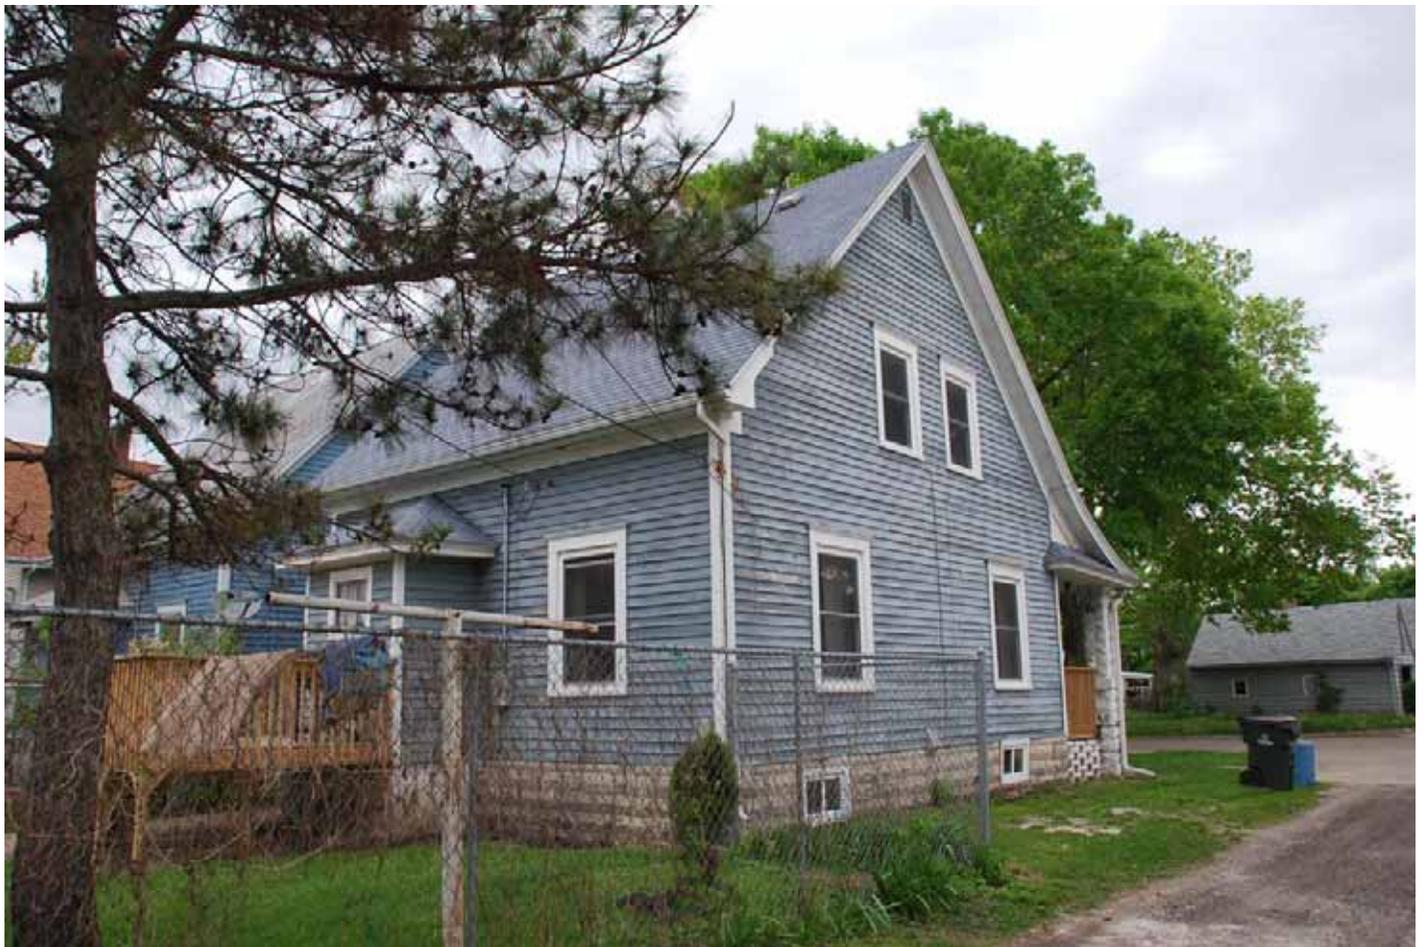
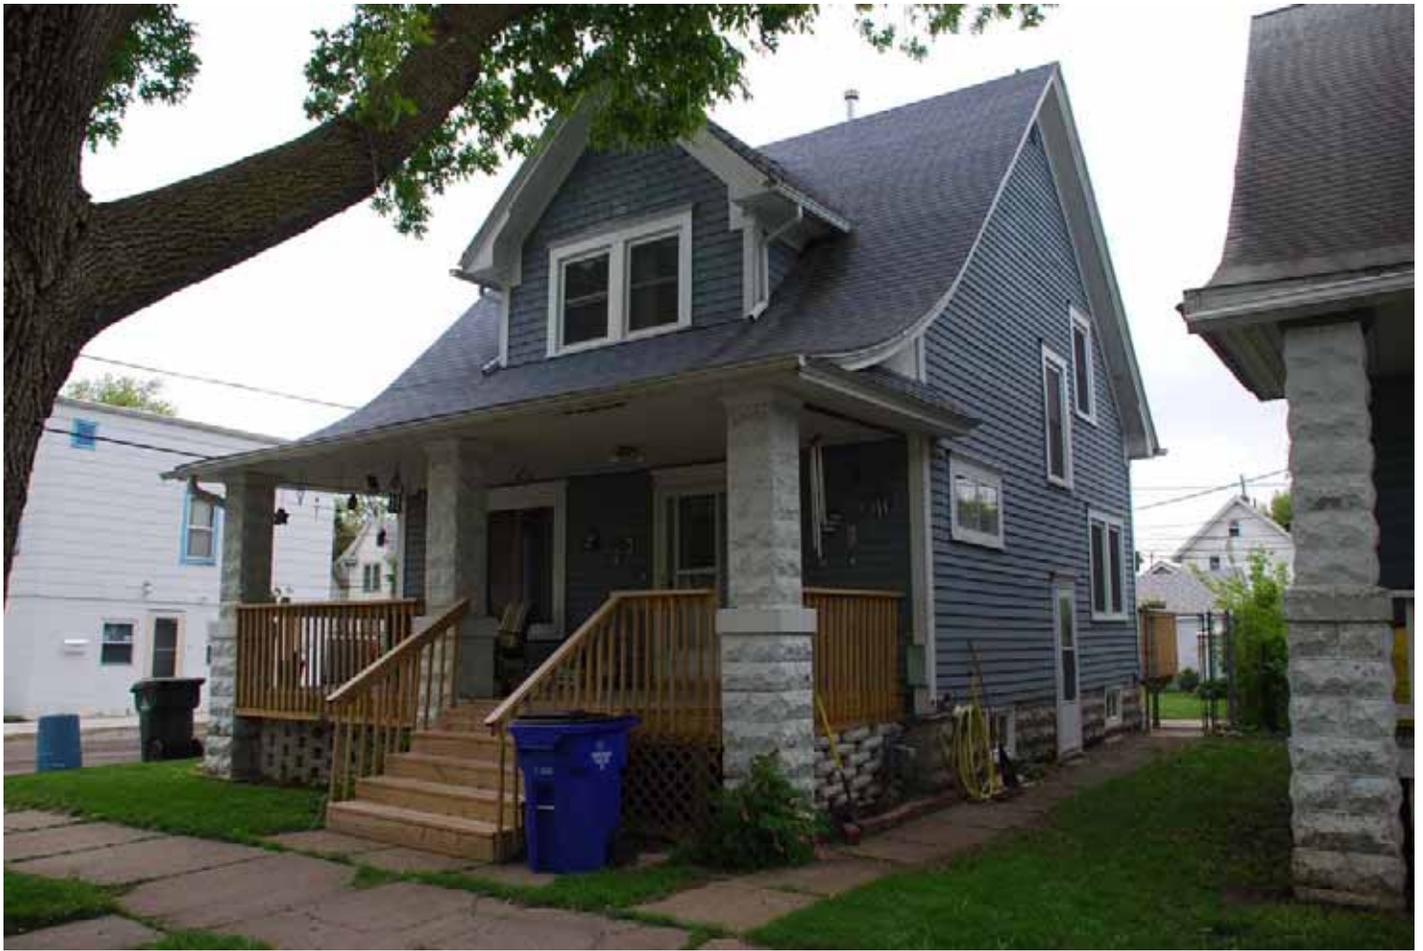
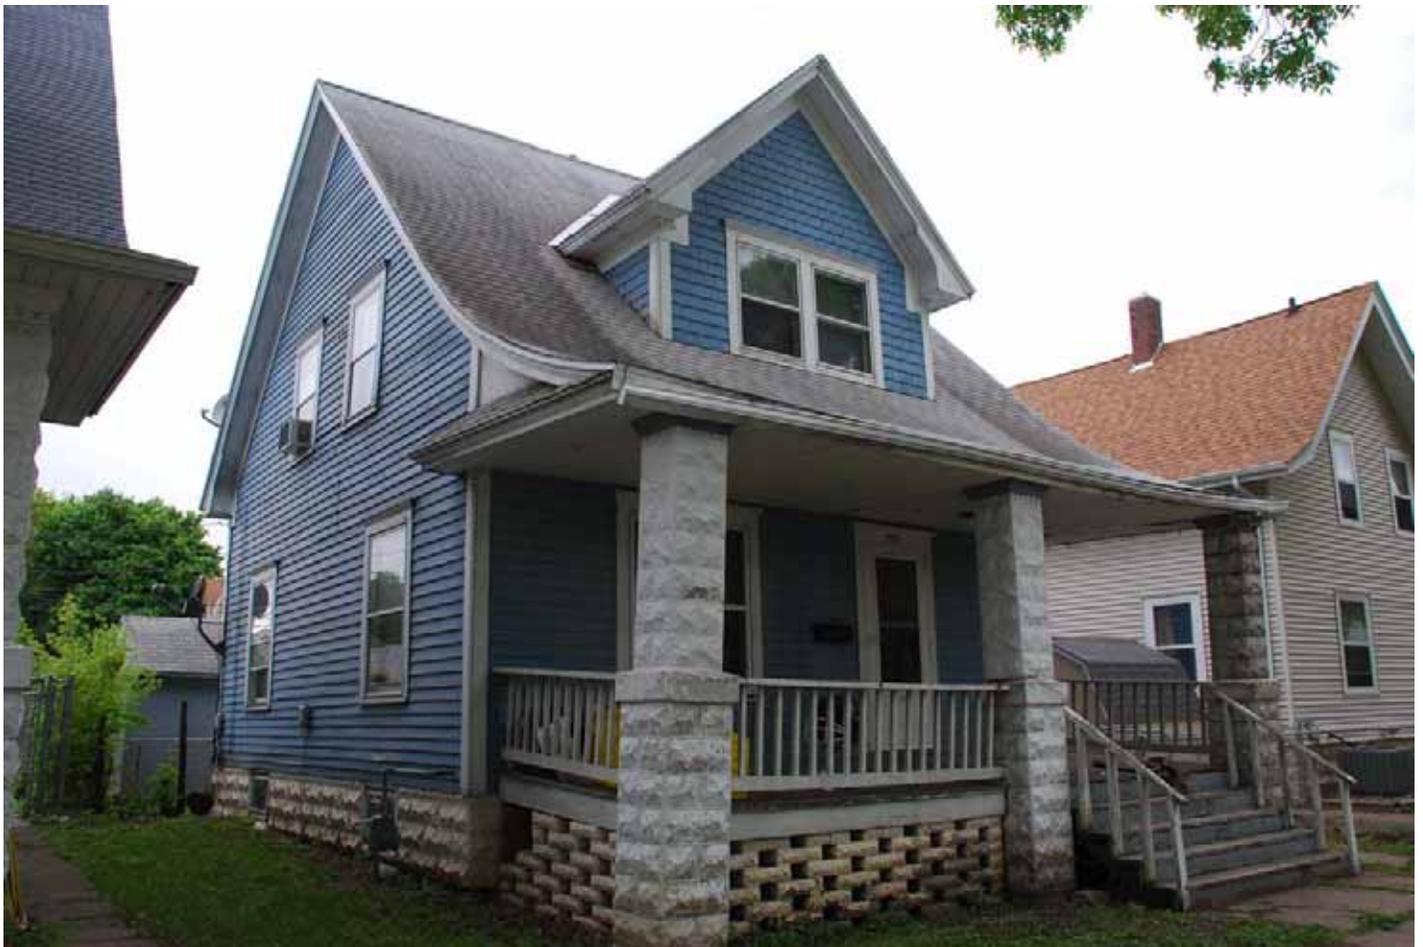
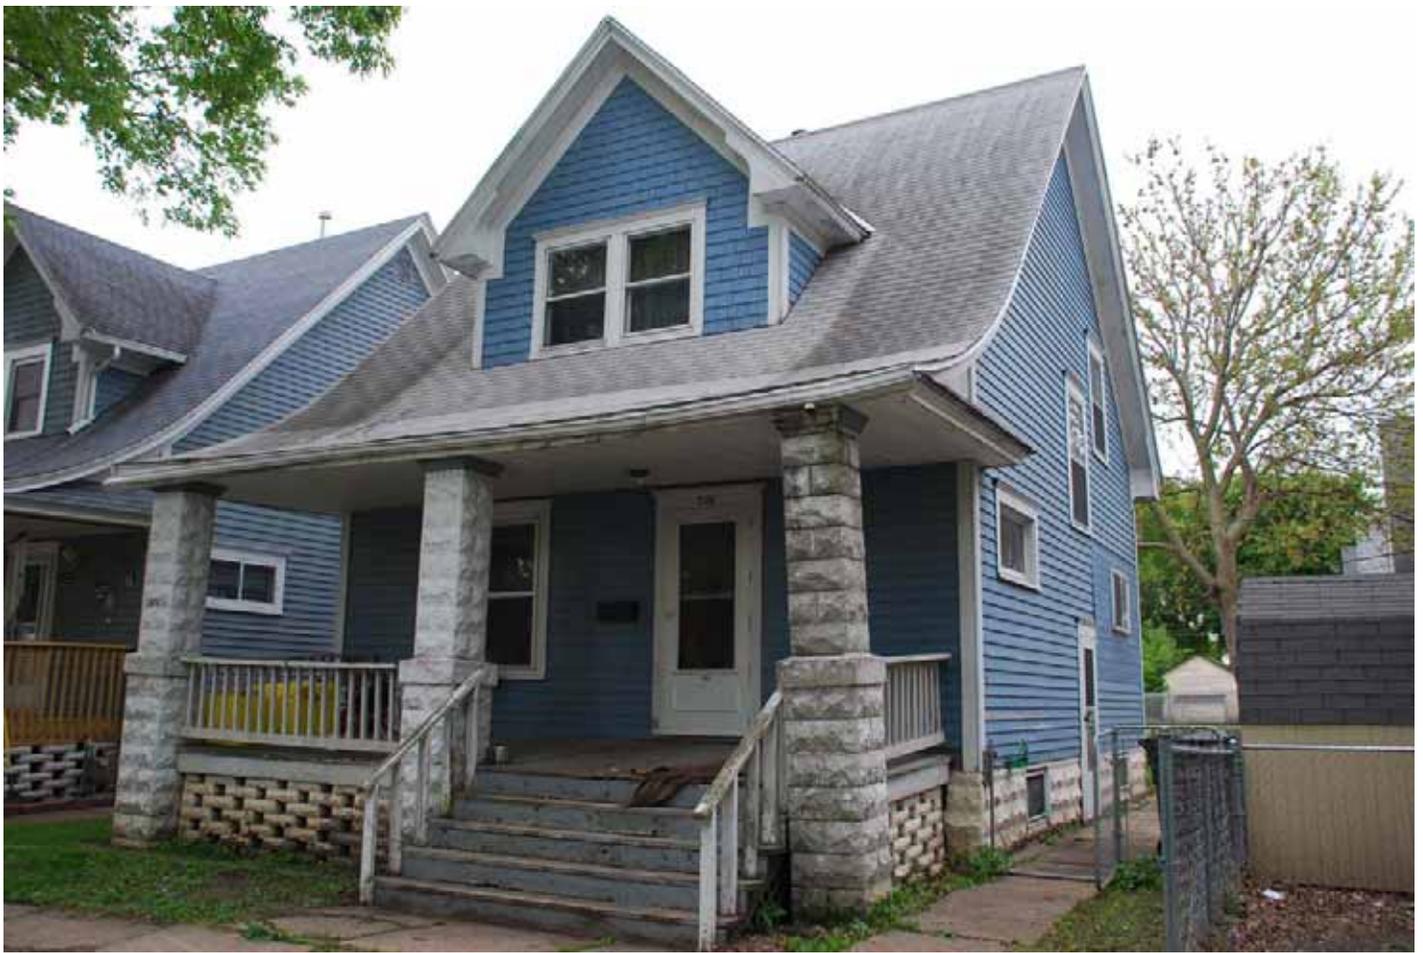
316 9th St NW_View NE.jpg

316 9th Street NW and 320 9th Street NW (1911) – These two houses are presented together since they are nearly identical in form, materials, and detailing and they are located next to one another facing east onto 9th Street NW between B and C avenues NW. The 1 ½-story, bungalow houses are covered by a broad, side-facing gable roof that extends to the front to cover the two-story front porch. Both dwellings are covered with weatherboards and are set on limestone foundations. A large gable-roofed dormer, clad with wooden shingle siding, is featured on the front of each dwelling and hold paired 1/1 wood-sash windows. The front porch features stout, square, limestone columns that are set on high stone piers. Wooden railings with square balusters between them are also present. The railings and stairs at 316 9th Street NW are new; however, these elements closely replicate the original elements as seen on 320 9th Street NW. The fenestration of the side elevations is also identical on both houses; each appears to retain all original windows. The dwellings at 316 and 320 9th Street NW fall into a category identified in the 2000 MPD *Architectural and Historical Resources of Cedar Rapids Residential Neighborhoods, 1870 – 1940* as the “Bungaloid” (Svendsen 2000:Section E, Page 34). These two dwellings, both built in 1911, are potentially eligible for listing in the National Register as locally significant examples of the Bungaloid-style of house. Each retains character defining elements of the style as described above and retain very good overall integrity. The significance of the dwellings is heightened by their proximity to one another. Additional research may reveal additional information about the builders and original occupants of the dwellings.
