**Architectural Reconnaissance Survey
for St. Patrick's Neighborhood
in Cedar Rapids
(57-086)**

Linn County, Iowa

June 8, 2009

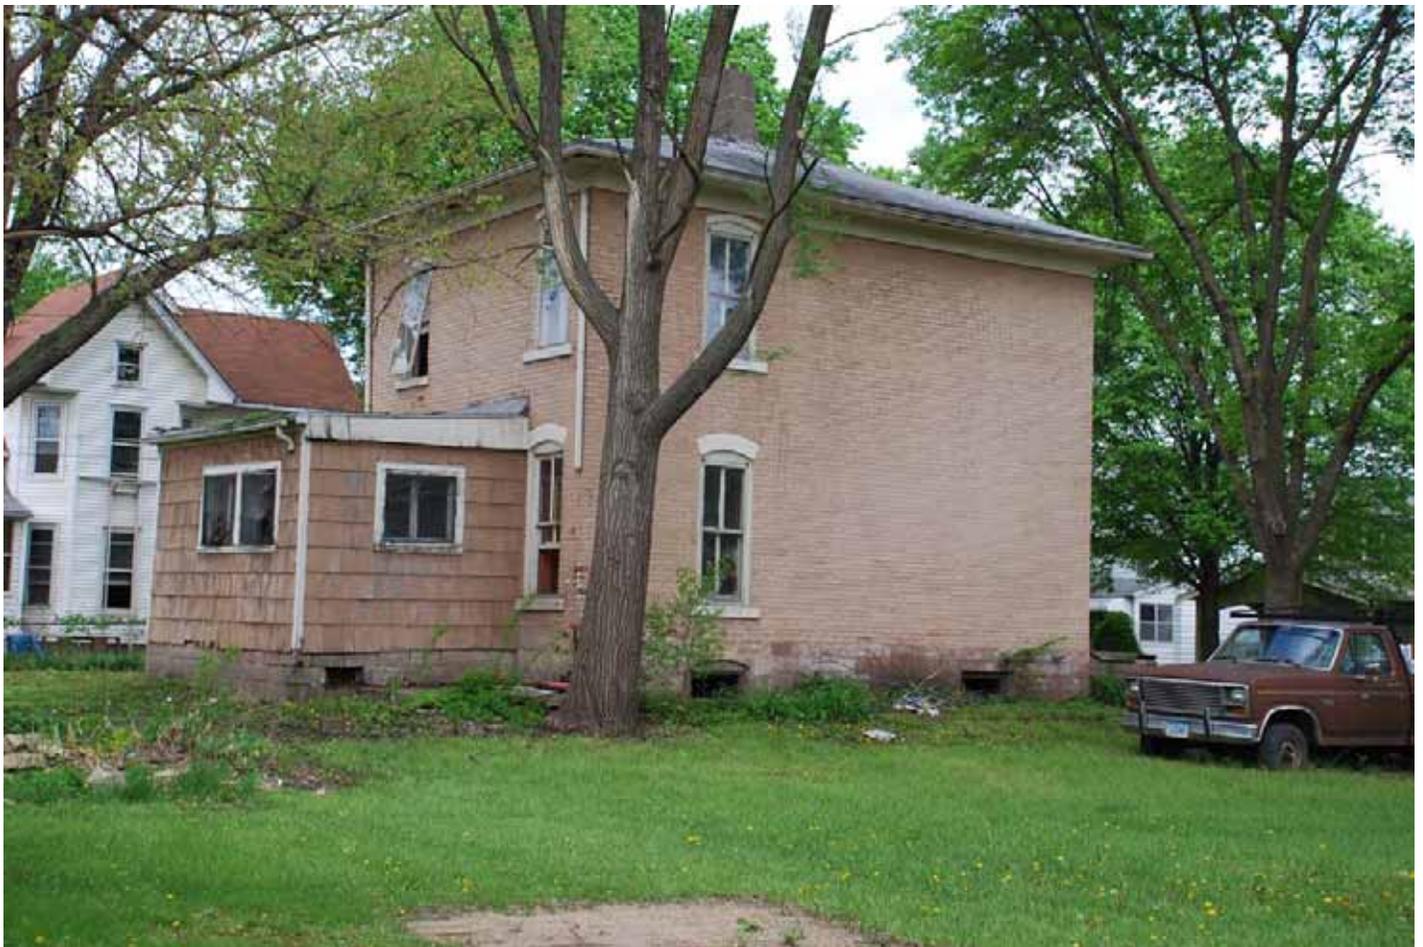
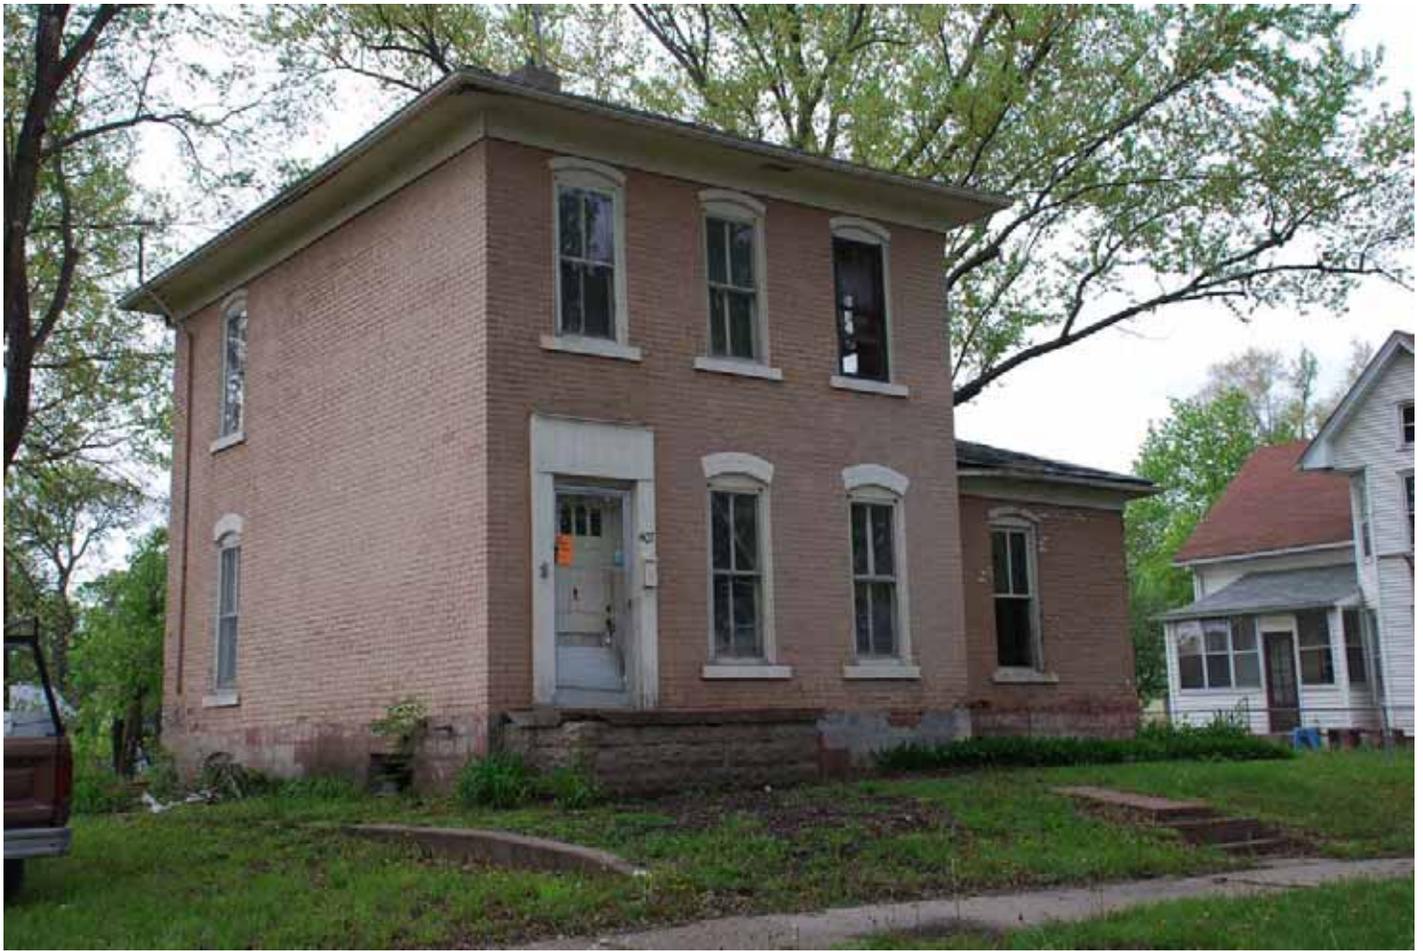
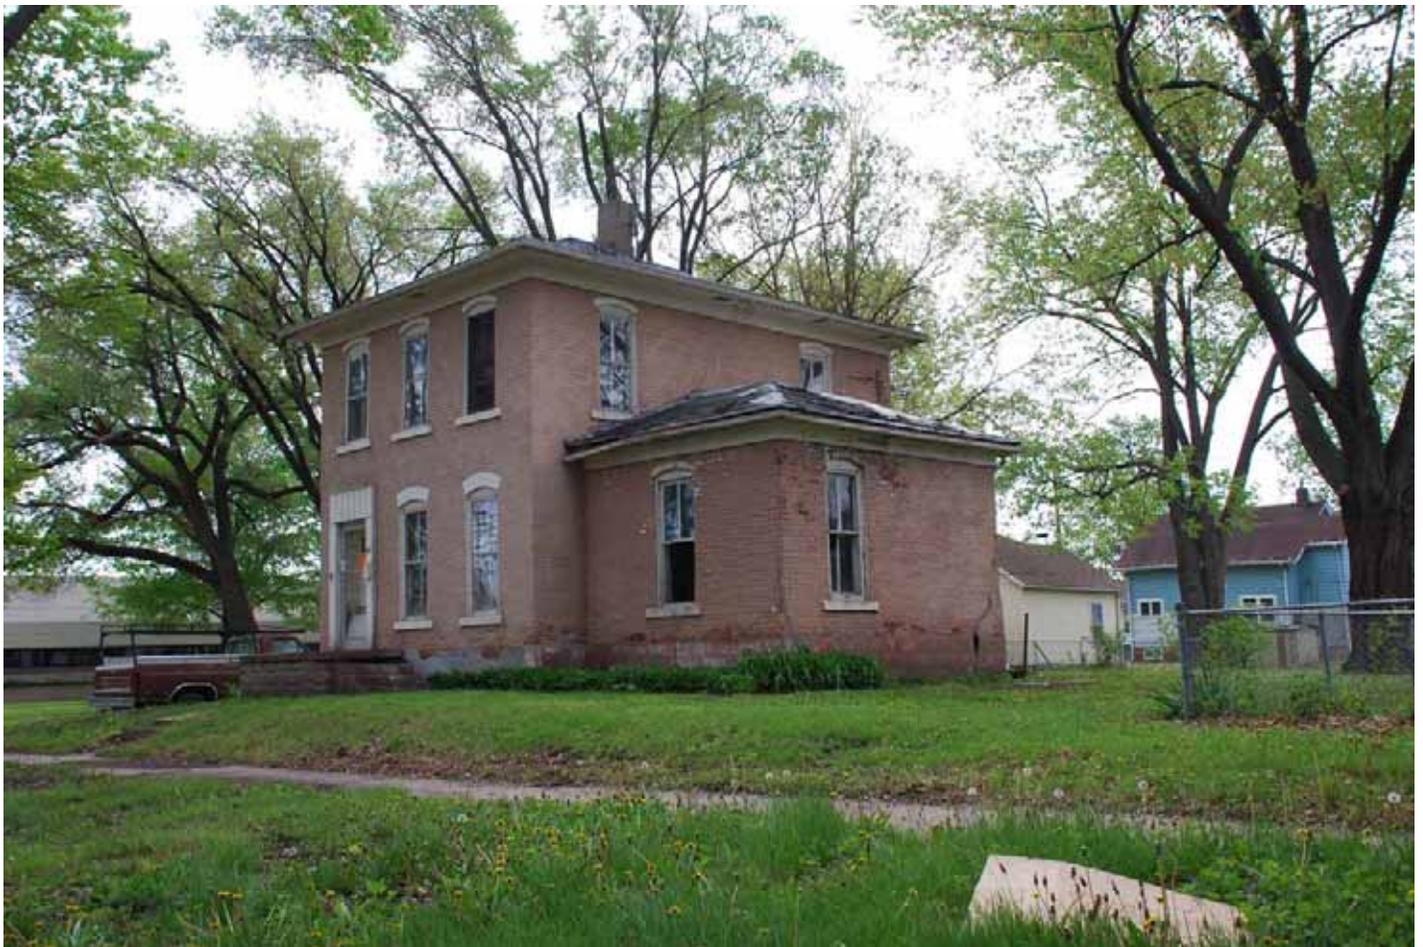
407 B Avenue NW_View NW.jpg

407 B Avenue NW (1870) – This 2 story, brick Italianate dwelling is covered by a low-pitched, hipped roof with a centrally located stucco-covered chimney. The three-bay front features an entrance in the easternmost bay and two window openings in the westernmost bays. The second-floor level holds three window openings. All window openings are detailed with a segmental arch above and hold 2/2 wood-sash windows. The recessed entrance holds a replacement door: the surround has been modified, possibly obscuring a more detailed opening or replacing an earlier entrance porch. There is a concrete stoop in front of the entrance that is raised on a rusticated stone foundation. The house is set on a plain stone foundation. Other details include the deep, overhanging roof eaves and a broad, plain frieze board that encircles the house. A one-story, hip-roofed brick addition (running bond) is located on the west side of the house. The wing is similar to the main section of the house in materials and details and includes 2/2 wood-sash windows set within arched openings (single brick deep), a wide frieze board, and a stone foundation. Another one-story addition has been constructed at the rear (south) of the house. This addition is set on a concrete block foundation, is clad with wooden shingle siding, and holds 2-pane casement windows. This dwelling is in poor condition; however, it retains sufficient integrity to convey its historical appearance and architectural character. The house is an example of a brick Italianate-style dwelling, a nationally popular style during the late nineteenth century. The house exhibits such hallmarks of the style as the low-pitched hipped roof with deep overhanging eaves, arched window openings, 2/2 wood-sash windows, and a wide frieze board. Typical of Italianate townhouses, the entrance is located in the side bay. This dwelling is potentially eligible for listing in the National Register under Criterion C as an example of a late-nineteenth-century Italianate-style dwelling executed in brick. While the rear addition is inappropriate to the house, it appears to be easily removed without damage to the overall integrity of the dwelling.

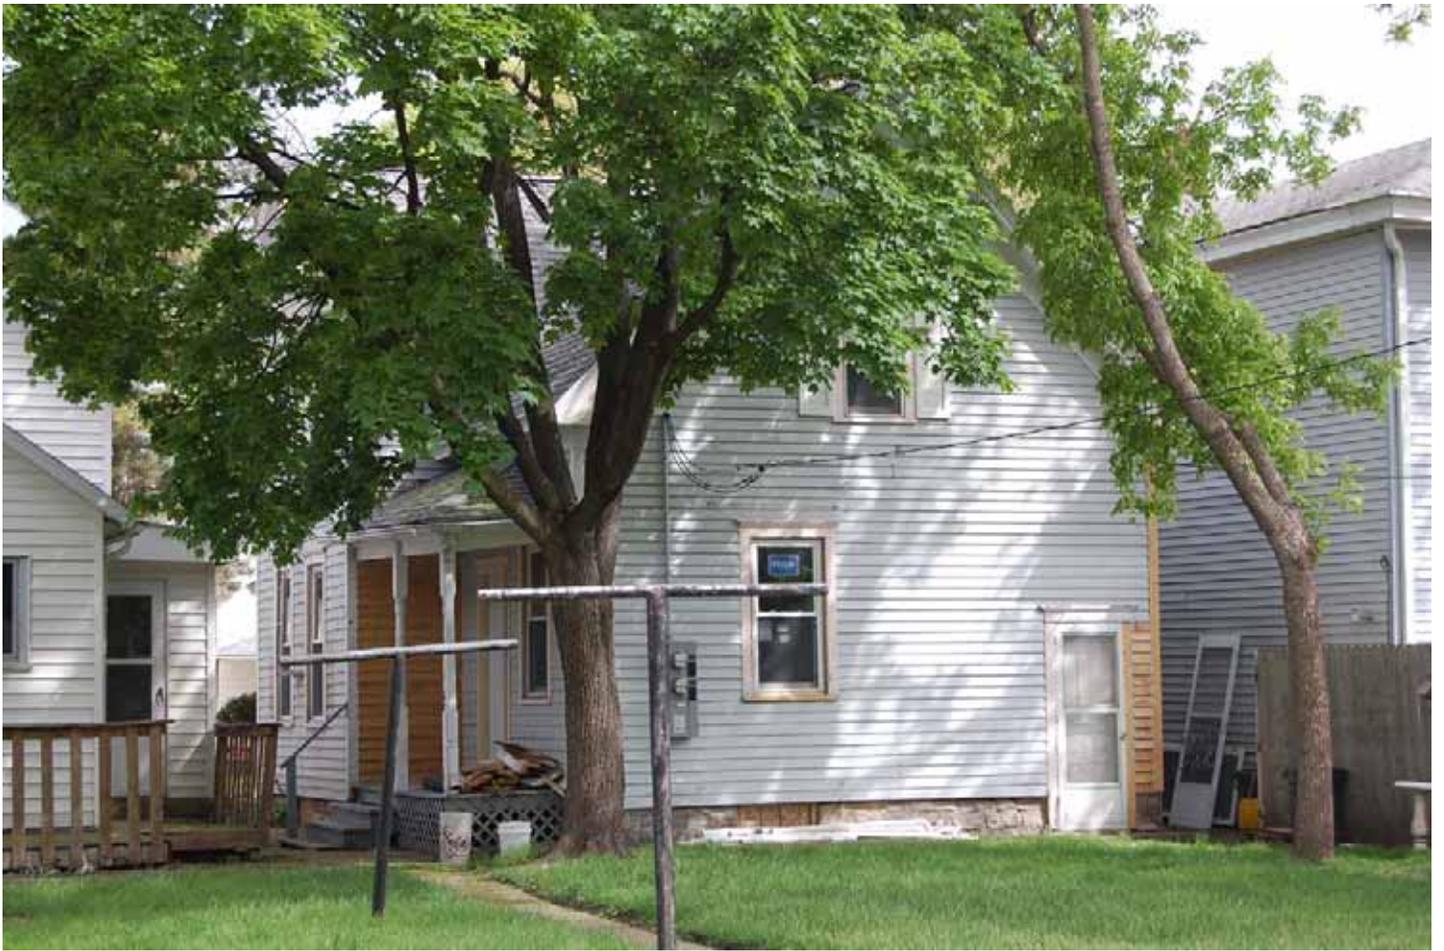
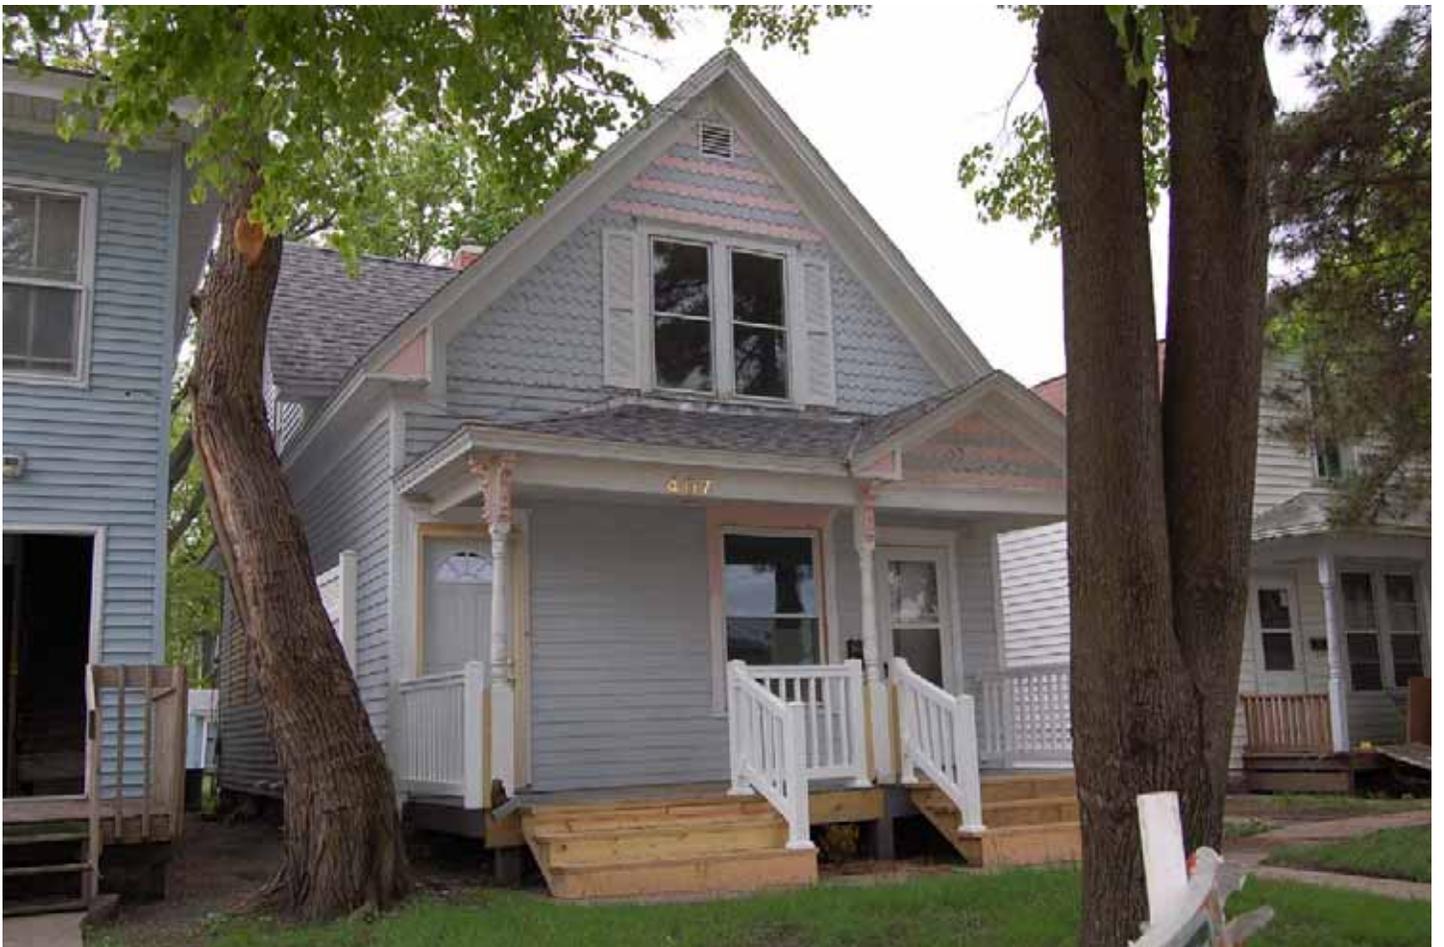
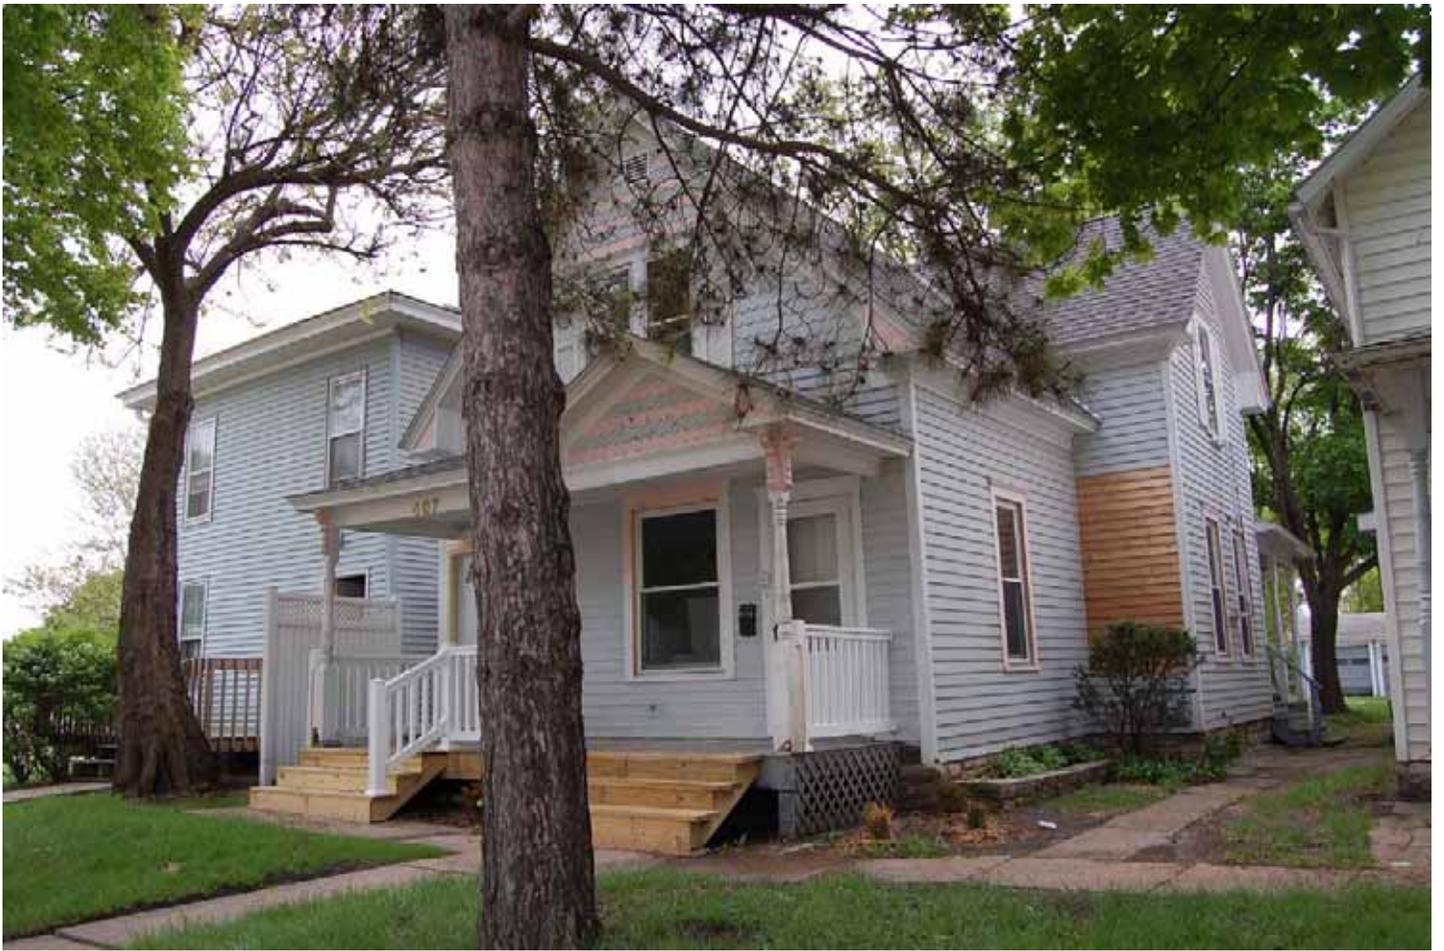
407 C Ave NW_View NNE.JPG

407 C Avenue NW (ca. 1900) – This vernacular 1 ½-story, frame dwelling is covered by a front-facing gable roof, clad with weatherboard siding, and set on a limestone foundation. The front gable end is clad with shaped wooden shingles and features enclosed corner eaves. The front porch is covered by a hipped roof with a cross gable, featuring shaped wooden shingles in the end, at the northern entrance bay. Porch details include turned wooden posts with decorative sawn brackets. The three-bay front features entrances in the northern and southern bays and a wide 1/1 window between them. Paired 1/1 windows are present in the gable end. This dwelling is eligible for inclusion in the NRHP under Criterion C as an important example of a front-gable dwelling as it retains its original early twentieth century porch, which is rarely seen on extant examples of this vernacular house type. Though the house has been altered with the installation of a second entrance door and modern porch railing, the remainder of the house retains a high degree of integrity.

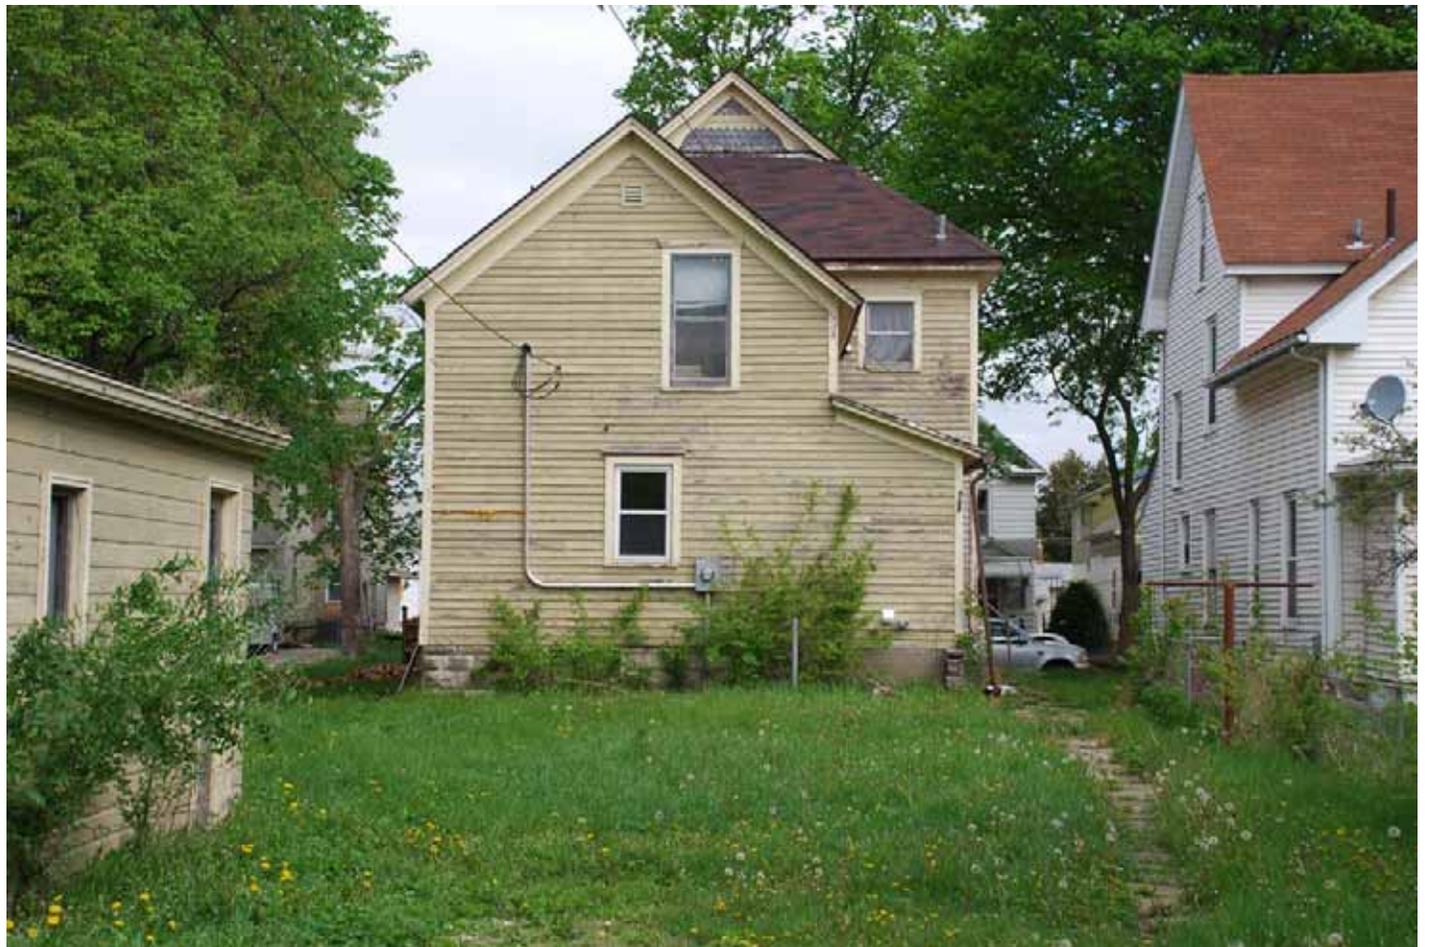
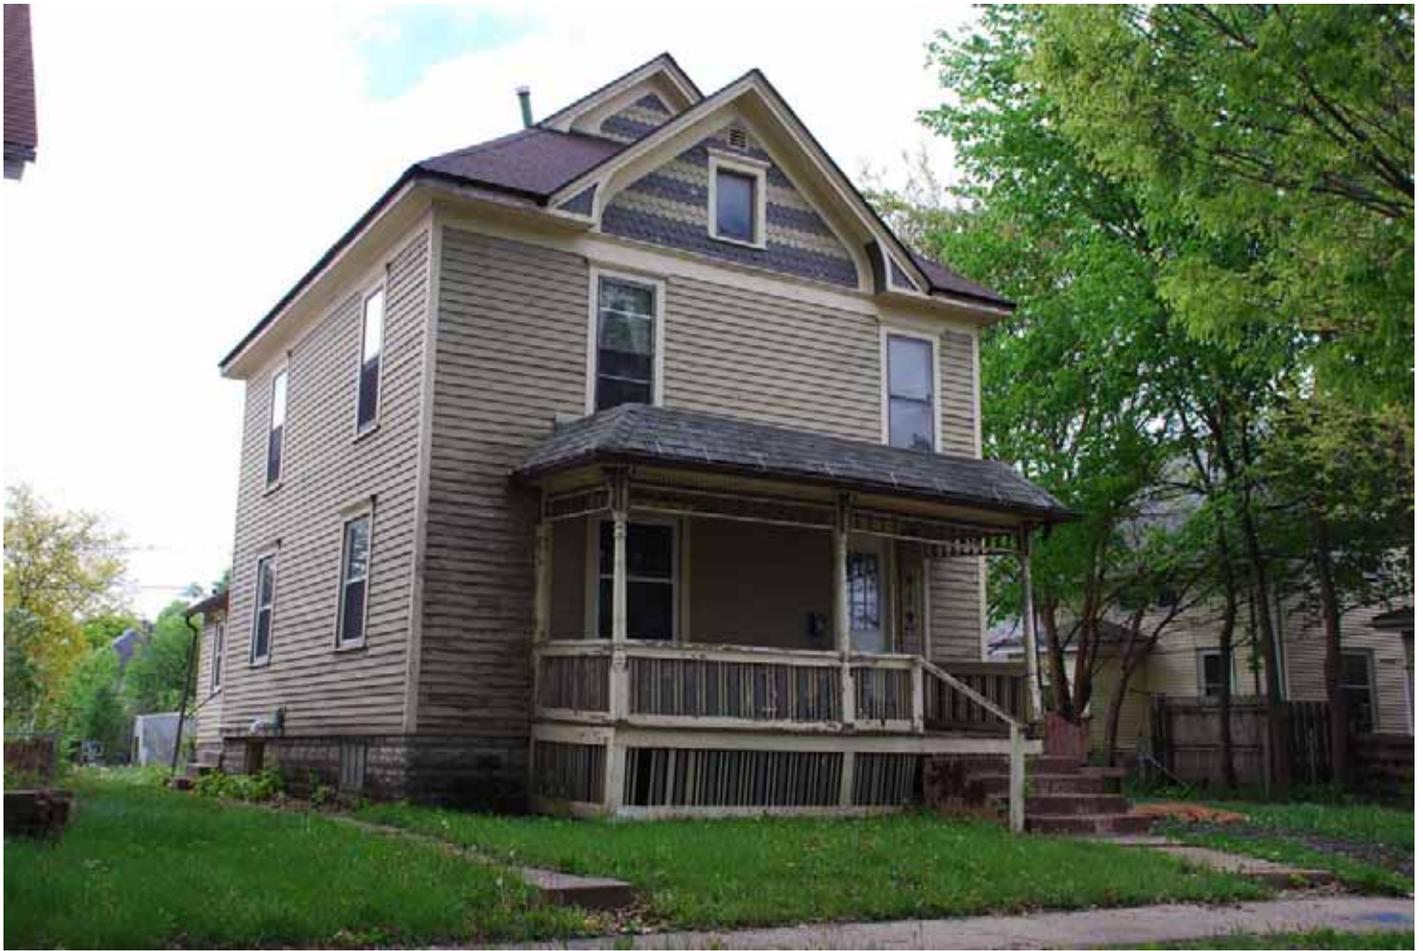
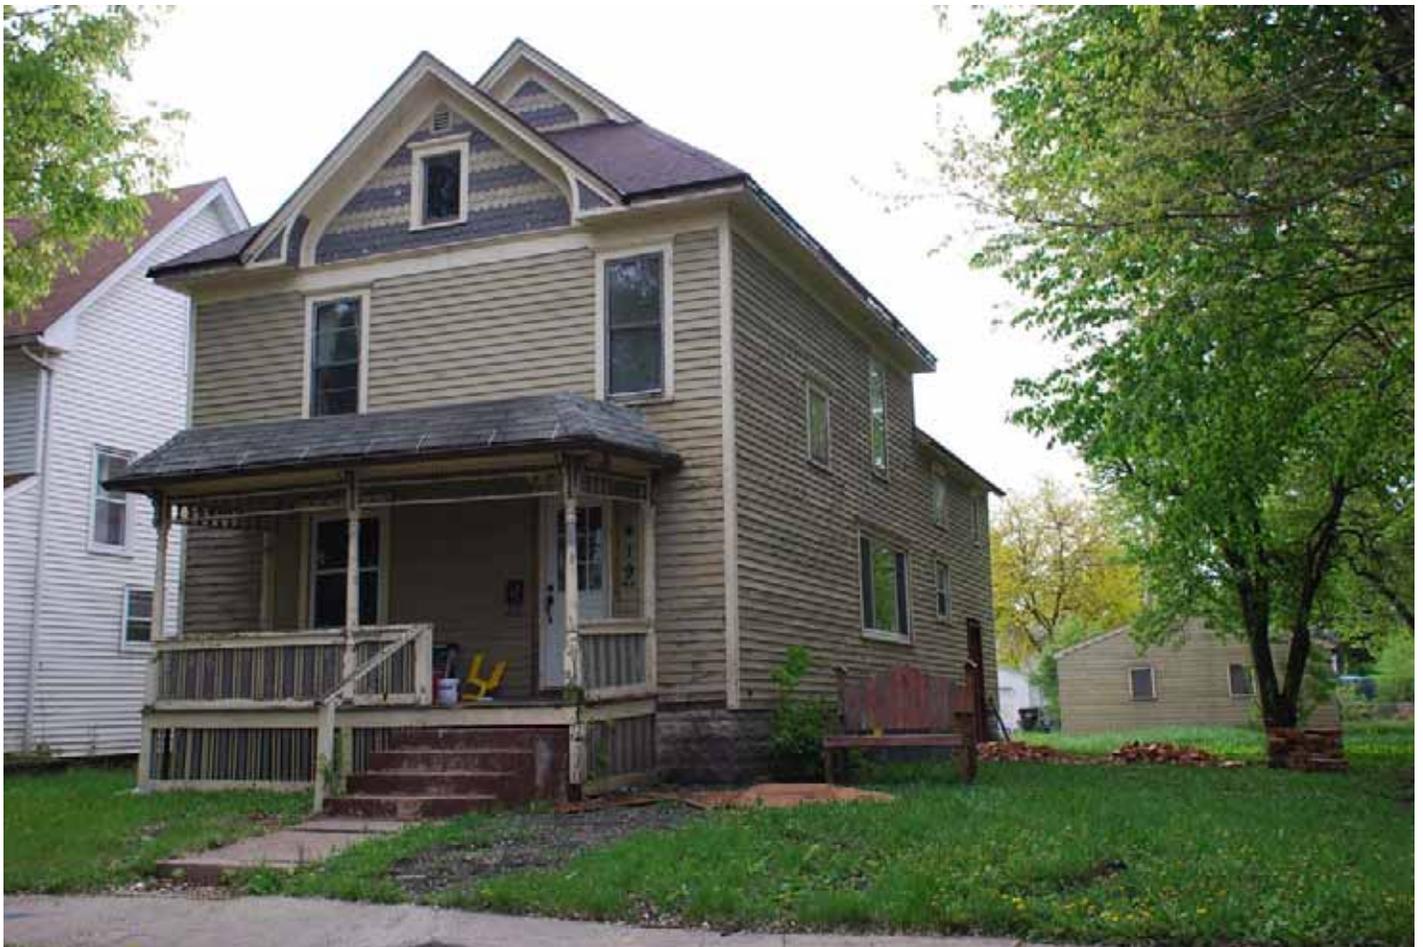
419 B Avenue NW_View NE.jpg

419 B Avenue NW (1890) – This 2 ½-story, frame dwelling is covered by a gable-on-hip roof with a centrally located front gable. The gable ends are notable for the use of shaped wooden shingles that are painted in two colors in alternating rows. The house is clad with weatherboard and is set on a rusticated limestone foundation. The entrance (replacement door) is located in the western bay and windows are 1/1 wood-sash. The two-bay front porch extends over the entrance and the window opening on the first-floor level. It is covered by a modified hipped roof that is supported by turned wooden posts with elaborate spindlework and brackets. The porch railing consists of alternating wide and narrow boards, as does the porch foundation skirting. Other distinctive details on the house include deep eaves, a wide frieze board, corner boards, and a full basement with window openings on the side elevations. This dwelling was identified in the 2000 MPD *Architectural and Historical Resources of Cedar Rapids Residential Neighborhoods, 1870 – 1940* as an individually eligible resource located outside of existing historic districts (Svendsen 2000: Section F, Page 76). The house was labeled as the Emanuel & Barbara Gerdl House. This dwelling is eligible under Criterion C as an interesting combination of the symmetrical nature of an American Four-Square dwelling (two bays deep and two bays wide) with decorative elements that show influence of the Queen Anne-style. The latter include the use of the front gables that are detailed with wooden, shaped shingles, and the elaborate detailing found on the porch elements. The enclosed corners of the gable ends are another detail that is often found in houses in the area and may reflect an element associated with immigrant influences.

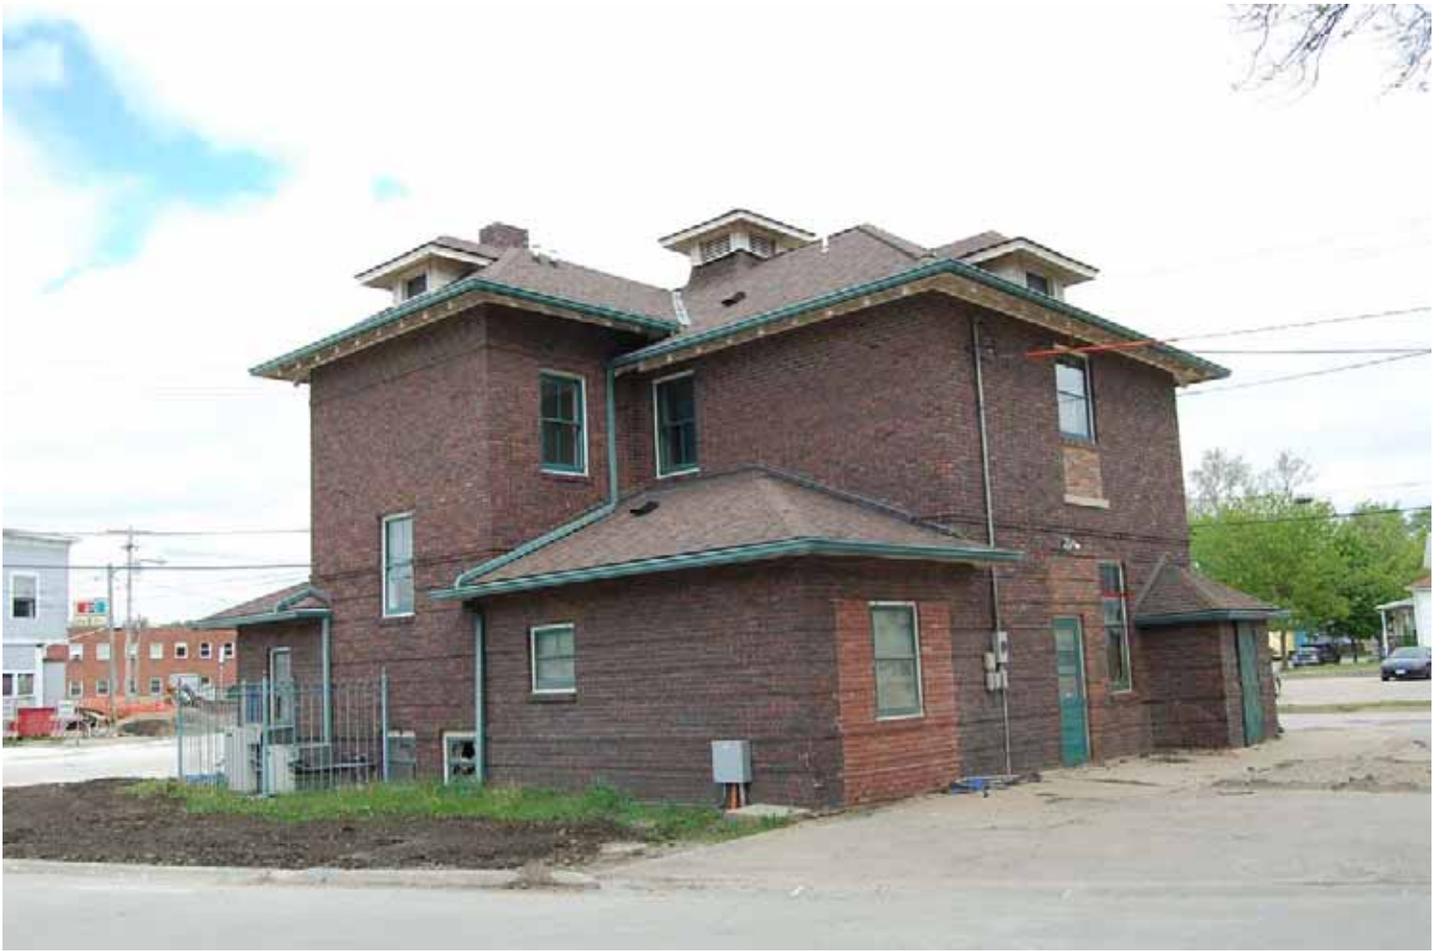
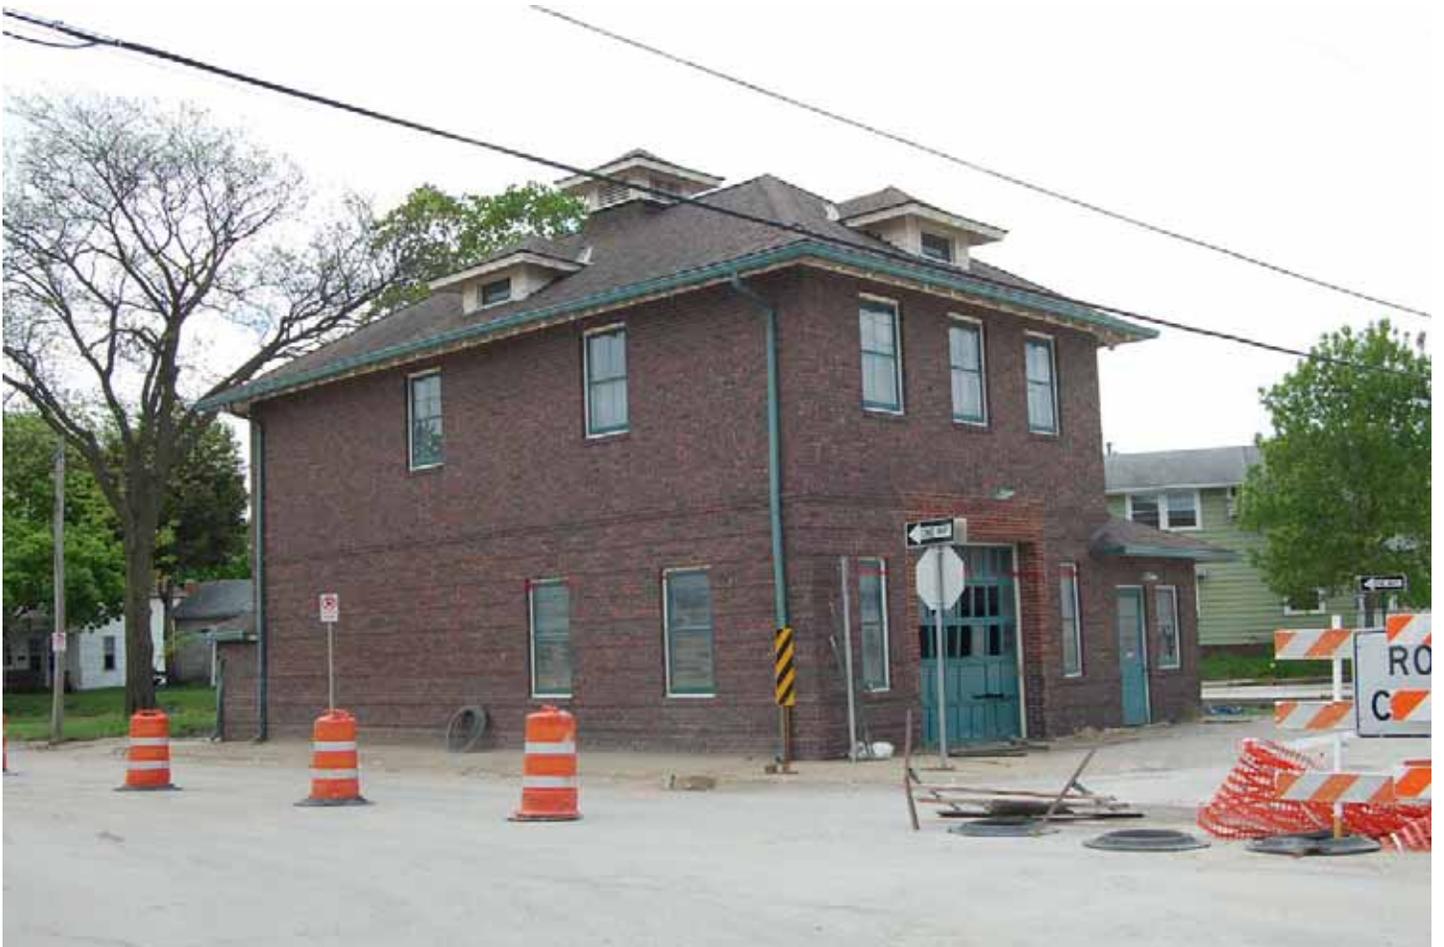
423 5th St NW_View NW.JPG

423 5th Street NW (1908) – This 2 ½-story, brick building is covered by a hipped roof with low-pitched hip-roofed dormers on each side. A pyramidal-roofed cupola with louvered sides is centrally located along the roof ridge line. The deep overhanging eaves of the main roof are detailed with exposed rafter tails with curved ends. The three-bay front features a centrally located overhead door (a later addition) that is flanked by 2/2 wood-sash windows. The second floor level holds three 2/2 windows. The brick walls are laid in a distinctive, though untraditional, bon pattern. The first floor level features four rows of stretchers separated by rows of slightly projecting stretchers. The string course also features a row of corbelled headers. Small, one-story, hip-roofed sections are located at the southwest, southeast, northeast corners of the building. Window and door openings on the rear of the building have been modified with brick that does not match the original. This building is the former Fire Station #2 that was built in 1908 in the Time Check neighborhood. The building is now used by the City's ground transportation department. Although some alterations to openings have occurred, this building is eligible for listing in the National Register under Criterion A for its association with the early-twentieth-century development of the neighborhood and under Criterion C for its architectural distinction and unusual brickwork.

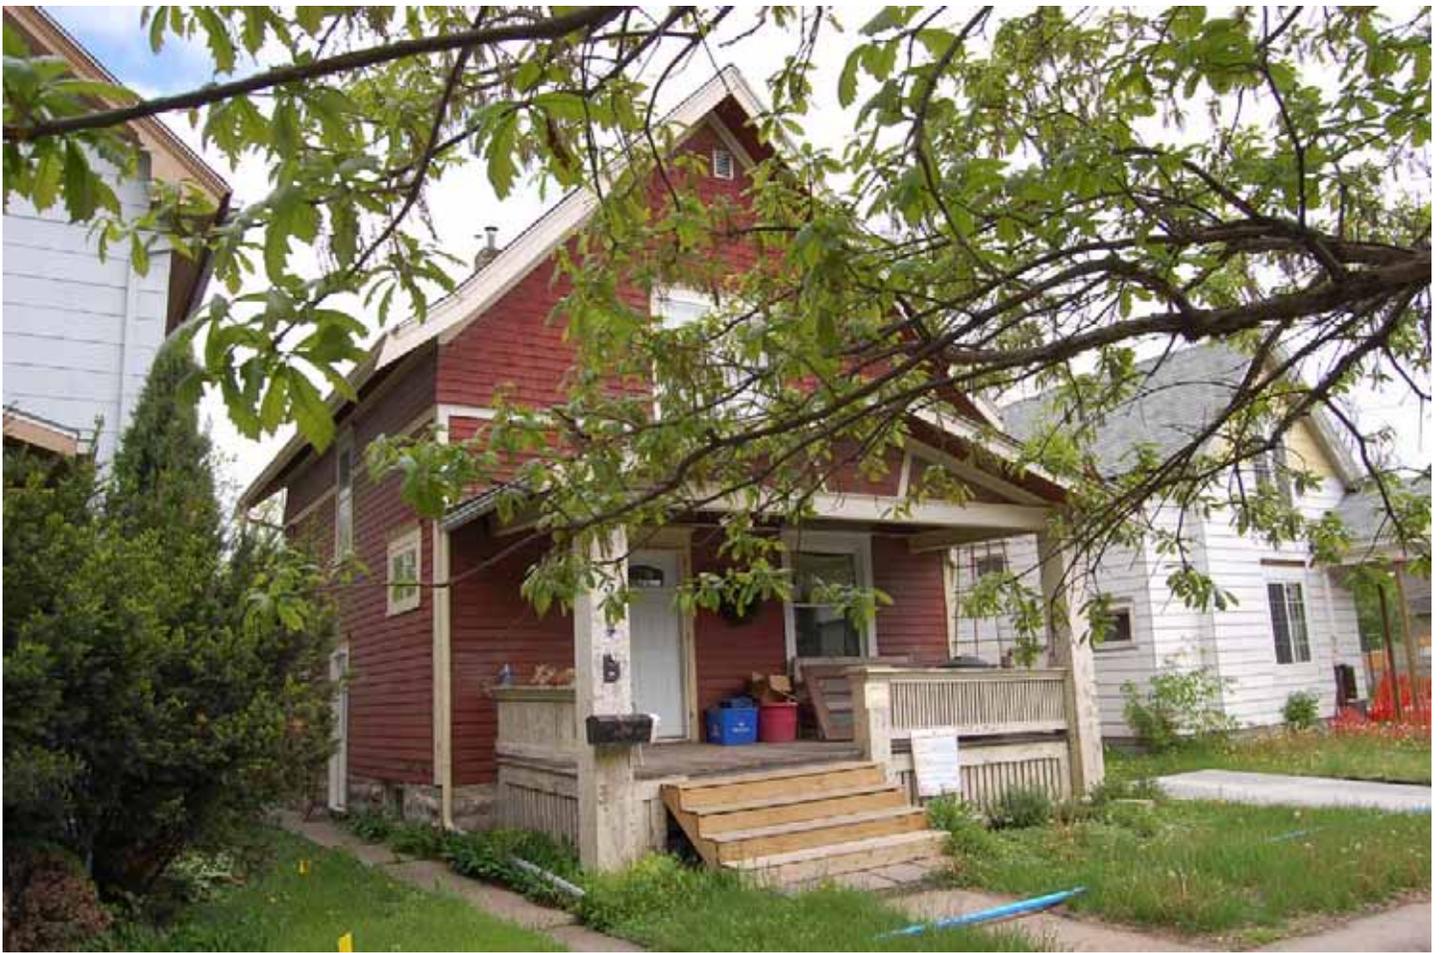
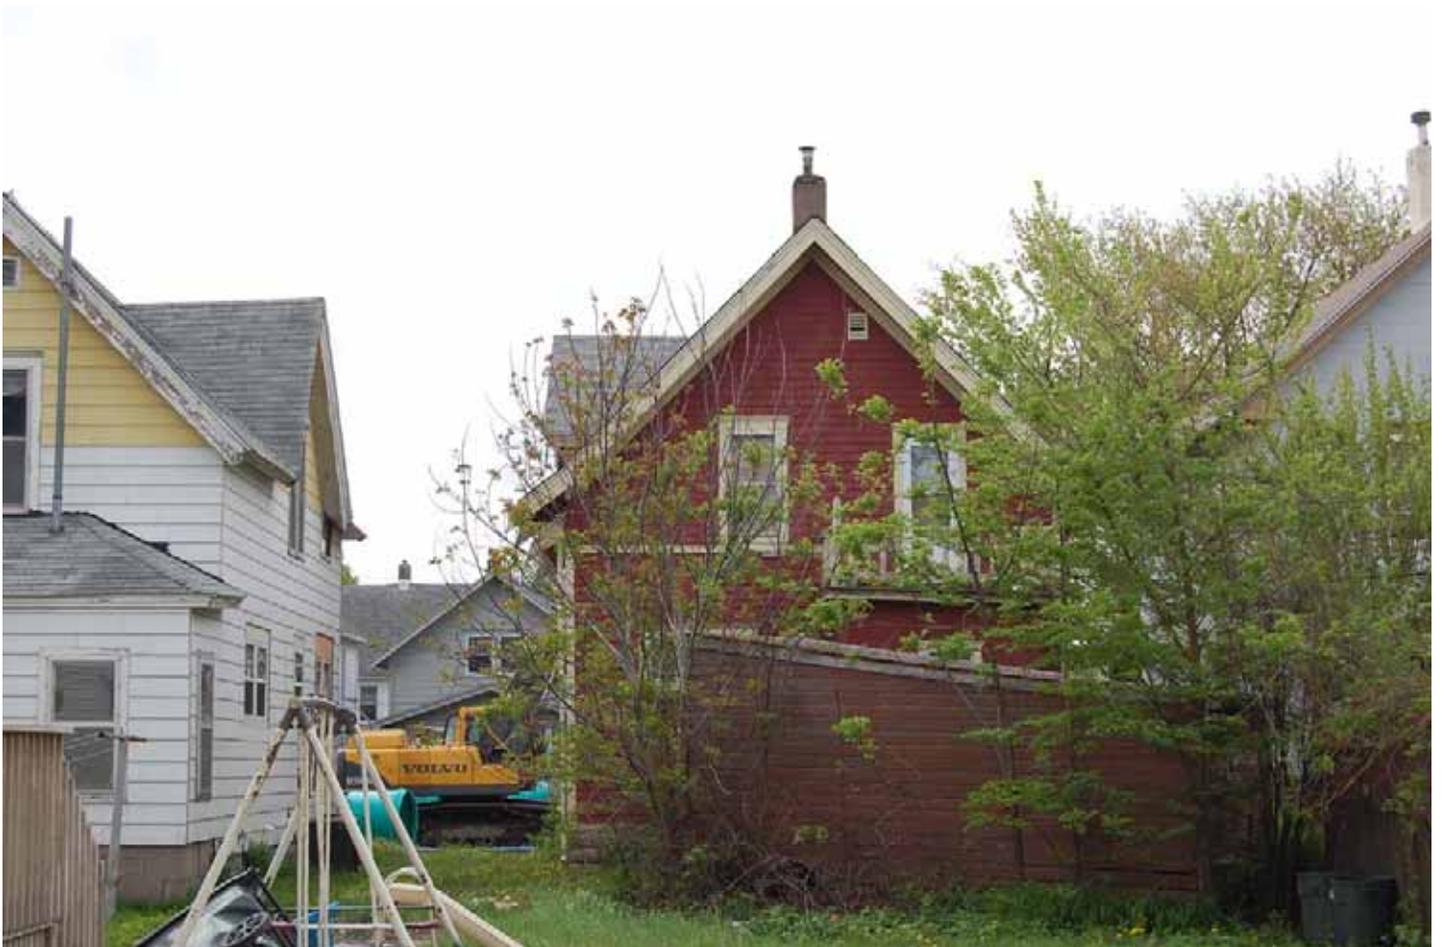
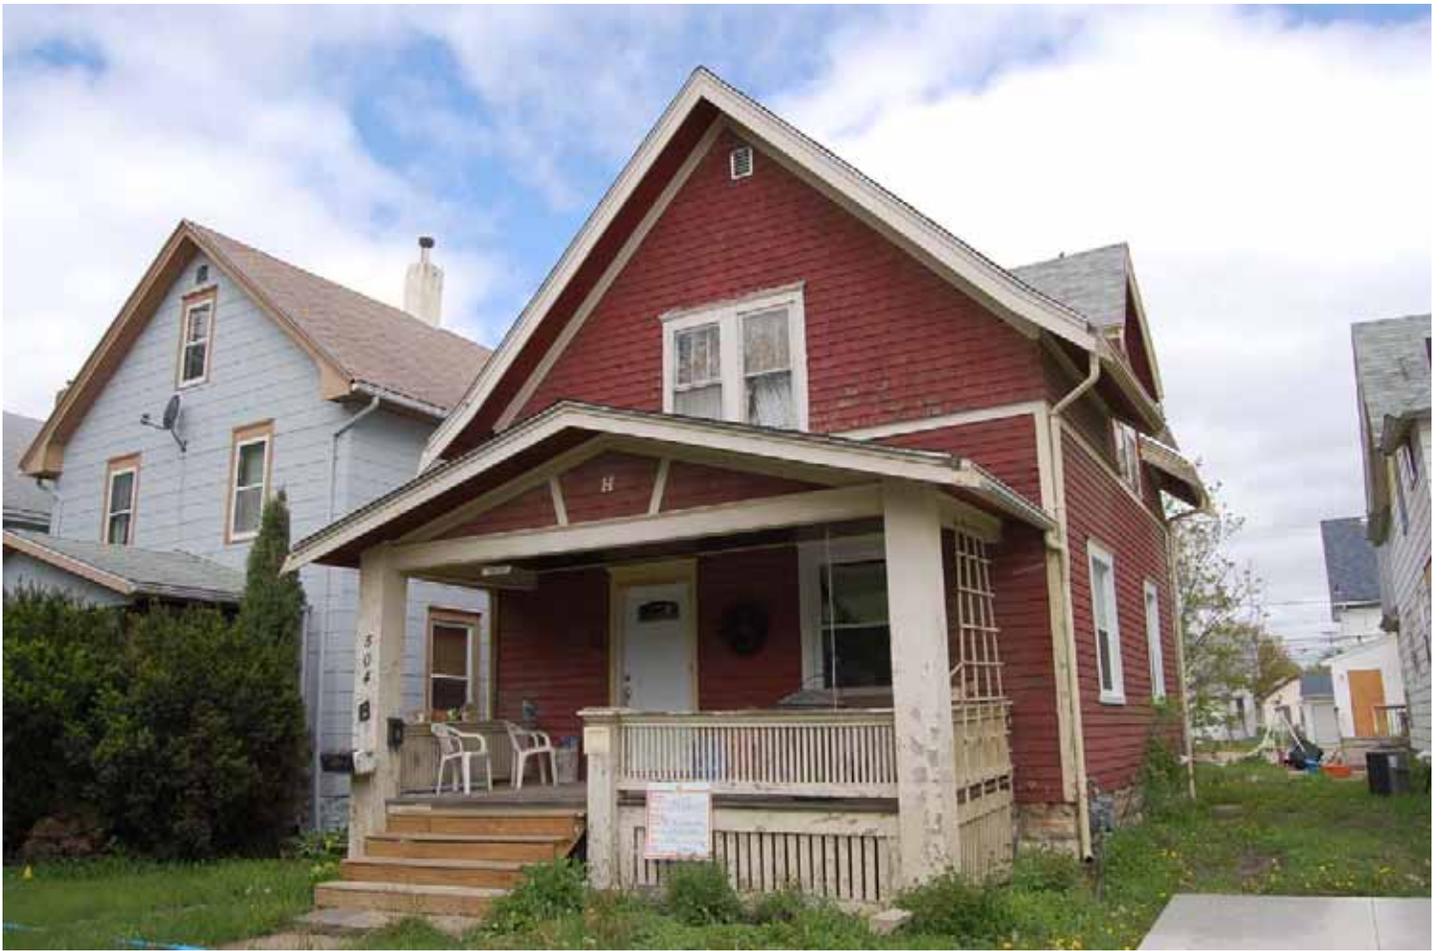
504 B Ave NW_View N.JPG

504 B Avenue NW (1915) – This 1 ½-story, frame gable-front dwelling is clad with weatherboard and wooden shingles and is set on a limestone foundation. Paired 3/1 wood-sash windows are present in the front gable. The two-bay front (east) contains an entrance (replacement door) and a 1/1 window. The front porch gable roof is supported by square posts that extend to ground level. A wooden railing with wooden pickets encircles the porch. In April 2009, Berger recommended this house, named the Koffron

House, as eligible under Criterion C as it is a significant example of the gable front vernacular style that represents the most popular house type in the City found in all quadrants of the core areas, but particularly in the Time Check neighborhood.
