**Architectural Reconnaissance Survey
for St. Patrick's Neighborhood
in Cedar Rapids
(57-086)**

Linn County, Iowa

June 8, 2009

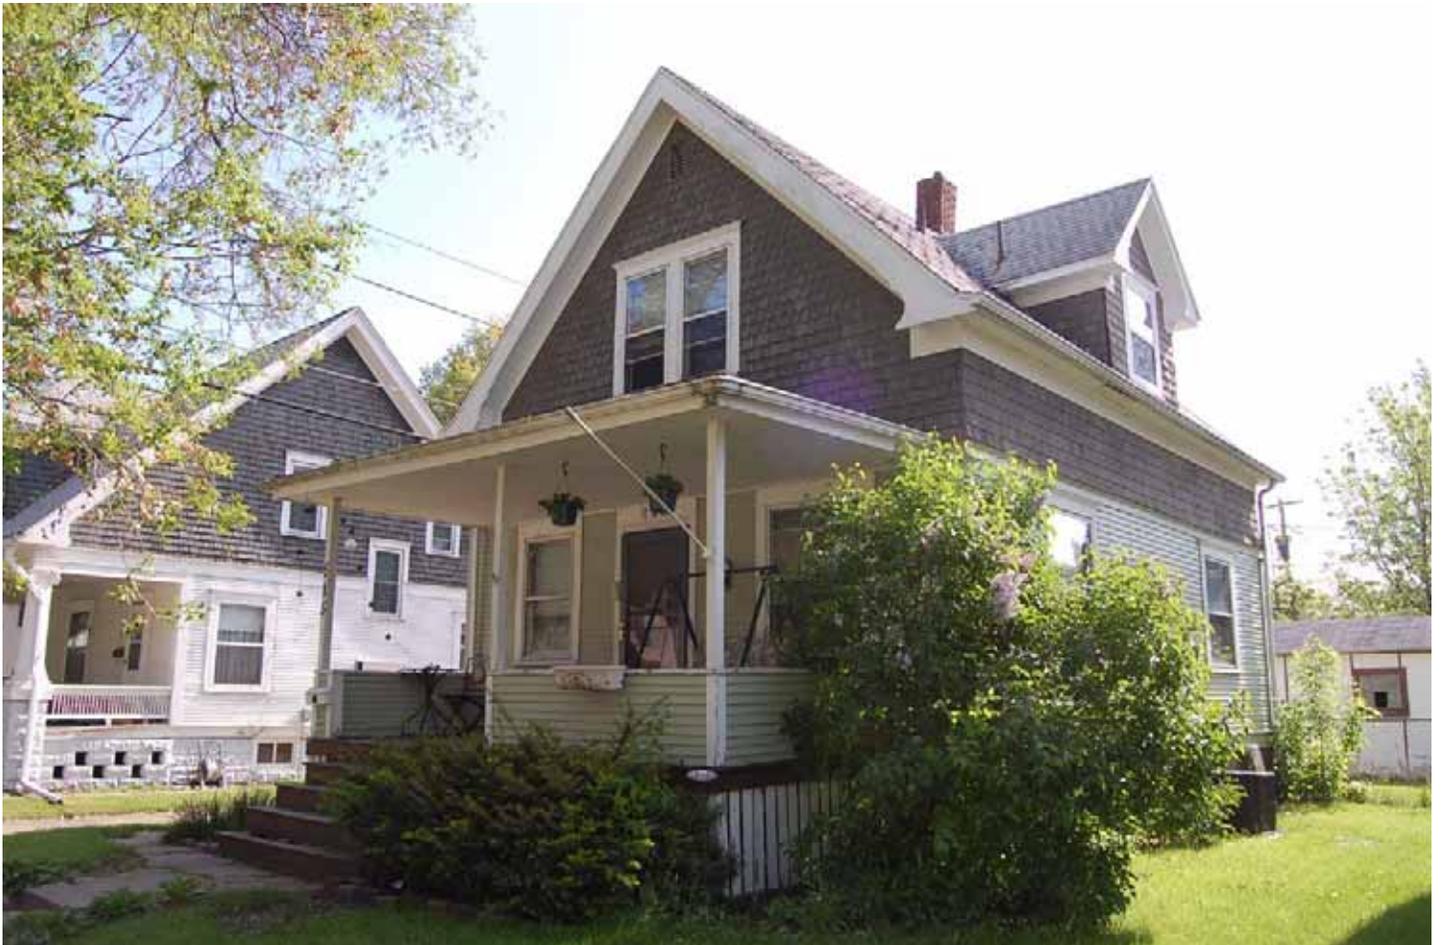
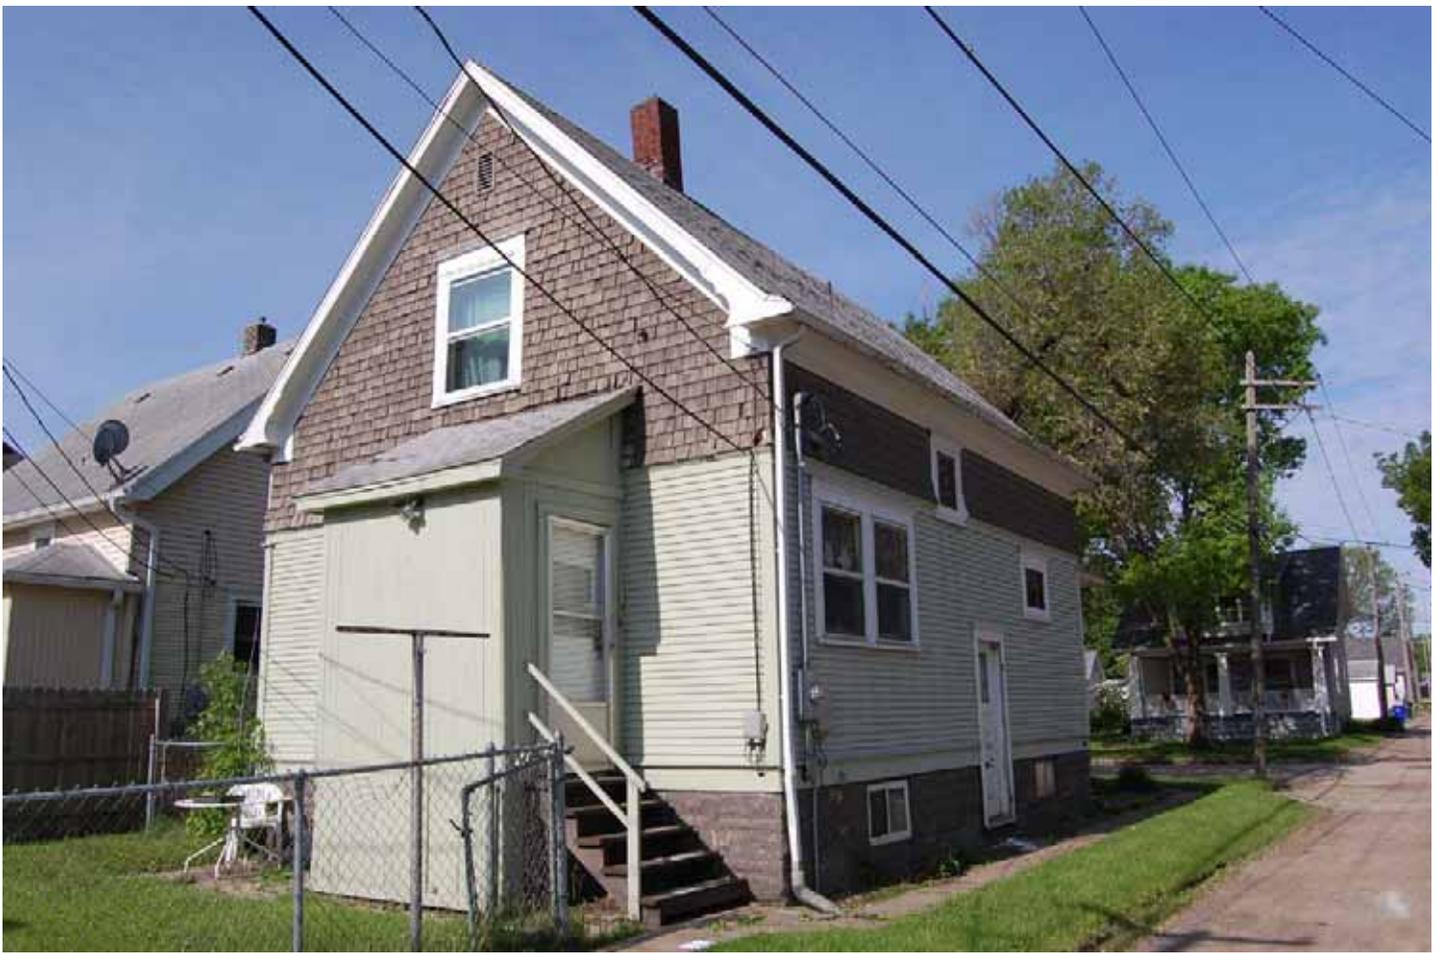
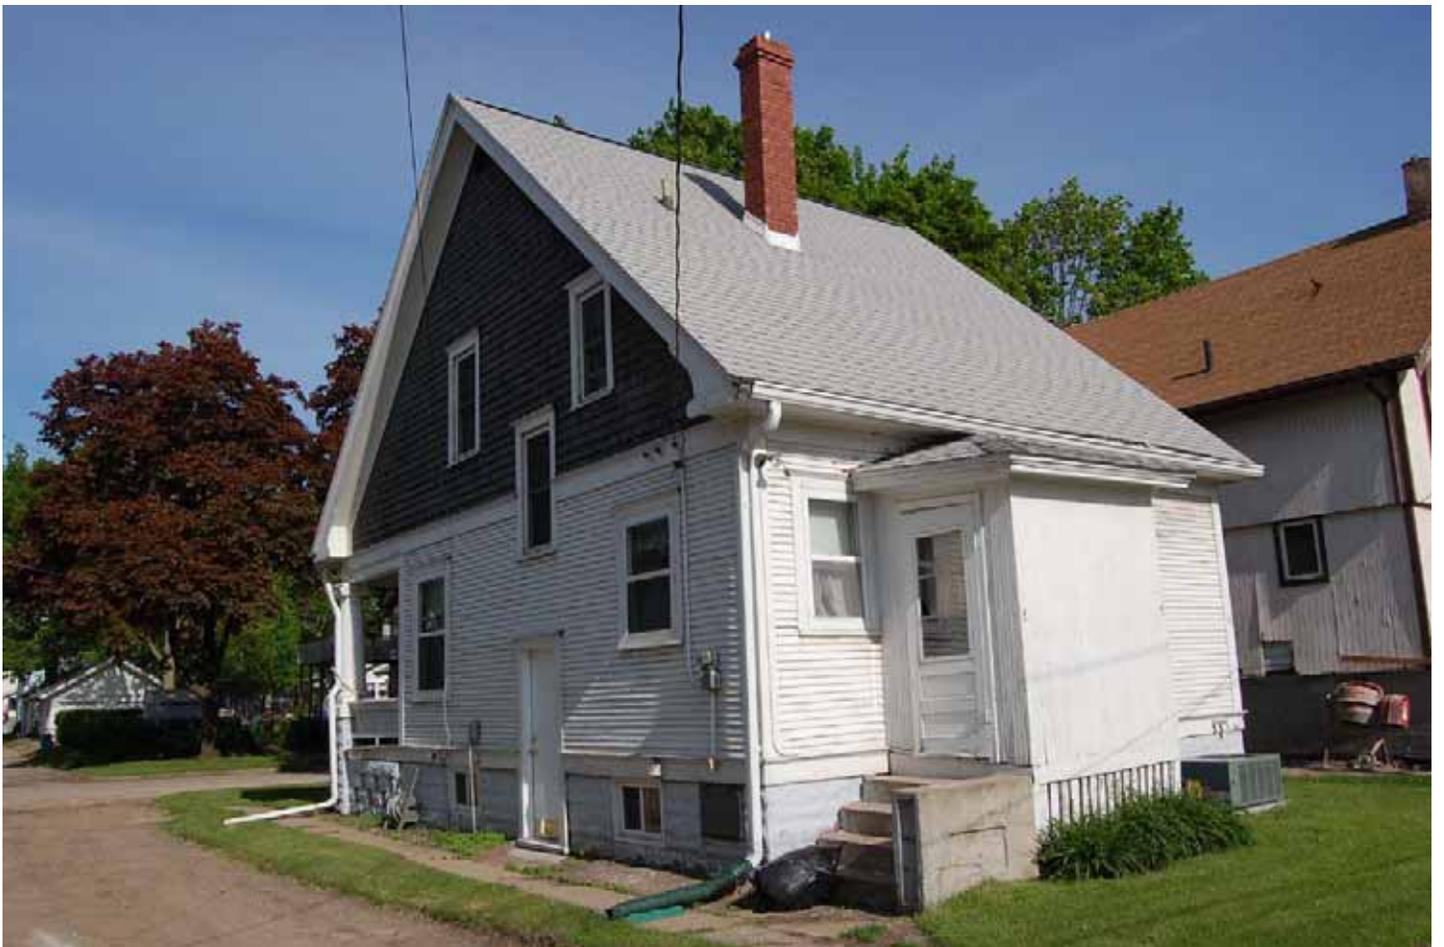
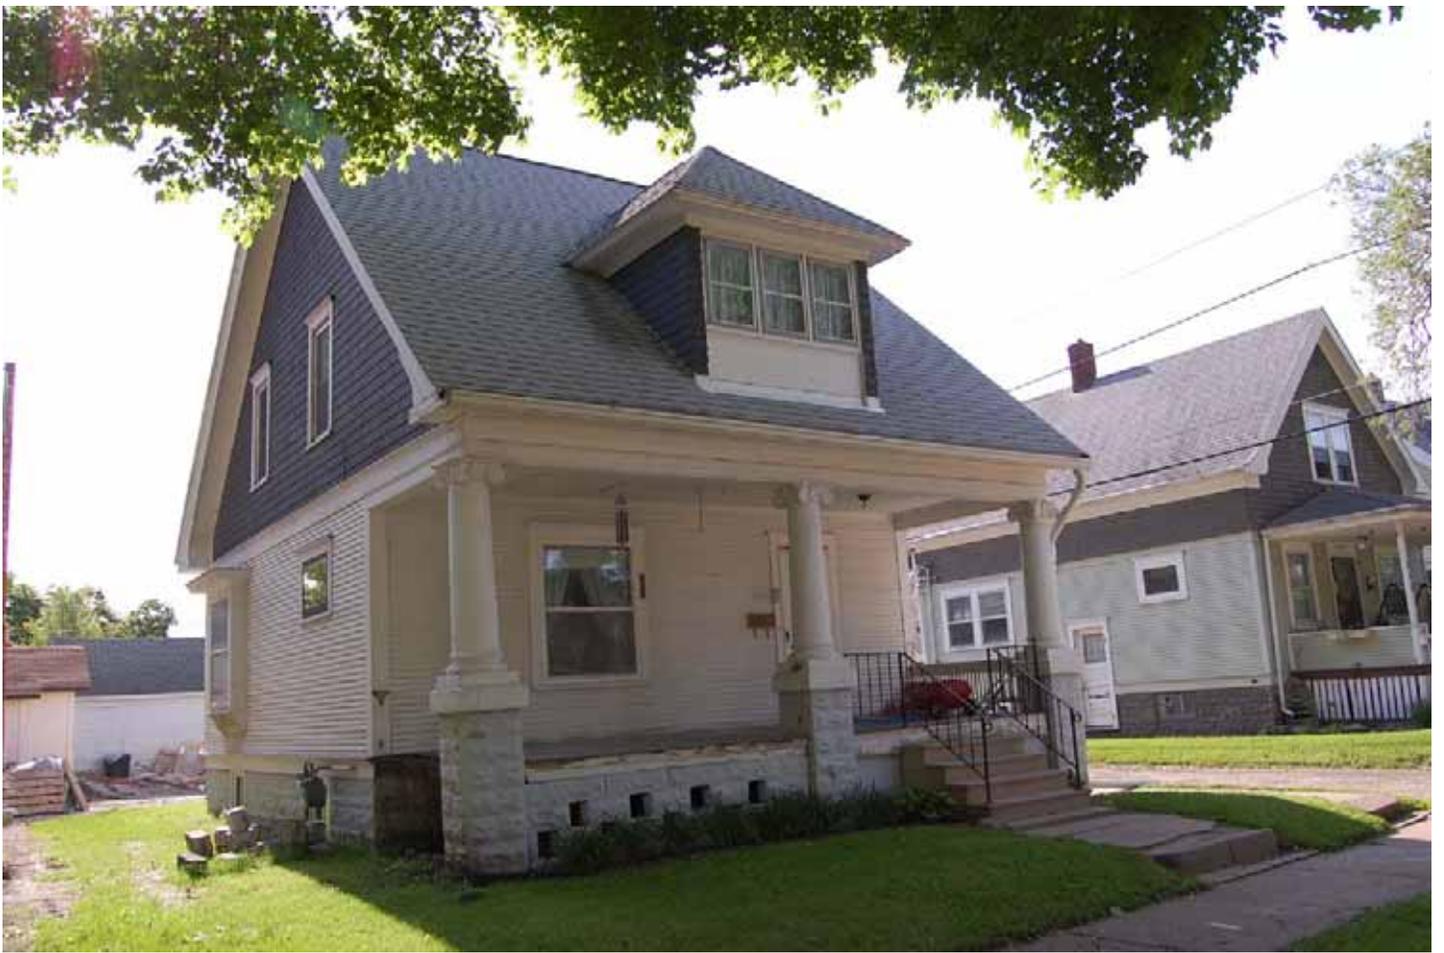
515 9th St NW_View NE.JPG

515 and 517 9th Street NW (1915) – These two houses are presented together since they appear to have been built by the same builder with similar shingles in the upper story and are situated next to each other on 9th Street NW. The house at 517 9th Street NW is a 1 ½-story, side-gable roofed dwelling that features a two-bay front porch supported by Ionic columns, weatherboard siding, on the first floor, shingle siding on the upper story, and a limestone foundation with a full basement. The house at 515 9th Street NW is a 1 ½ story gable front structure with a hipped roof front porch with narrow posts and clapboard railings, weatherboard siding on the first floor, shingle siding on the second floor, and a gable front dormer clad with shingles. The façade of the upper story flares out where it meets the weatherboard siding below. Both dwellings are identified in the 2000 MPD *Architectural and Historical Resources of Cedar Rapids Residential Neighborhoods 1870 – 1940* as individually eligible resources (517 labeled as the William and Meta Price House; 515 labeled as the Karl Jadrnick House). Though there are alterations to both porches, the dwellings retain sufficient integrity to be eligible under Criterion A for their association with the development of the neighborhood in the early twentieth century. Additional research may reveal important information regarding the original occupants or builders.

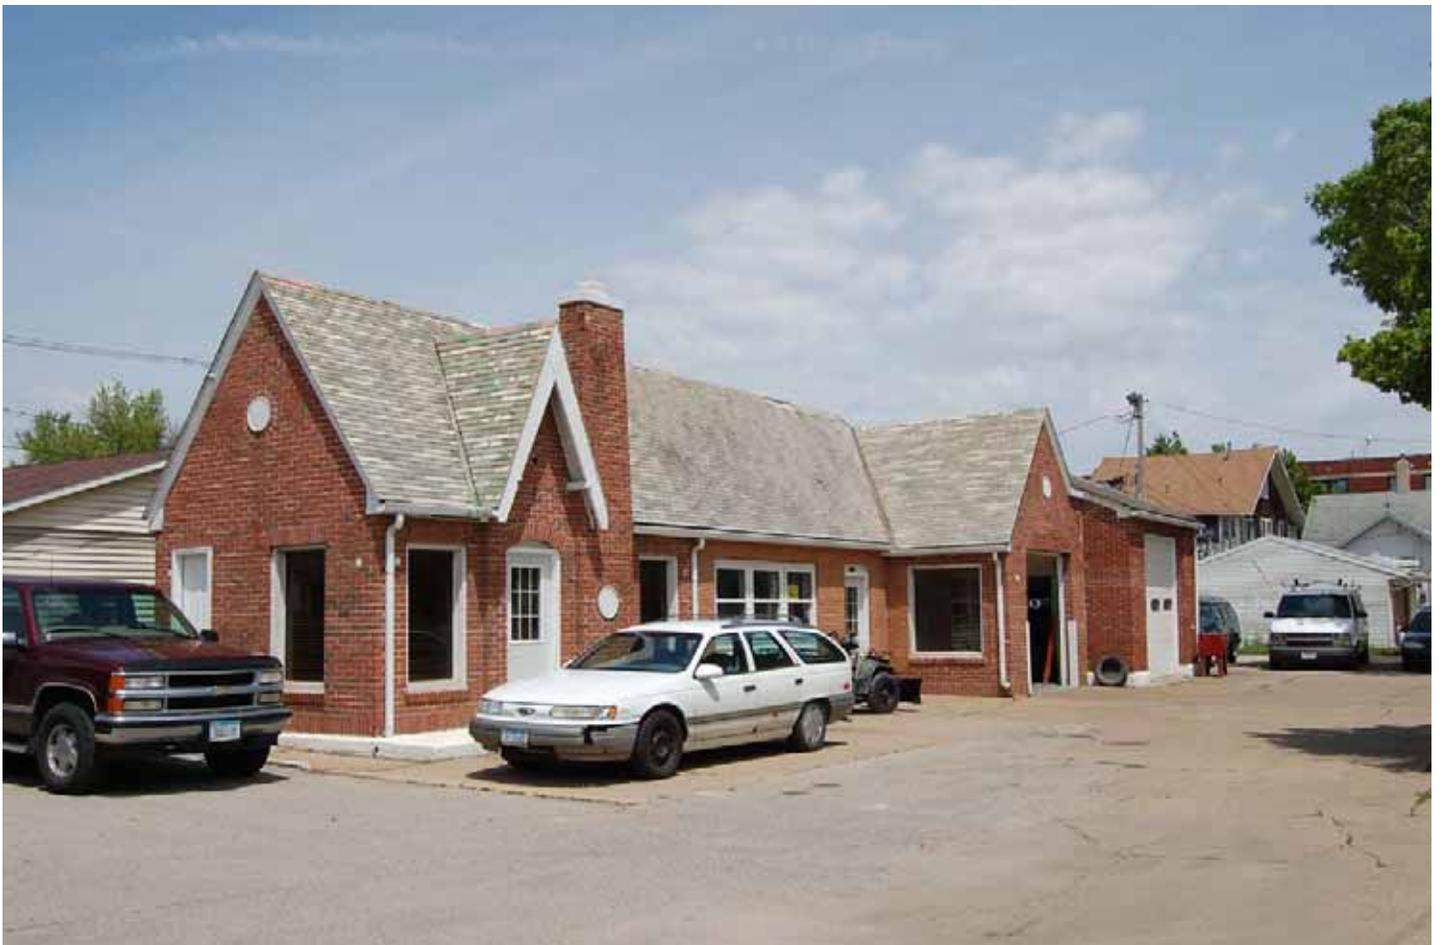
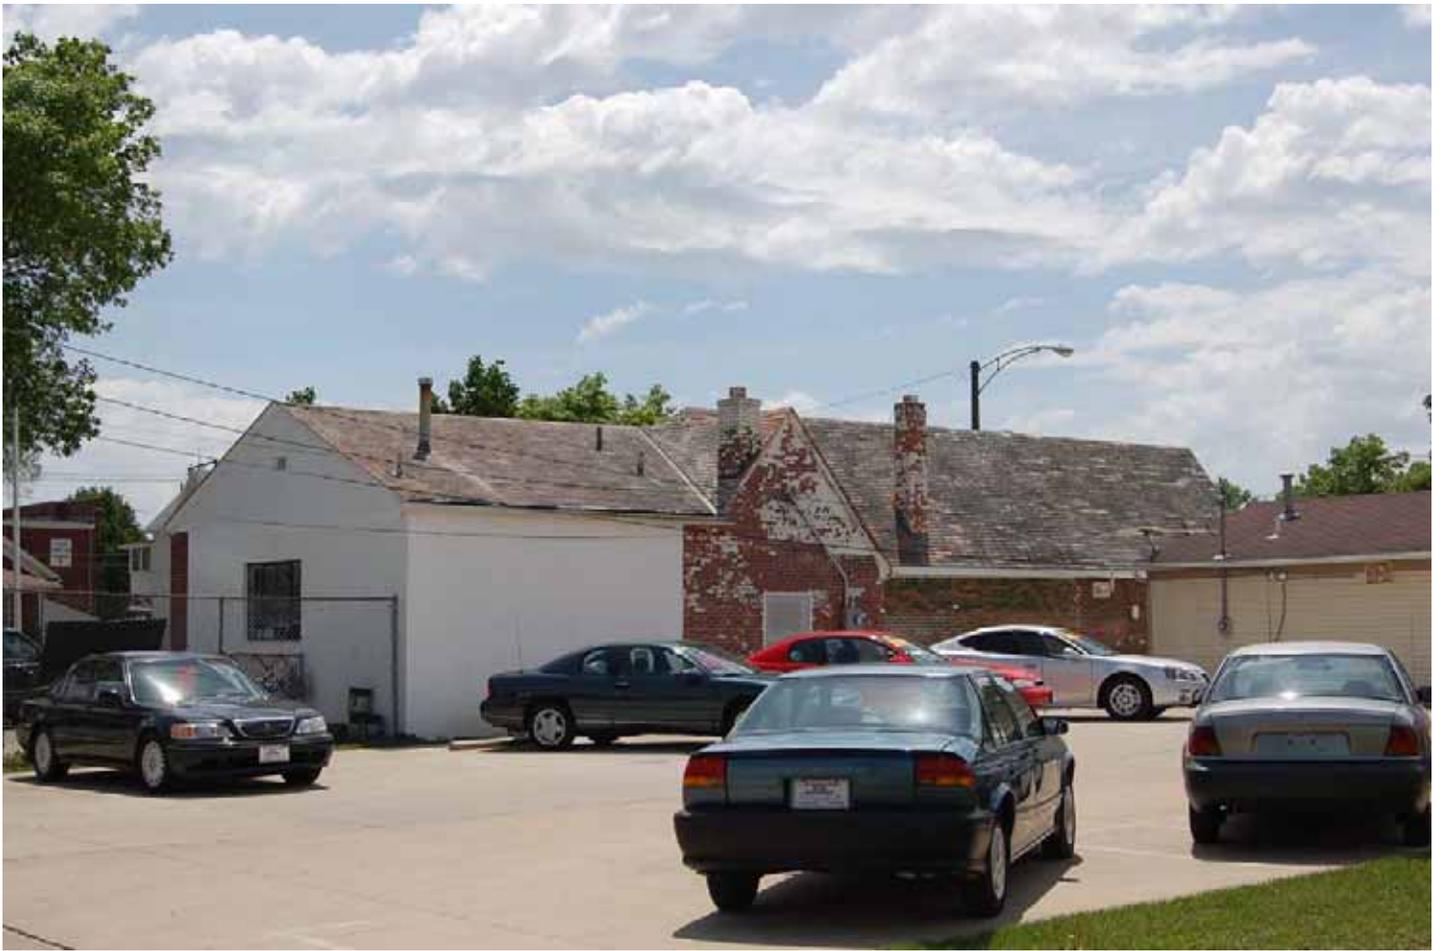
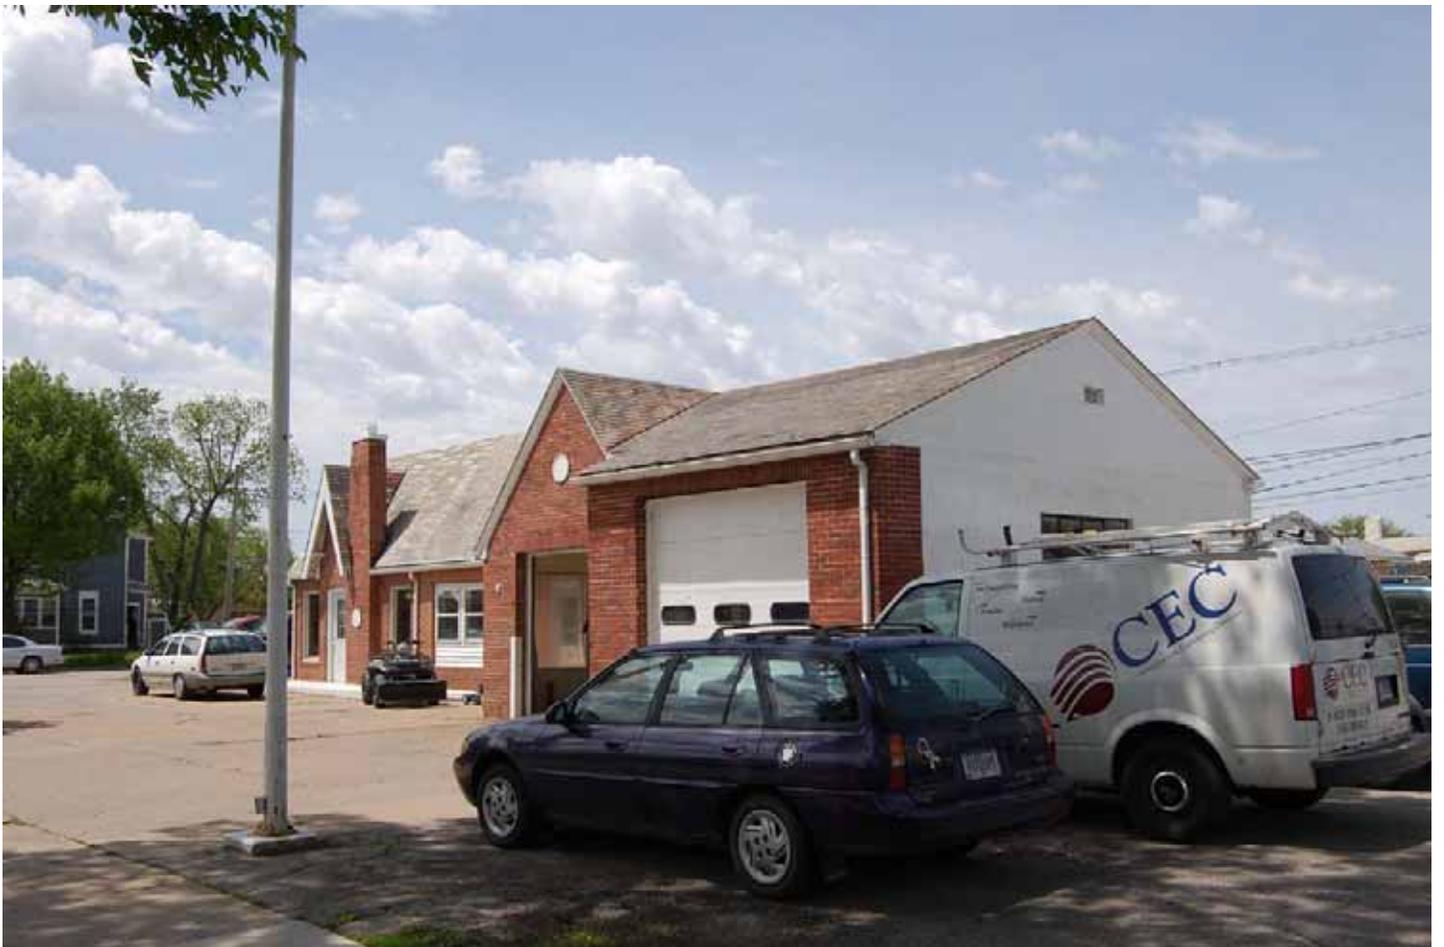
522 2nd Ave SW (A.K.A. 528)_View N.JPG

522 2nd Avenue SW (ca. 1930) – This vernacular, 1 story brick service station is covered by a long, side-facing gable roof with a steeply sloped cross gable at main entrance door and a projecting gable-roofed service bay at the north end. The window openings likely originally held multi-paned sashes, but currently hold fixed windows and 1/1 sashes. An exterior chimney is located near the main entrance; additional interior chimneys are located on the rear (west side) of the building. The building was built in phases beginning with the three-bay section on the south, including the exterior chimney; the second section included the triple set of windows and a secondary entrance; the projecting service wing was then added. An additional service bay, covered by a side-gable roof and constructed of concrete block, is located on the north side of the garage and appears to have been constructed in the mid-twentieth century. The station appears to be an example of the historic service stations operated by the Phillips 66 company during the early twentieth century and built in a “cottage” style of architecture (often referred to as a “Tudor” style), evoking both a domestic and a commercial appearance and meant to blend into residential areas. The company’s signature blue shingles of the original design are visible on much of the building. As the station prospered, additional service bays were needed, such as the additional bay on the north end of this station, and additional area was paved. A pump island most likely would have been located near the main entrance on the east side of the building; however, this element has been removed. While some alterations may have diminished the integrity of the station’s design (i.e., replacement windows, removal of original paint), it still retains sufficient integrity of location, setting, design, workmanship, feeling, materials, and association to be potentially eligible for listing in the National Register on a local level under Criterion C as an important example of an early 20th century cottage style service station located within a residential area. The building retains its basic form, materials, and major design elements and many of the additions appear to be at least 50 years old.

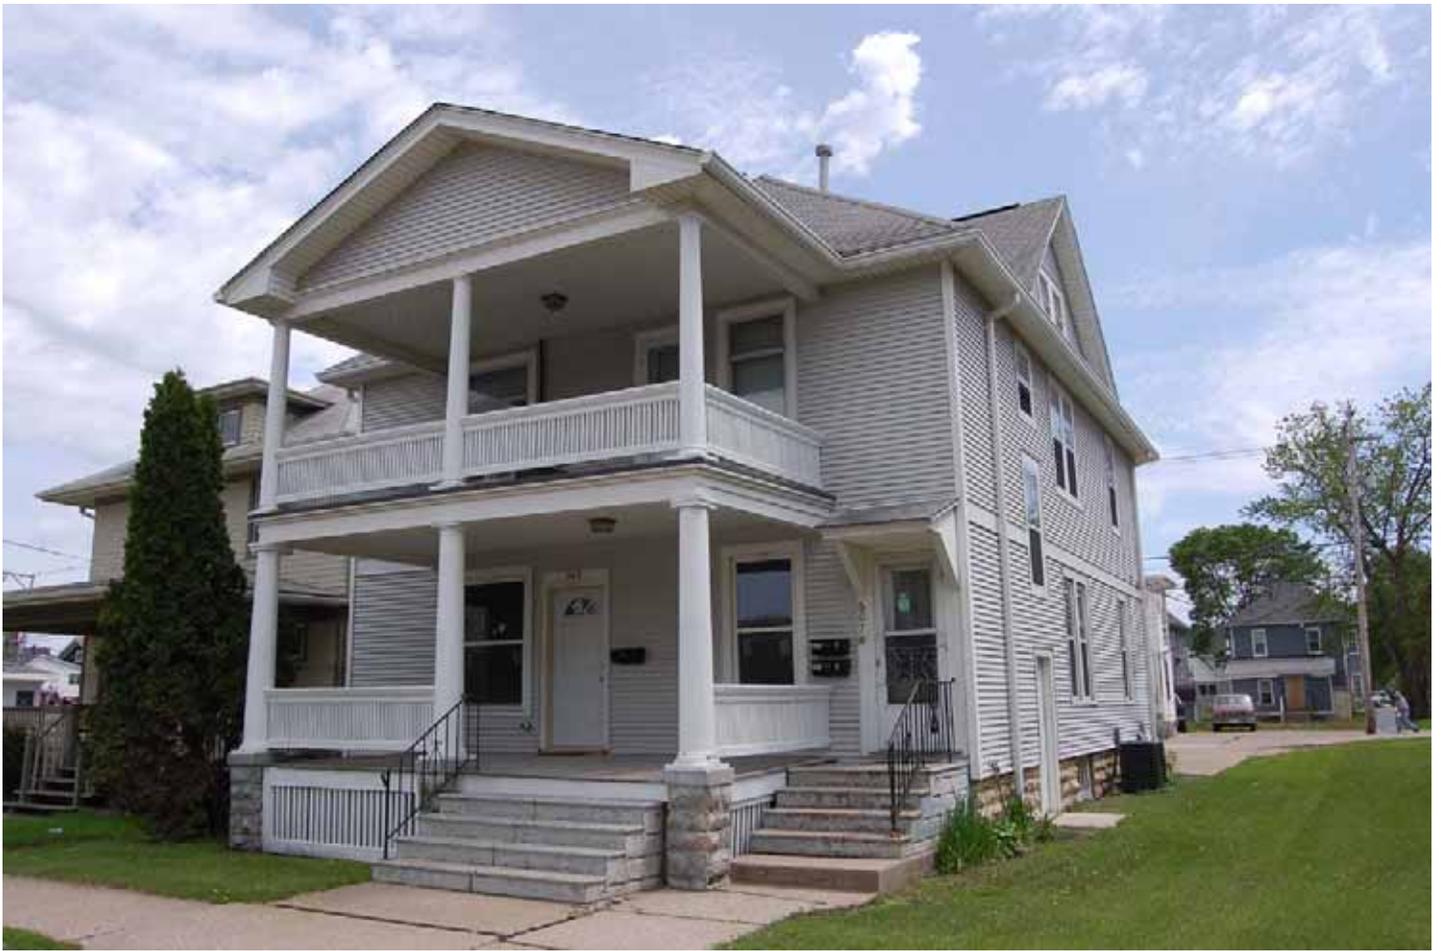
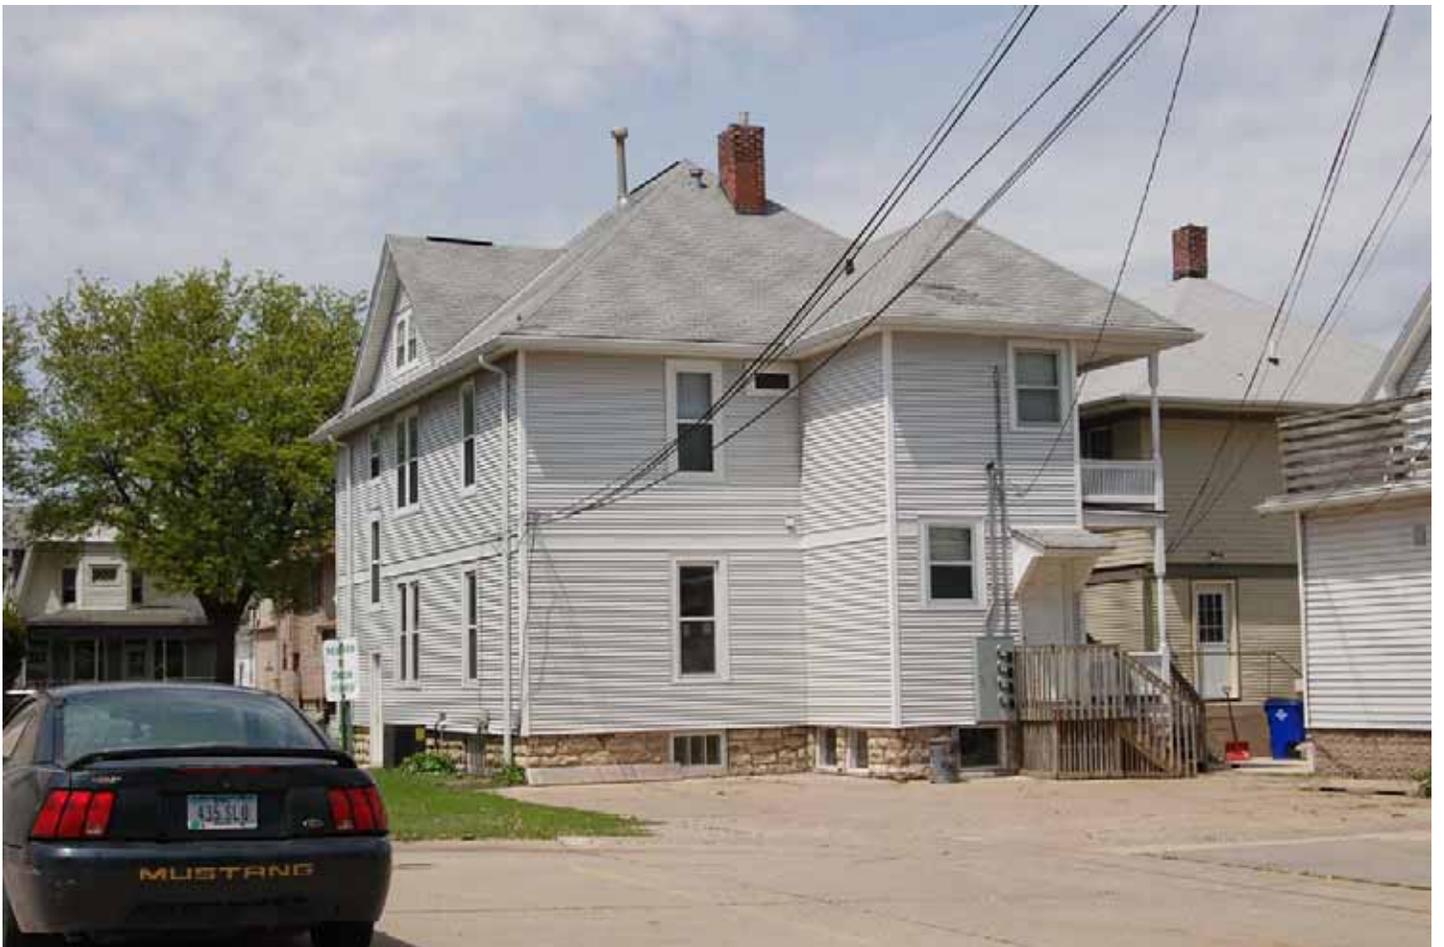
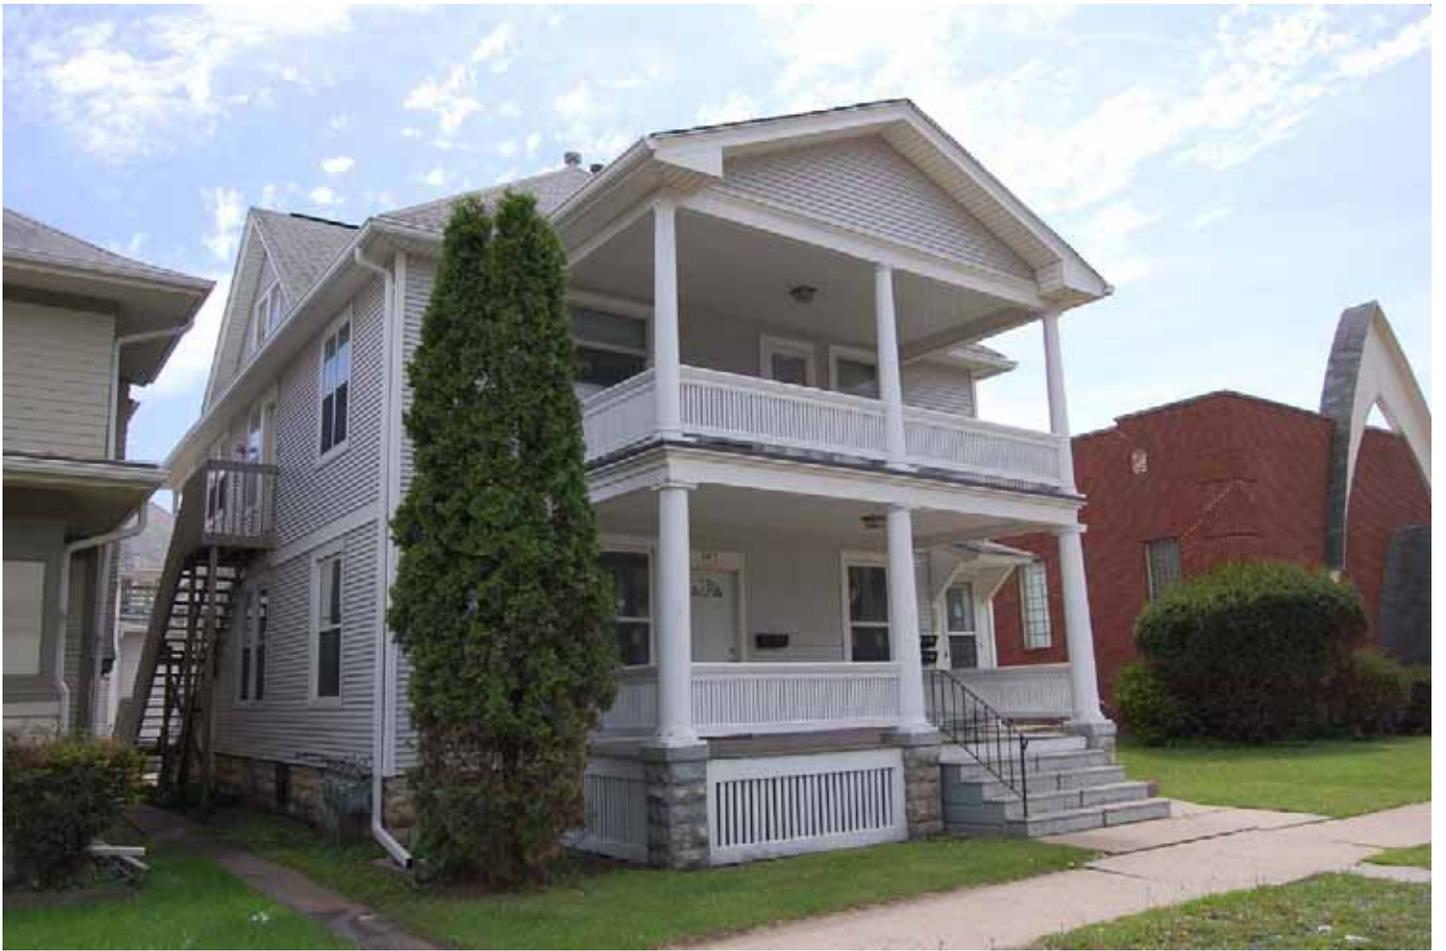
605 1st Avenue SW_View E.JPG

605 1st Avenue SW (1912) – Vernacular 2 story frame dwelling with a limestone foundation, vinyl siding, some vinyl windows, and a two-story, gable-front open porch with tapered round columns. A few of the original leaded glass windows remain on the second story of the main façade. Historic Sanborn Fire Insurance maps indicate that this structure was built as a multi-family dwelling with separate units on the first and second levels. These types of structures seem to be prevalent along 1st and 2nd Avenues in the northwest quadrant of the city. Though the house has been altered with synthetic siding and replacement windows, the structure still has sufficient integrity to be eligible under Criterion A for its association with the development of multi-family housing in the St. Patrick’s neighborhood.

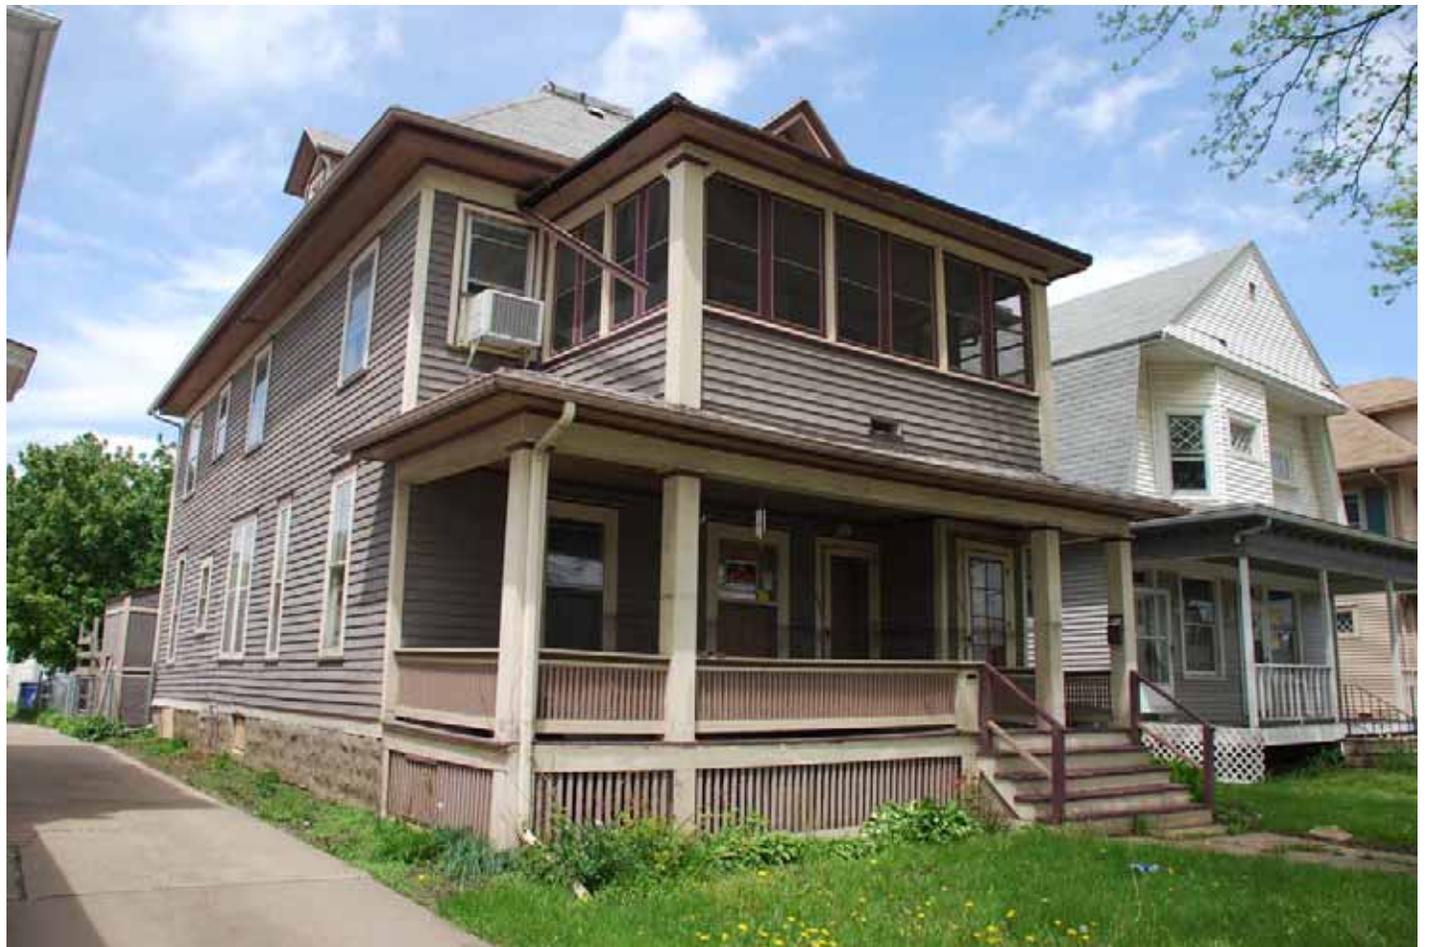
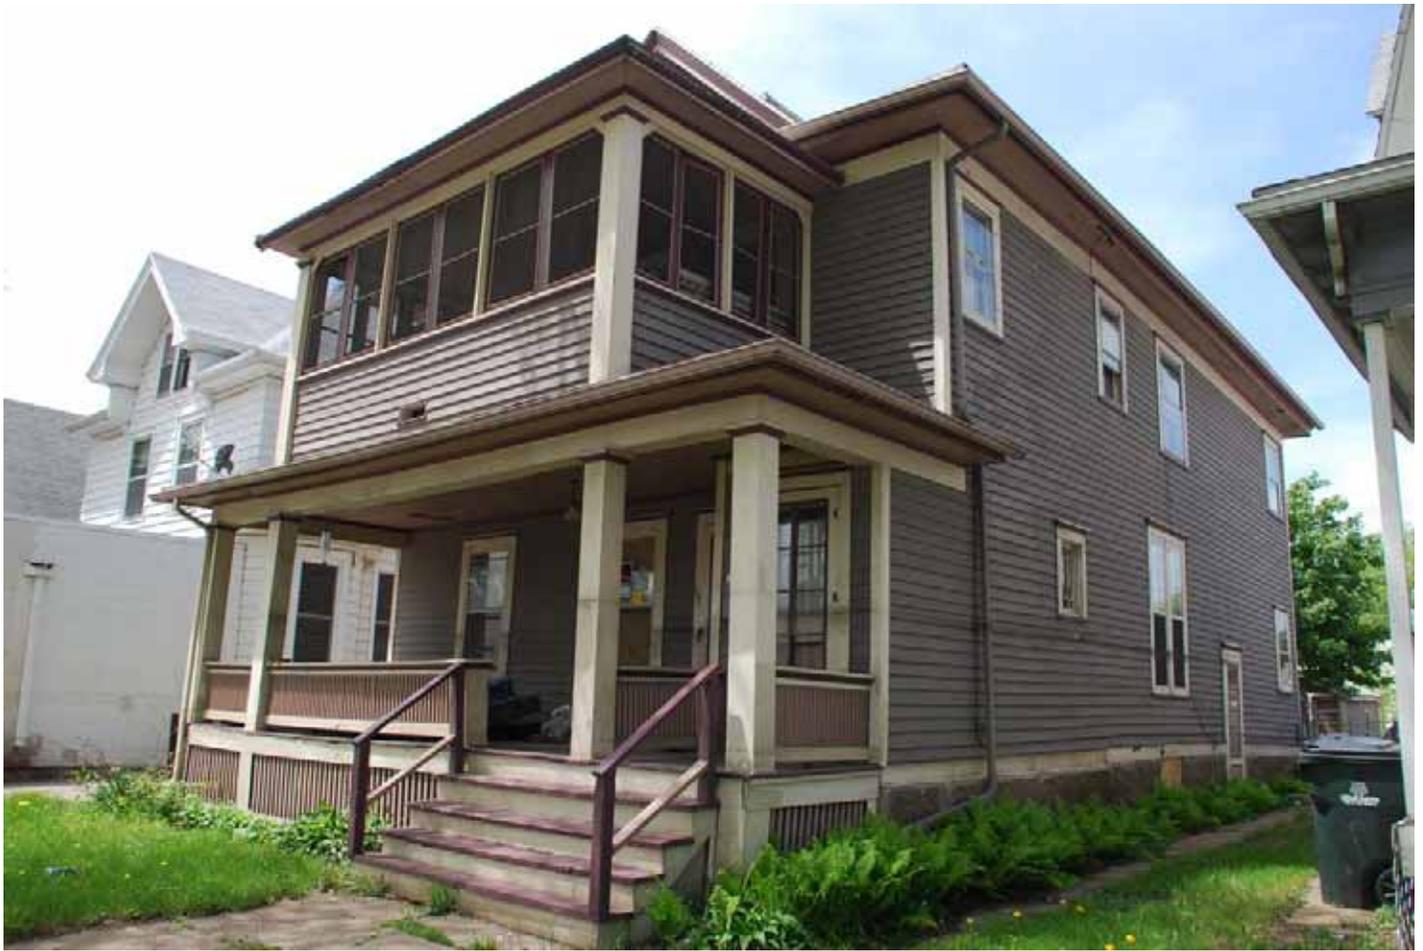
608, 606 1st Avenue NW_View NE.jpg

606-608 1st Avenue NW (ca. 1920) – This 2 story, frame dwelling is set on a foundation clad with stucco, is sheathed with weatherboard siding, and is covered by a clipped hipped roof with flared eaves. A cross gable is centrally located at the front of the house. The front elevation (southeast) holds two 1/1 windows and an entrance (606) and a second entrance (608) in the easternmost bay. This second entrance is a later addition and is located within an enclosed projecting bay. The three-bay front porch is covered by a hipped roof that is supported by square wooden columns. The hip-roofed enclosed porch located on the second-floor level holds six 1/1 windows on the front and two 1/1 windows on the sides. Other details on the house include deep eaves, gable-roofed dormers on the side elevations, a wide wooden frieze board, and a brick chimney centrally located on the deck of the clipped roof. Sanborn fire insurance maps indicate that this structure was built as a multi-family dwelling and that the porch is in its original configuration. As such, the dwelling is eligible under Criterion C as an important example of an early twentieth century multi-family dwelling with Colonial Revival-style influences and an unusual porch configuration.

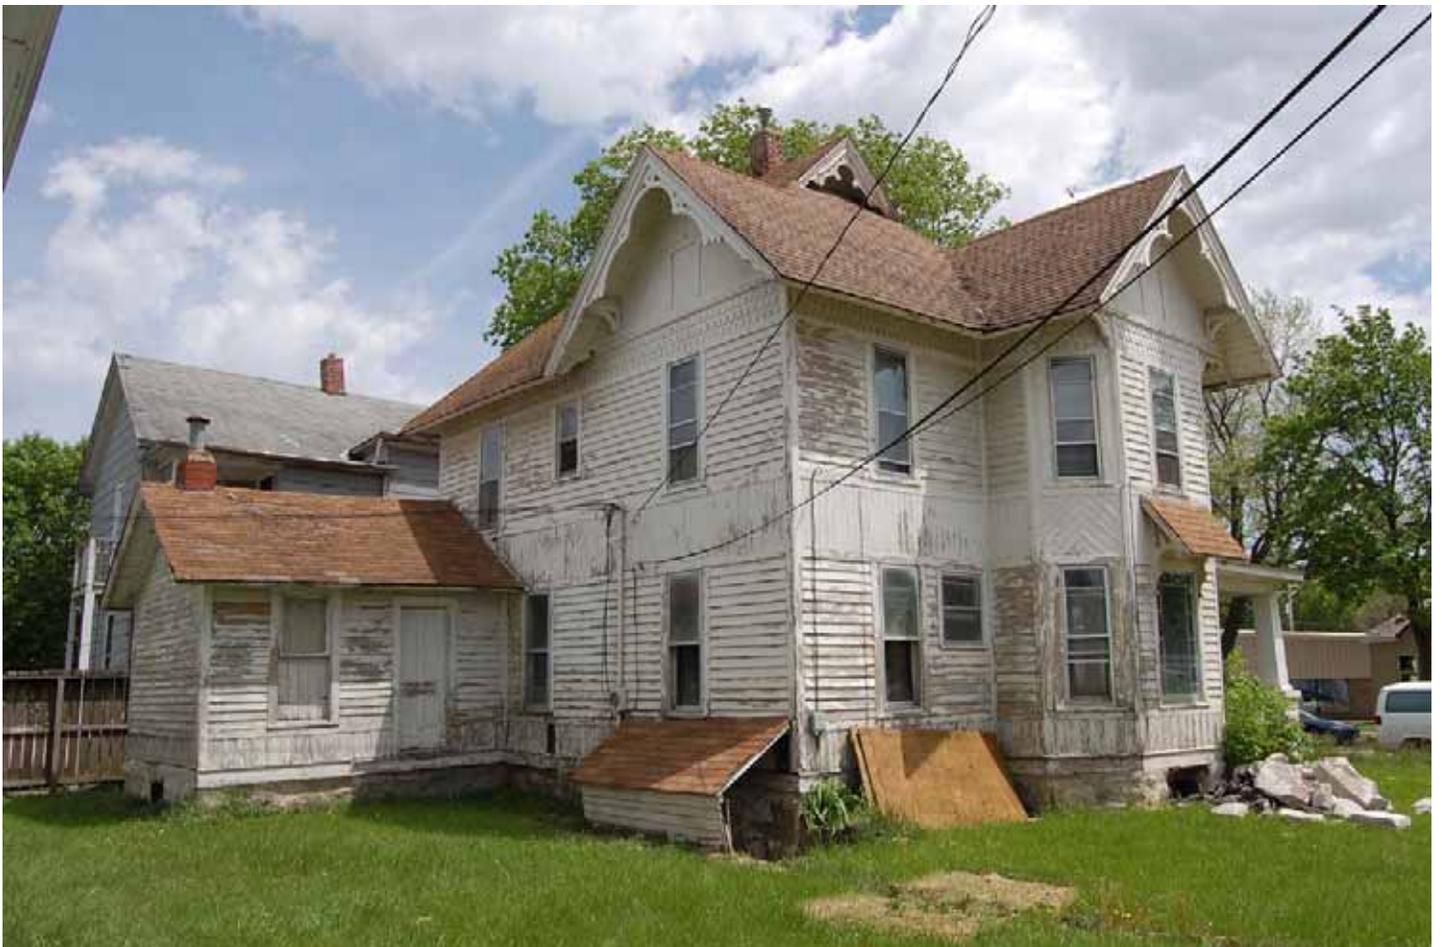
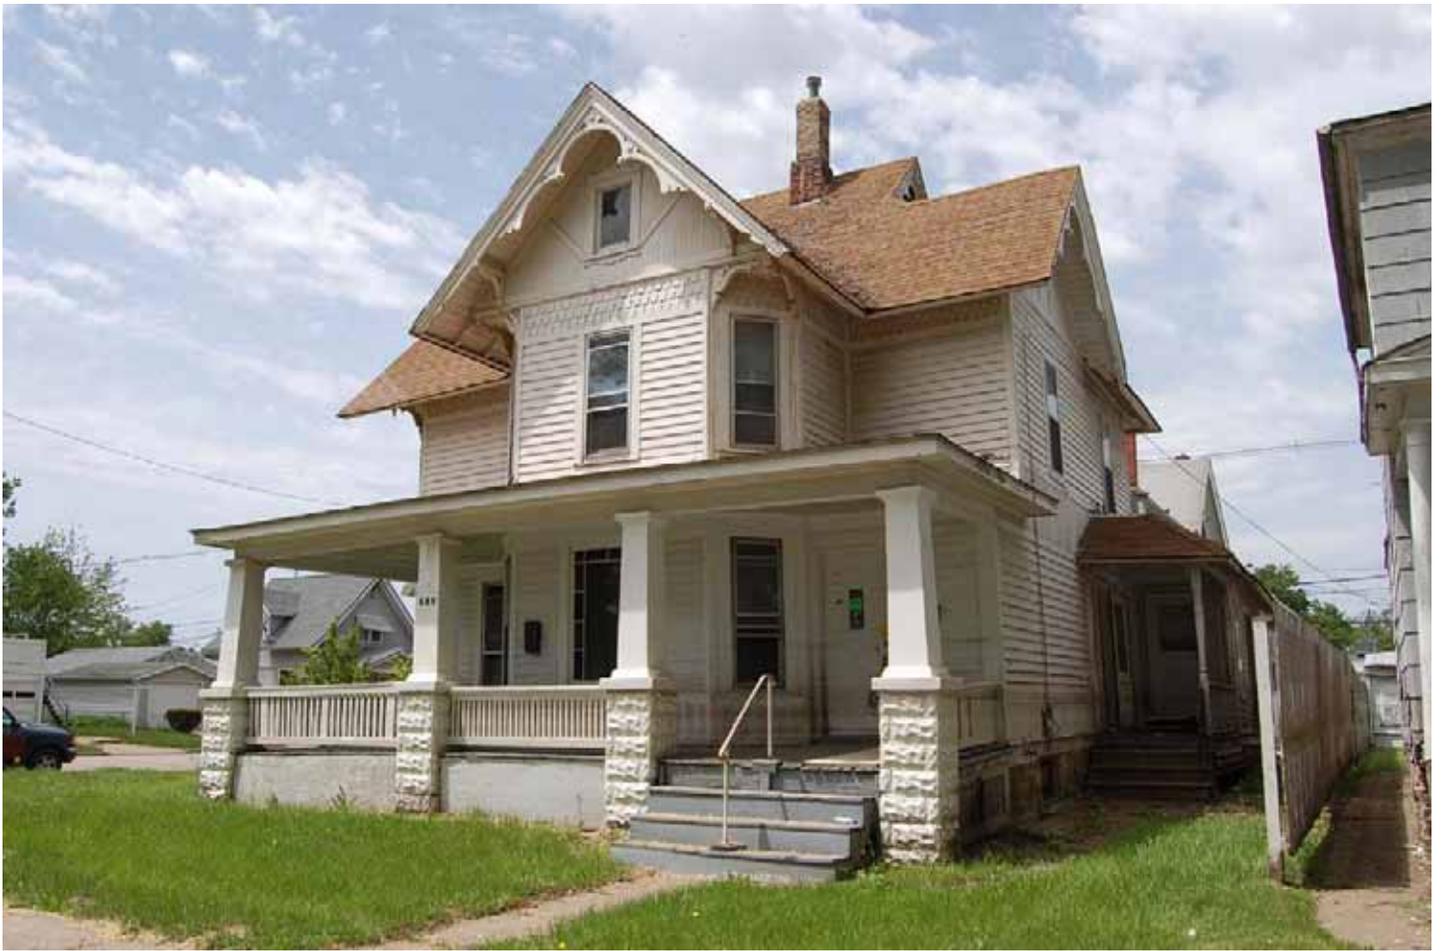
626 2nd Ave SW_View E.JPG

626 2nd Avenue SW (ca. 1890) – This 2 ½-story, frame dwelling reflects characteristics of the Queen Anne style in its use of a complex roofline, differing exterior wall textures, and projecting bay at the front. The majority of the house is clad with weatherboard siding. The 2 ½-story projecting bay, centrally located at the front of the house, exhibits vertical board siding in the gable end, imbricated wooden shingles at the eave level, and weatherboard below. Other details include stringcourses of vertical board siding and interior brick chimneys. The one-story, three-bay front porch features classically inspired square columns set atop rusticated stone piers. A small one-story, gable ell projects from the rear (north). Most windows are 1/1 wood sash; however, at least two original windows are present that feature a center fixed pane surrounded by smaller rectangular panes. This dwelling was identified in the MPD *Architectural and Historical Resources of Residential Neighborhoods, 1870 – 1940* as an individually eligible property located outside of existing historic districts (Svendsen 2000:Section F, Page 78). The house was labeled as the Alvin & Elsie Bruch House. The MPD also noted that “a large number of the residences in this quadrant were built and occupied by first and second-generation Bohemian immigrant families” (Svendsen 2000:Section F, Page 74). While in need of some repairs, the house currently retains its historic form, materials, and overall historical appearance. Alterations include the removal of original windows, the replacement of original roof cladding, and modification of chimneys. The house is eligible for listing in the National Register on a local level under Criterion C as an important example of a late-nineteenth-century, Queen Anne-style dwelling that retains sufficient integrity to convey its historical appearance. Additional research may provide information on the builder and the original occupants of the house and may support eligibility under Criterion B.
