**Architectural Reconnaissance Survey
for St. Patrick's Neighborhood
in Cedar Rapids
(57-086)**

Linn County, Iowa

June 8, 2009

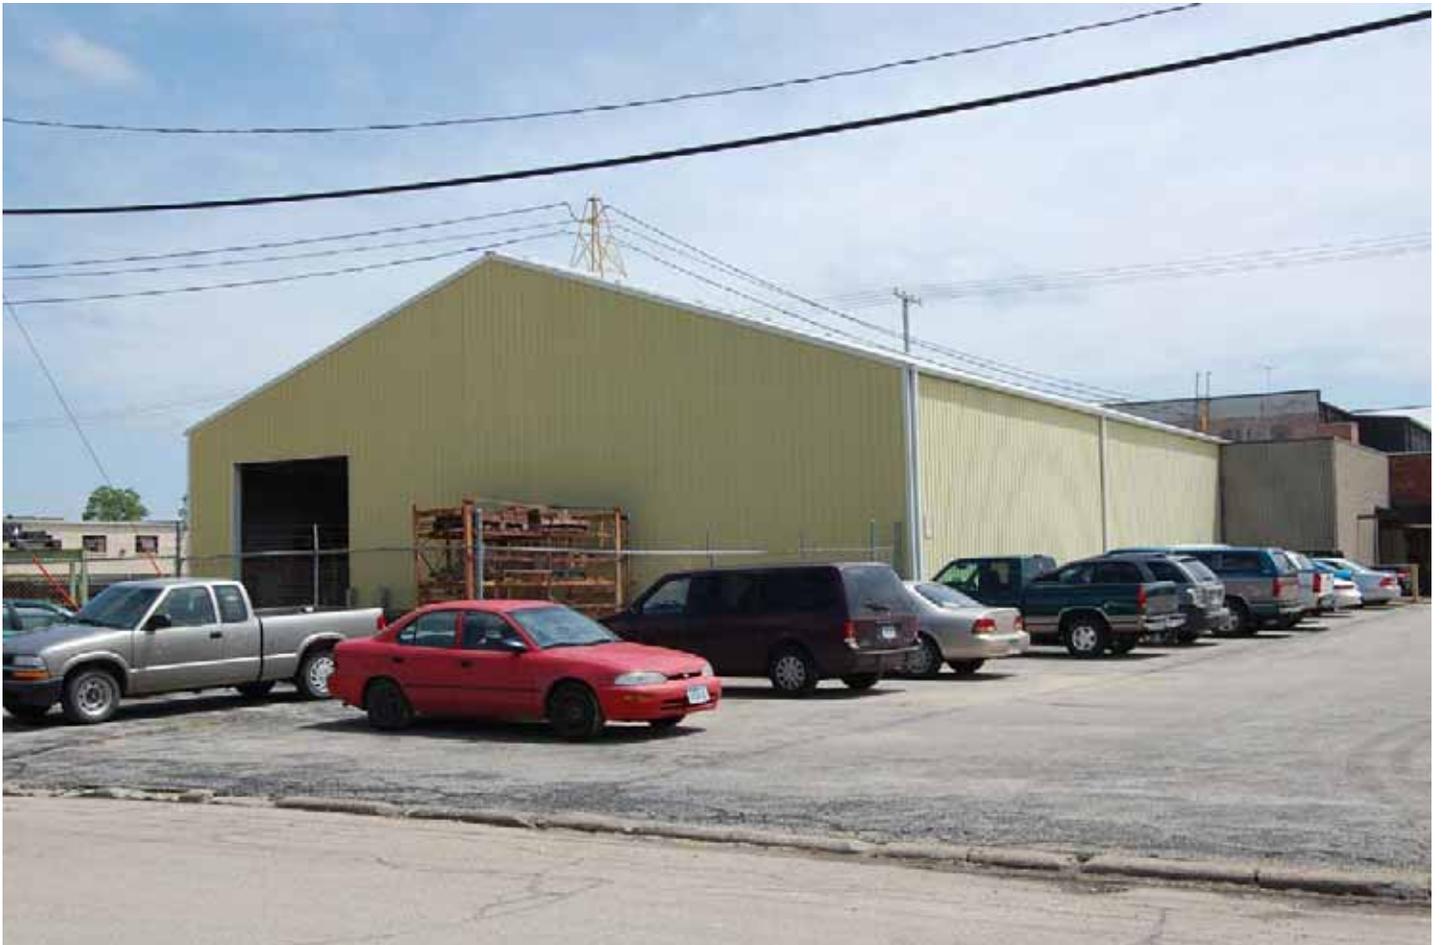
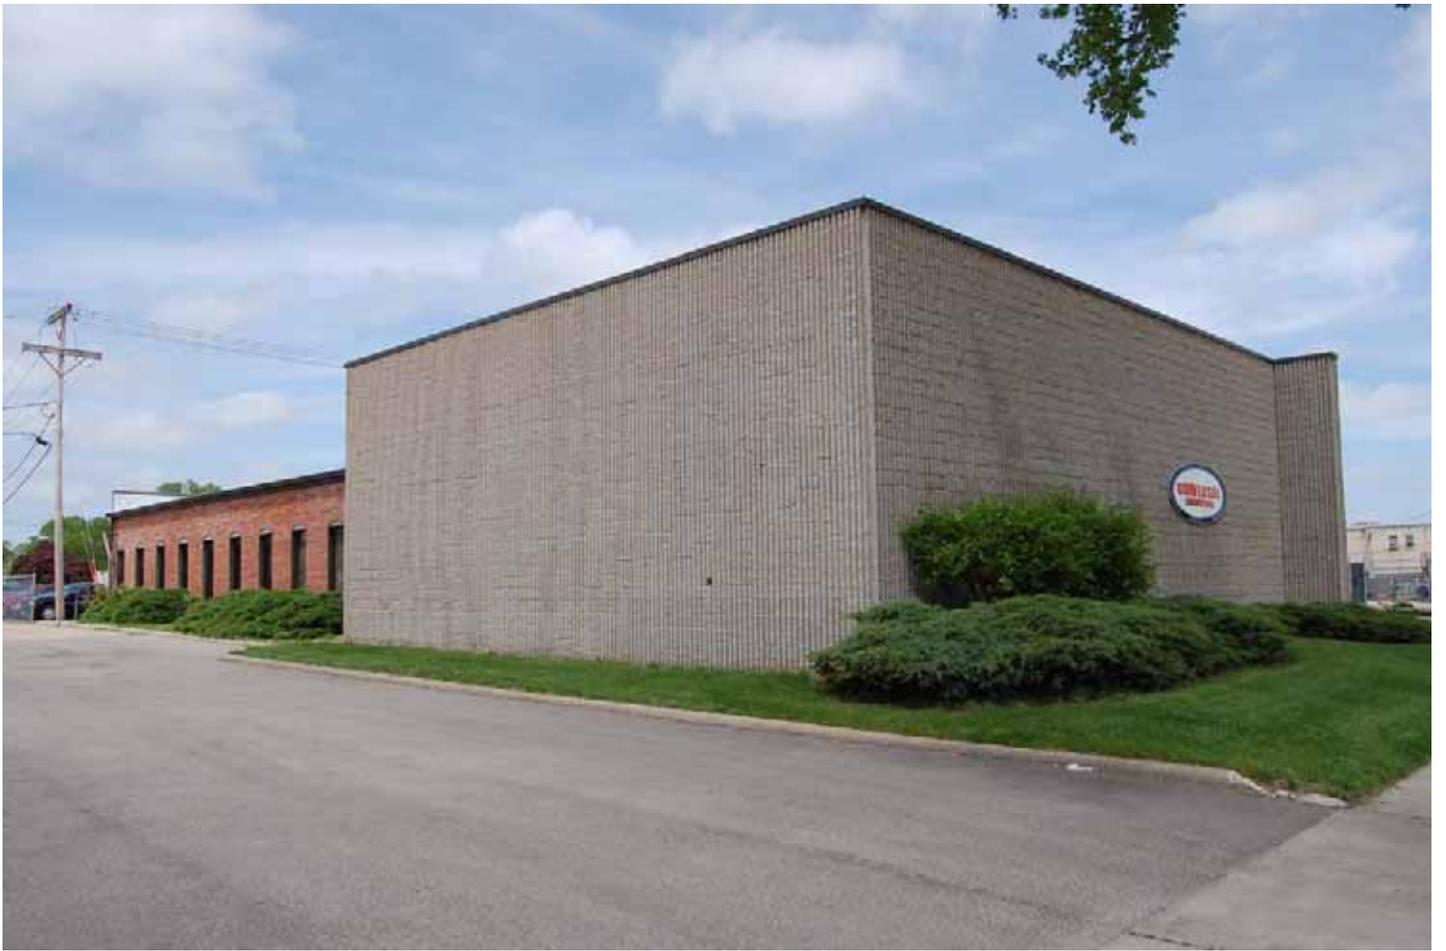
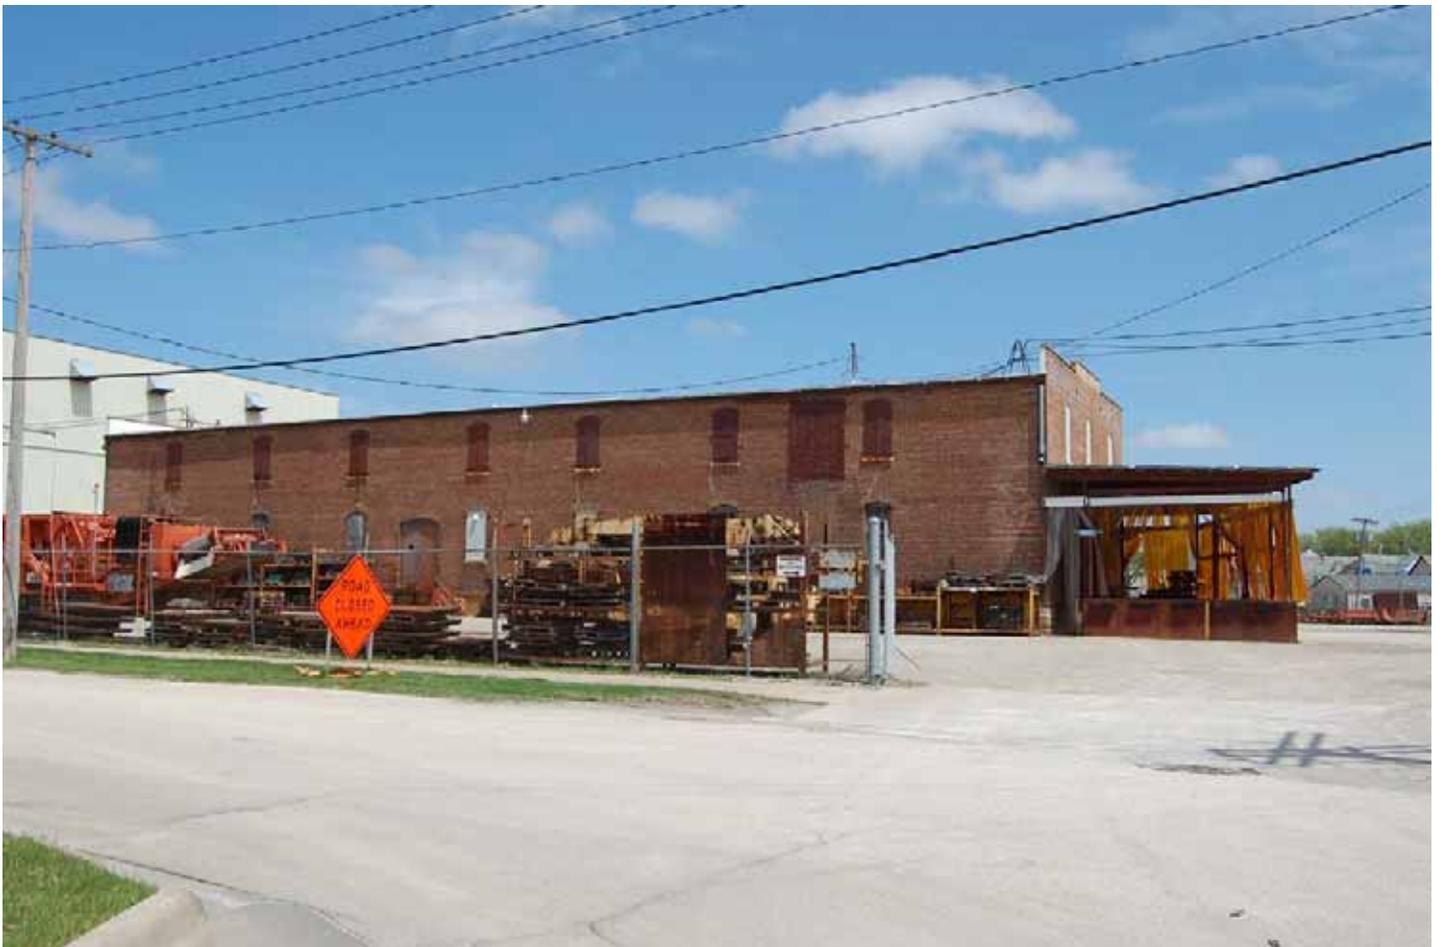
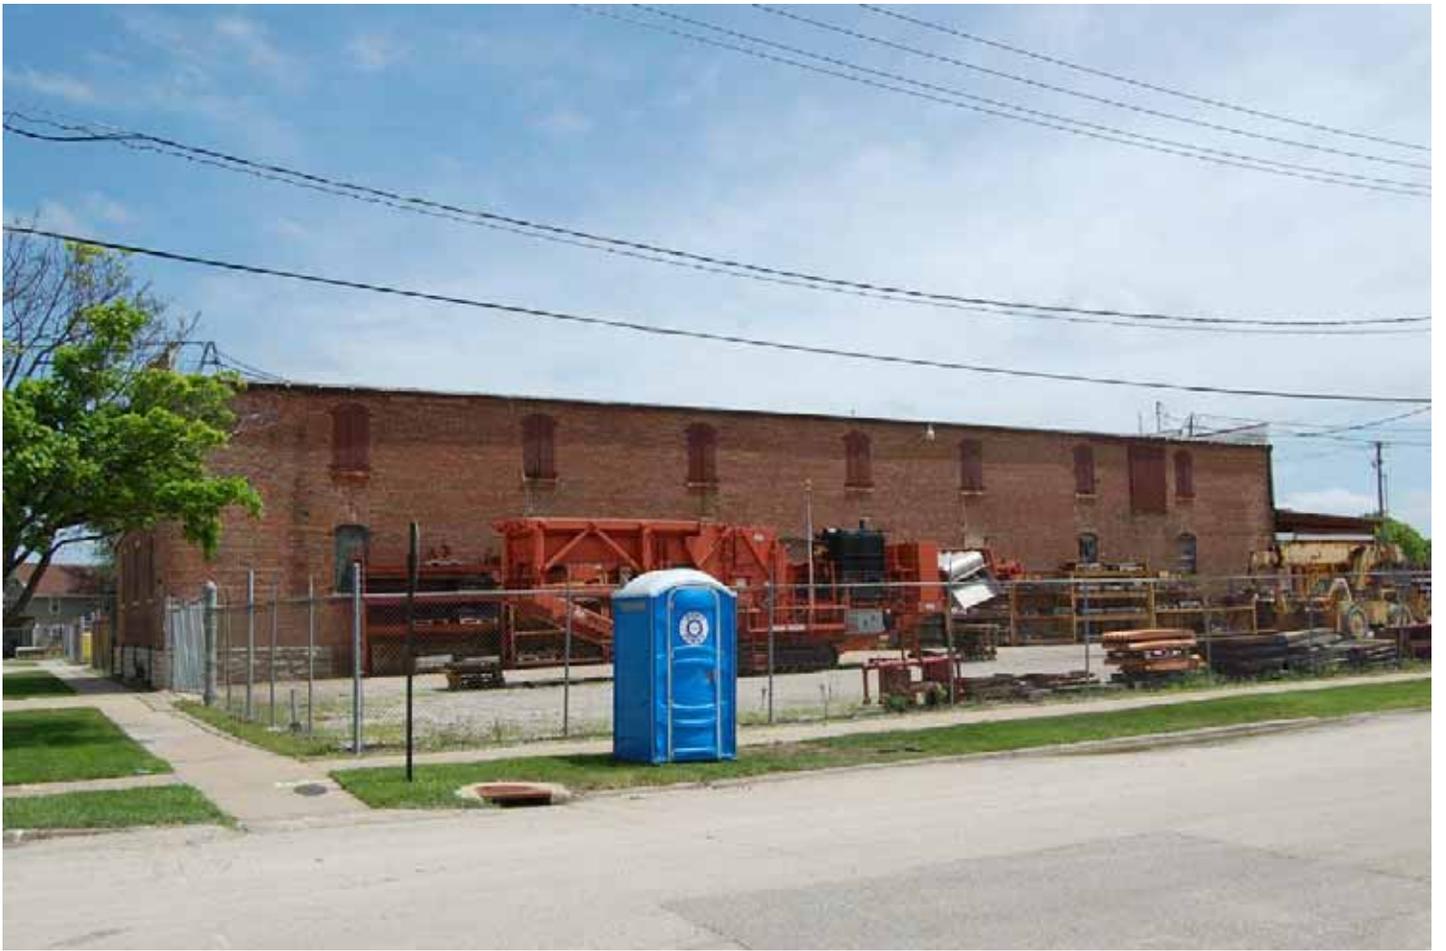
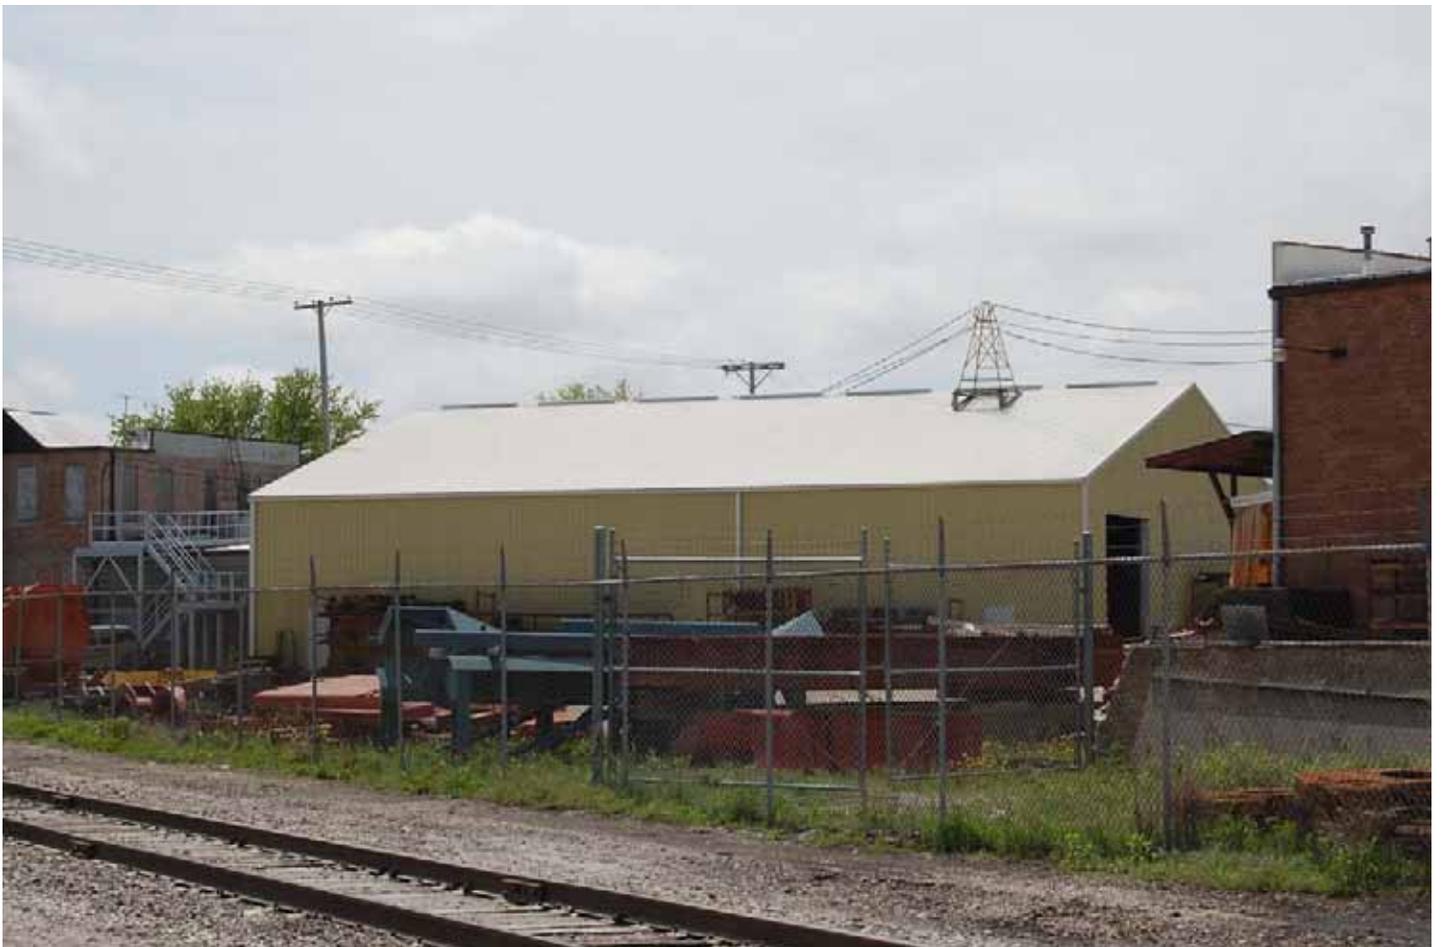
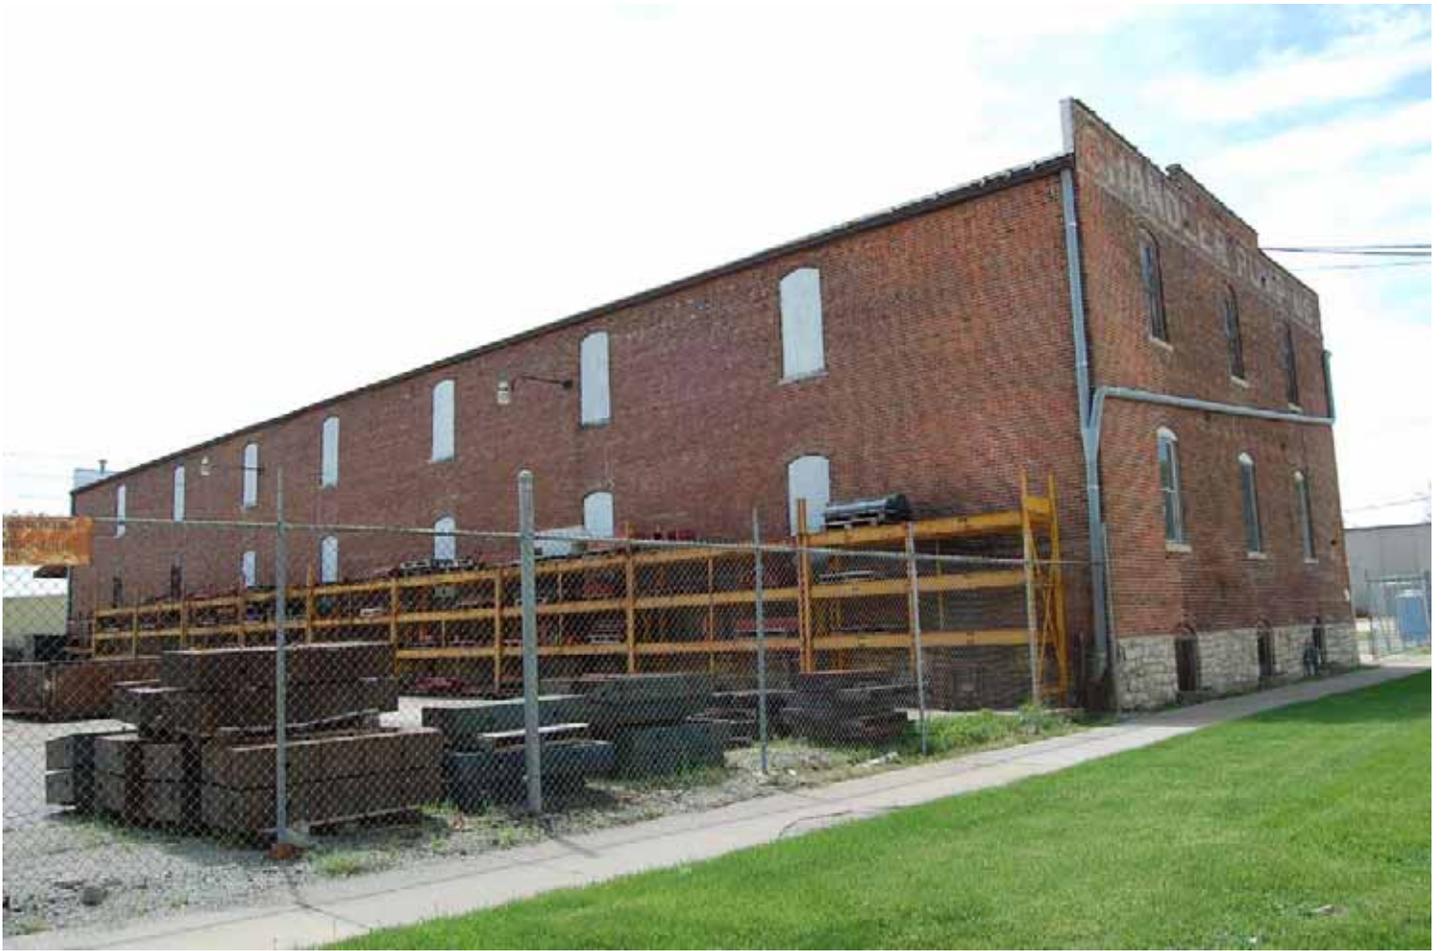
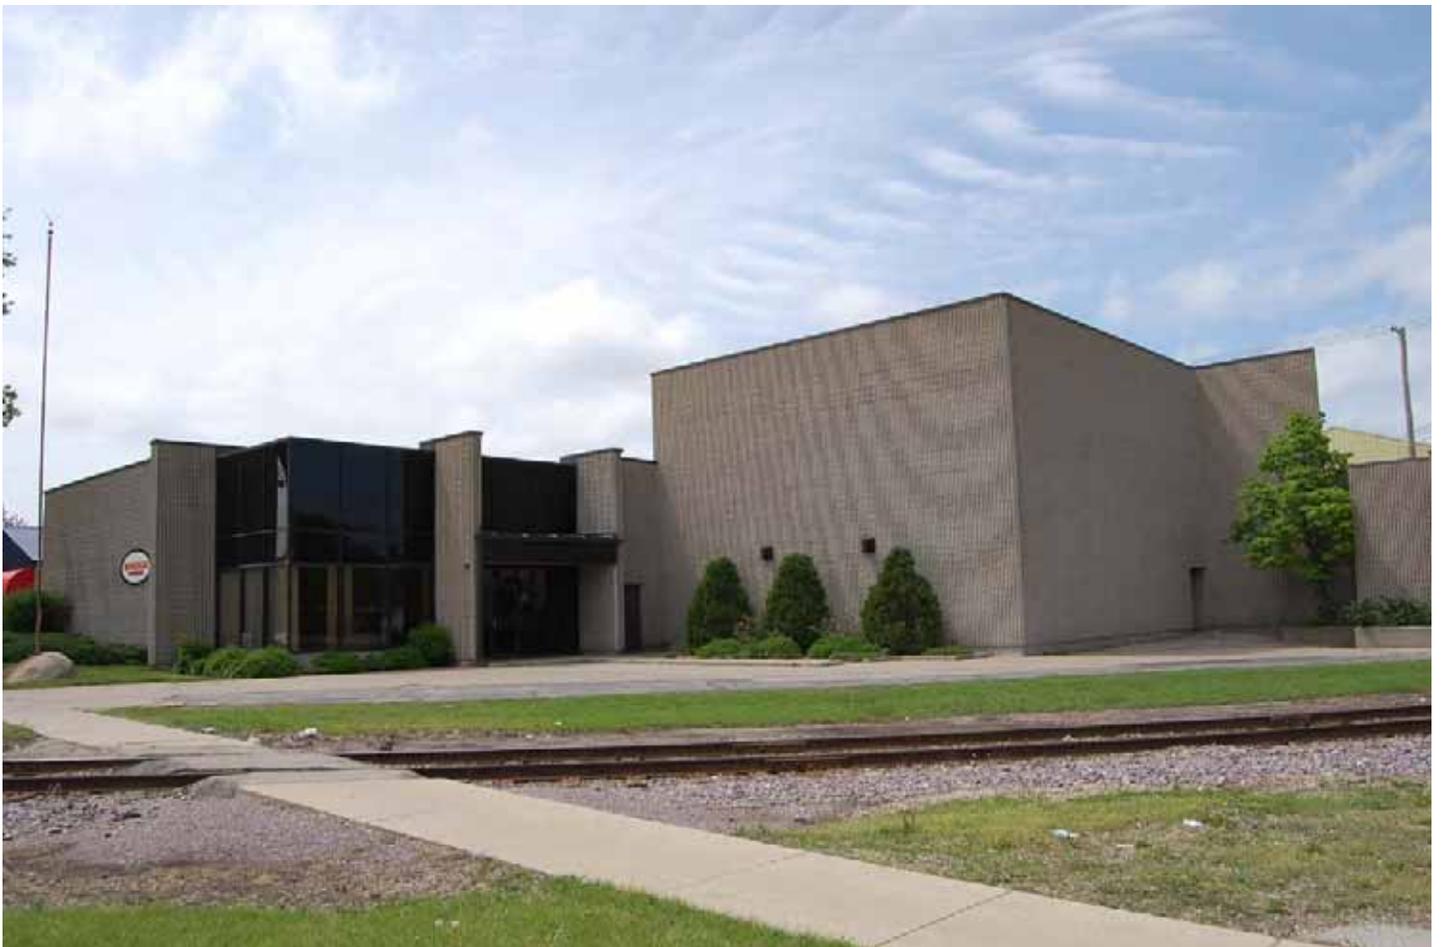
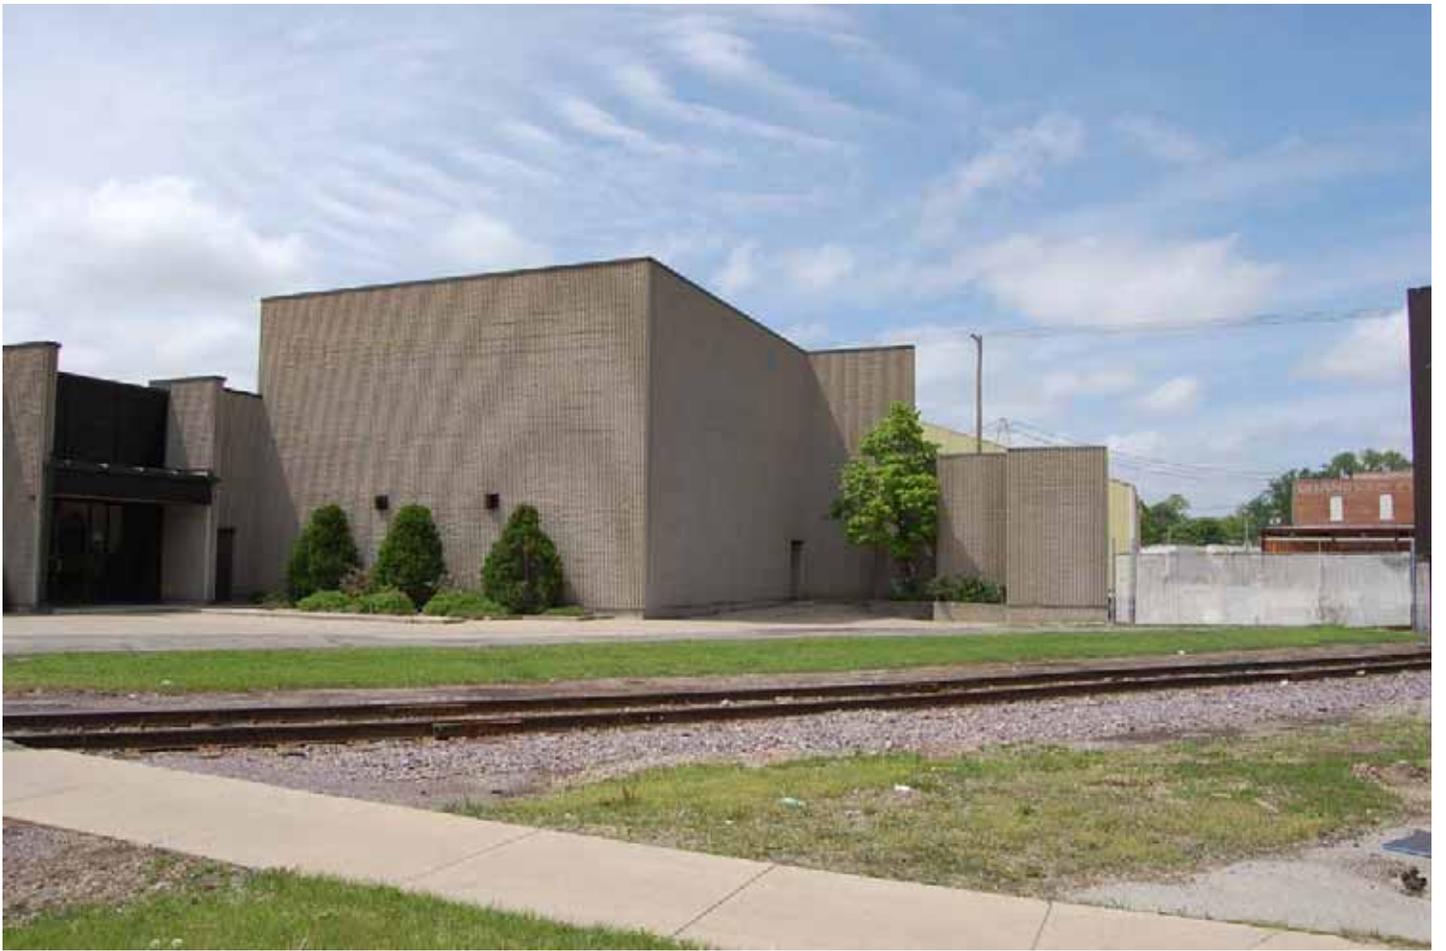
800 1st Ave NW (South Building)_View SE.JPG

800 1st Avenue NW (1903) – This 2 story, brick industrial building is covered by a shallow pitched gable roof with stepped parapet ends. A one-story, flat-roofed loading platform is located on the east end of the building. Window openings are detailed with two-brick, segmental arches and hold 1/1 wood-sash windows. Window openings on the side elevations are mostly covered by wooden shutters. The building is set on a high stone foundation. The lot around the building is enclosed by a tall chain link fence. A metal-clad, gable roofed building is also on the property. This building is one of the original facilities associated with the Chandler Pump Company, a wholesale plumbing supplier. Like many industrial complexes in the area, Chandler set up their facilities along the Chicago and North Western Railroad and near residential areas, which provided convenient housing for workers. The Chandler Company building is eligible for listing in the National Register under Criteria A and C. The company is associated with the early-twentieth-century industrial development along the Chicago and North Western Railroad line, as well as with “industrial trends, manufacturing and wholesaling practices, and business leaders who gave definition to the industrial corridors that developed along Cedar Rapids' railroads during the more than six decades (1880 - 1945) that Cedar Rapids grew from an economy of home consumption to a significant statewide and national food processor and machinery manufacturer” (Svendsen 1997:Section F, Page 68).

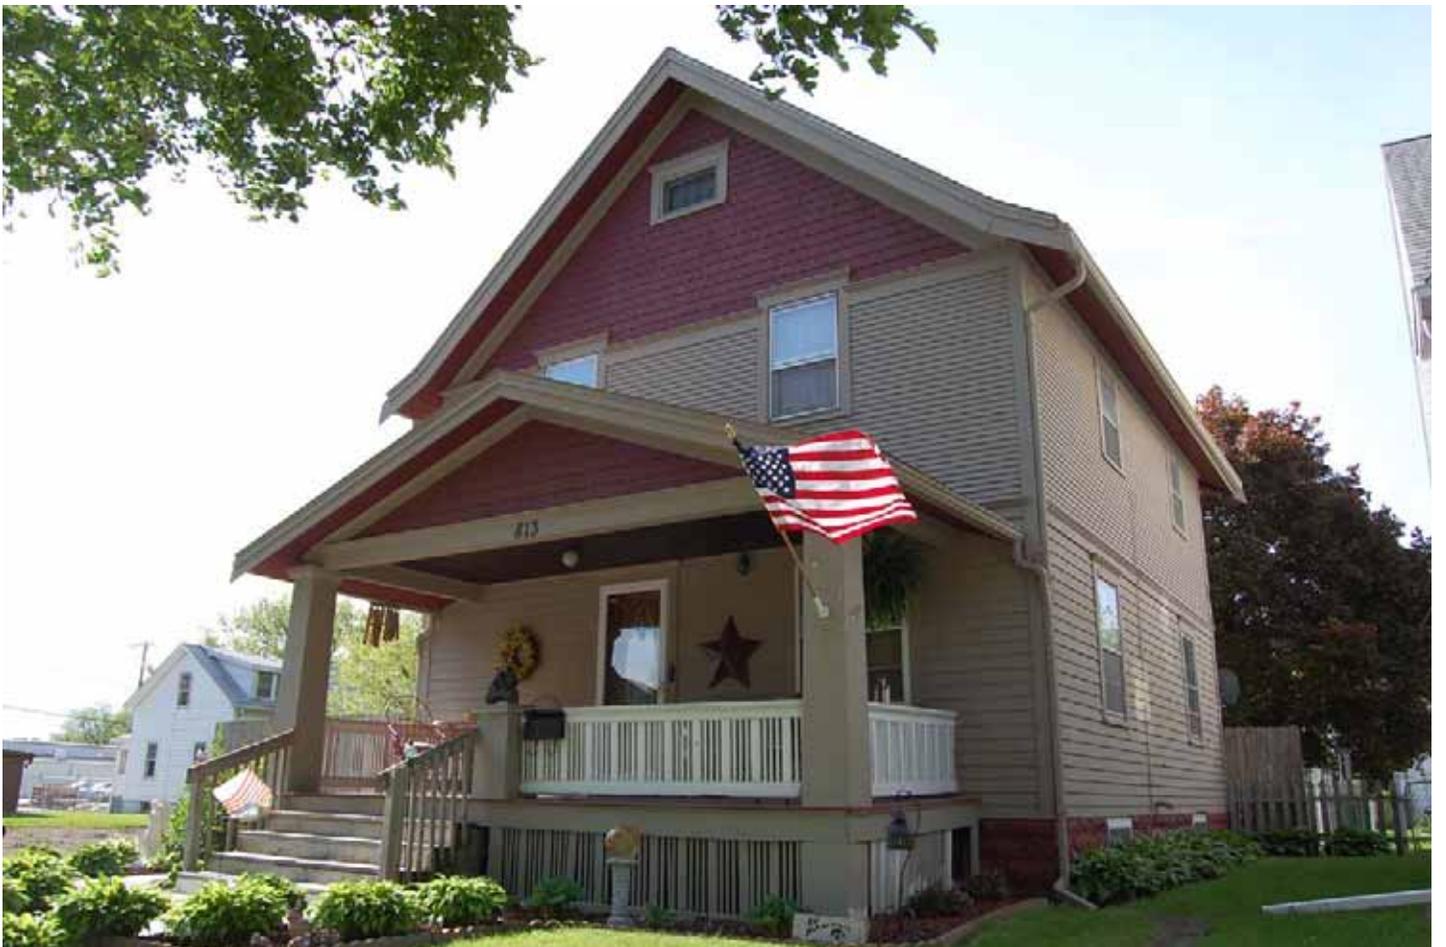
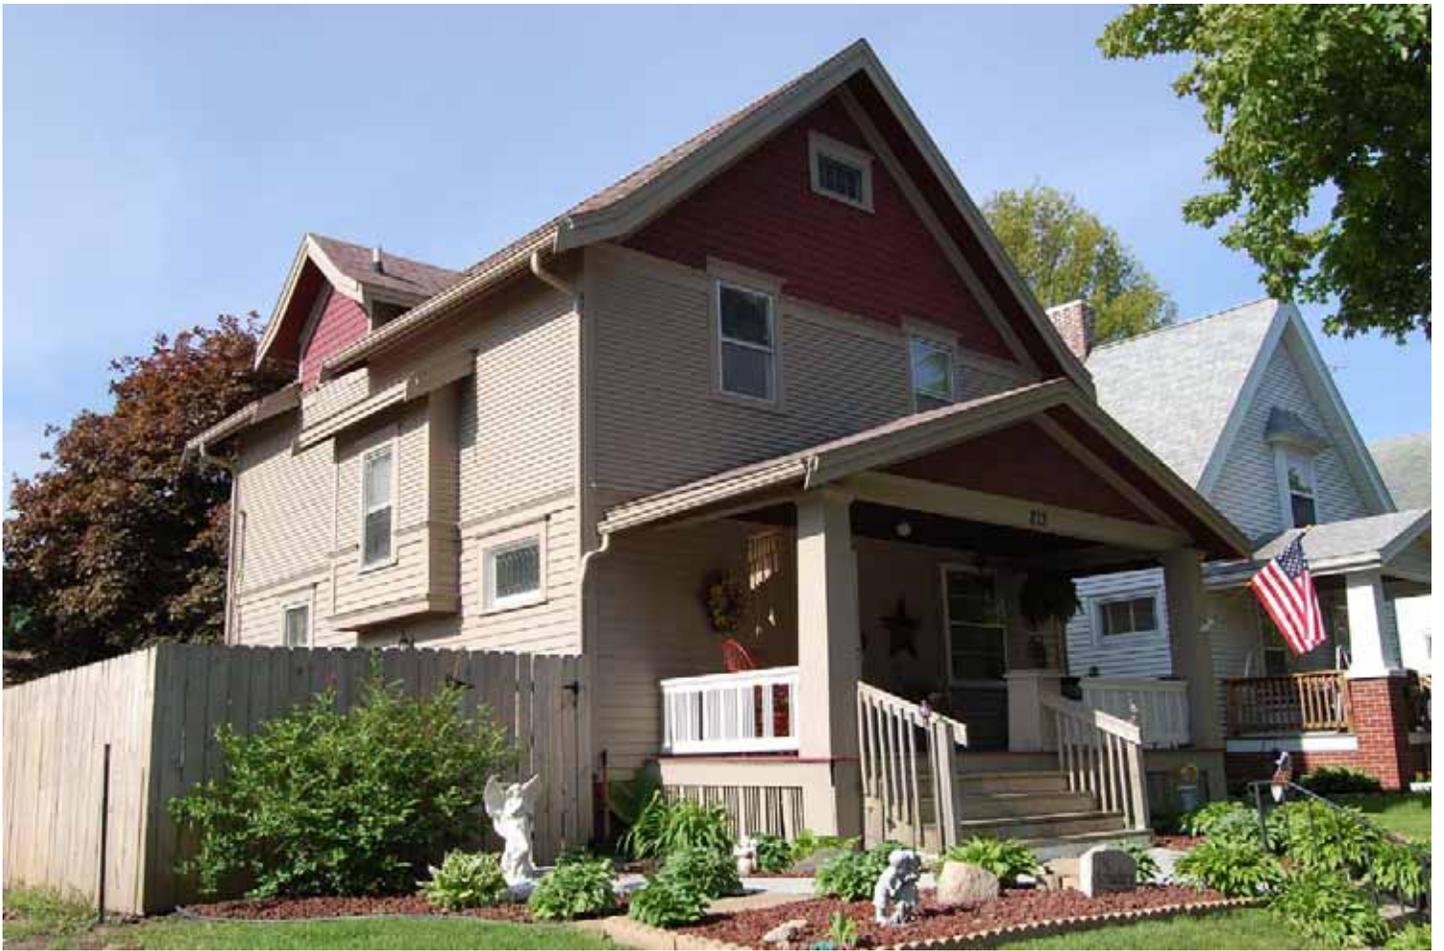
813 E Ave NW_View SE.JPG

813 E Avenue NW (1914) – This 2 ½-story, frame dwelling is covered by a front-facing gable roof, is clad with narrow and regular-width weatherboards, and is set on a stone foundation. The two-bay front holds an entrance and 1/1 windows. The gable roof of the full-width front porch is supported by battered square columns. A gable-roofed dormer and a projecting, shed-roofed window bay are located on the east side of the house. Other details on the house include slightly flared and overhanging eaves, corner boards, string courses, and decorative windows. This house is eligible for listing in the National Register under Criterion C as an important example of the two-story gable-front house form that was built in Cedar Rapids between 1890 and 1925. A common house form, these dwellings often featured Queen Anne-style or Craftsman-style details. Typical of the style, this example features a combination of exterior wall sheathing, belt courses, and projecting window bays. Craftsman style influences are seen in the porch elements. The house retains very good overall architectural integrity. Additional research may provide information on the original owners and builder.

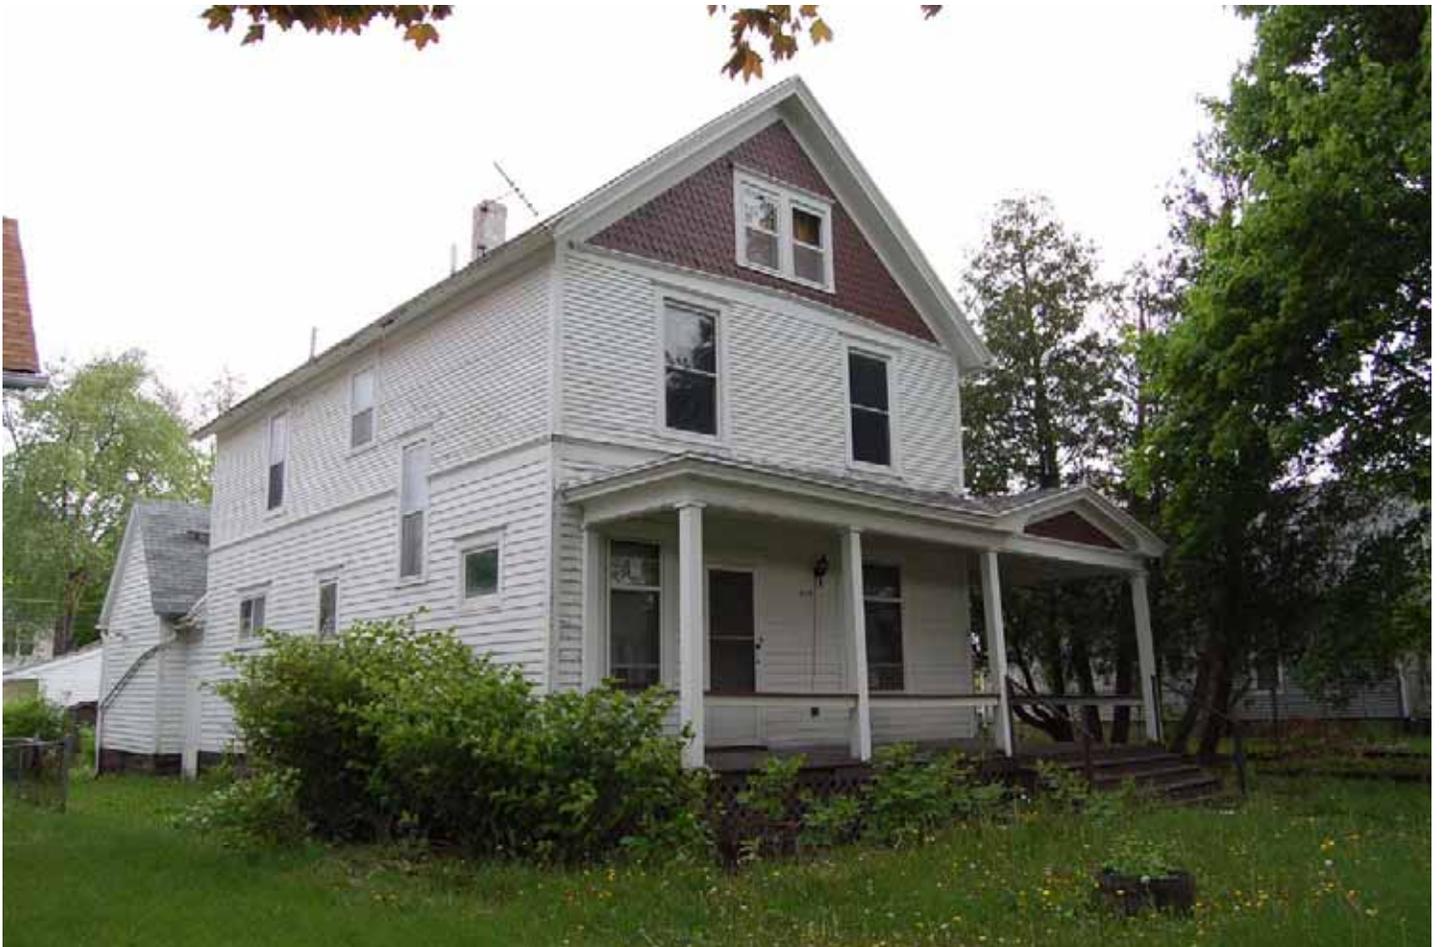
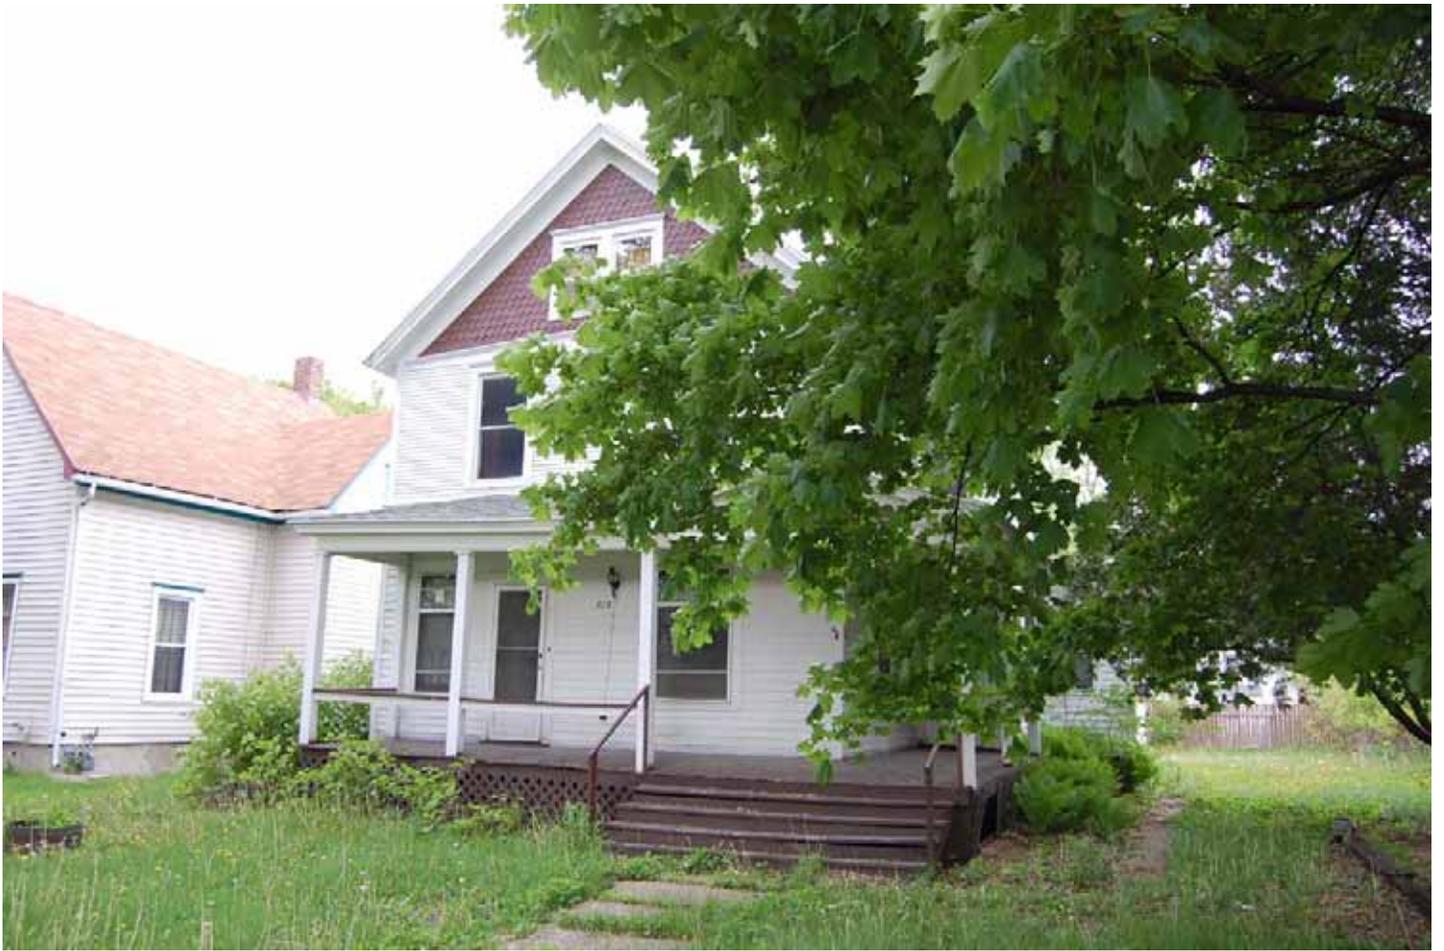
816 C Ave NW_View NE.JPG

816 C Avenue NW (1897) – Vernacular 2 story frame dwelling with a modified L-shaped porch, clapboard siding of varying widths on the lower and upper stories, a rear gabled addition, 1/1 wood and vinyl windows, and shingles in the gable end. The posts on the porch do not appear to be original and the railing has also been modified and/or removed. This structure is a large and early example of a gable-front vernacular dwelling. While this house has had alterations, it retains sufficient integrity to be eligible under Criterion C as an important, early example of the gable-front vernacular form. The house may also be eligible under other criteria with additional research.

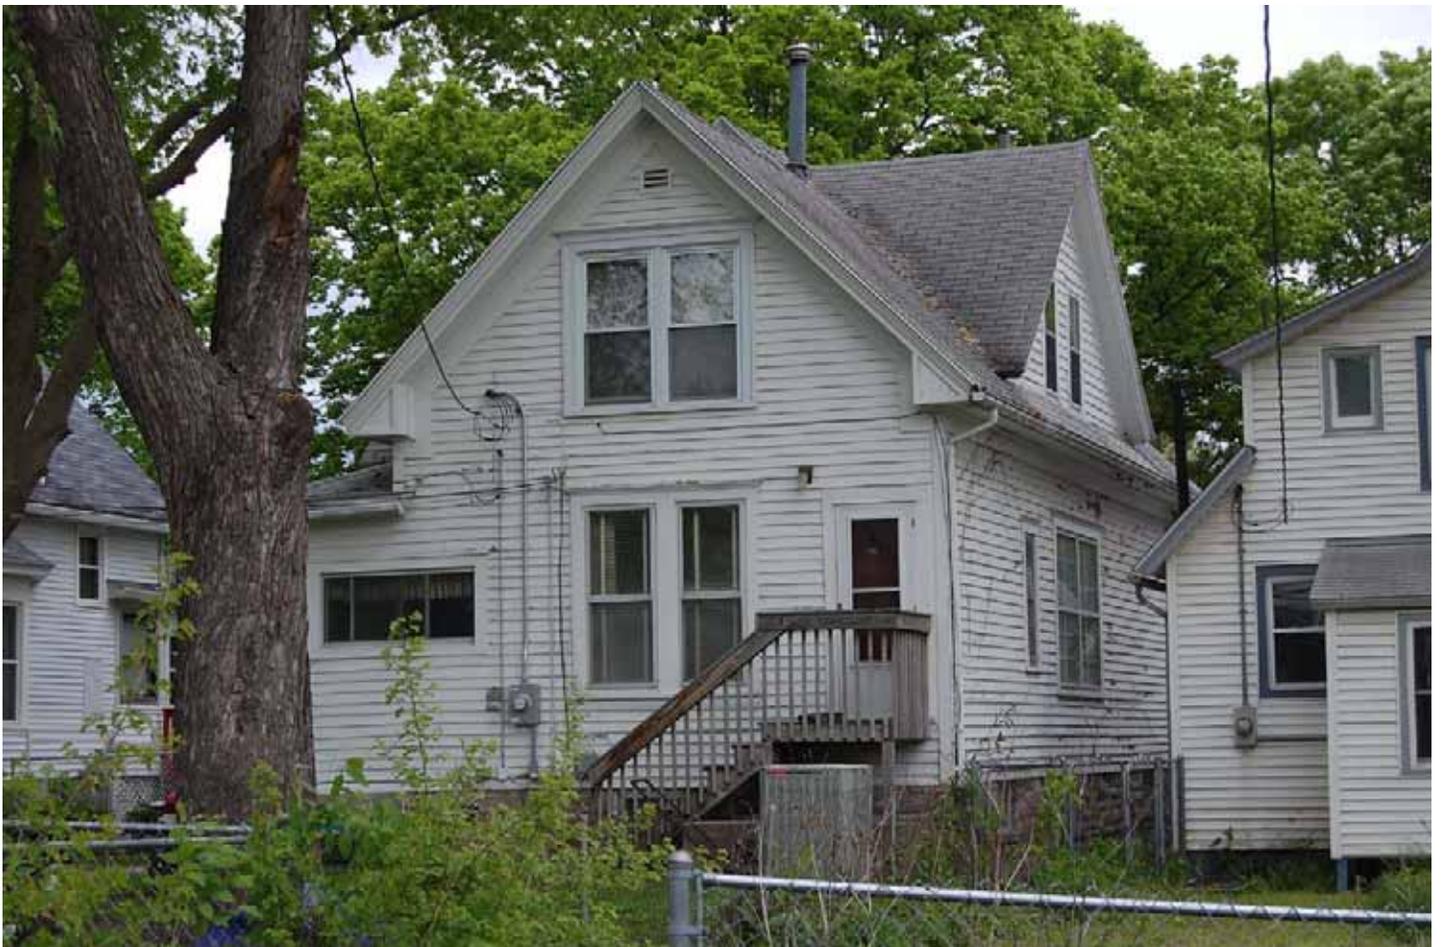
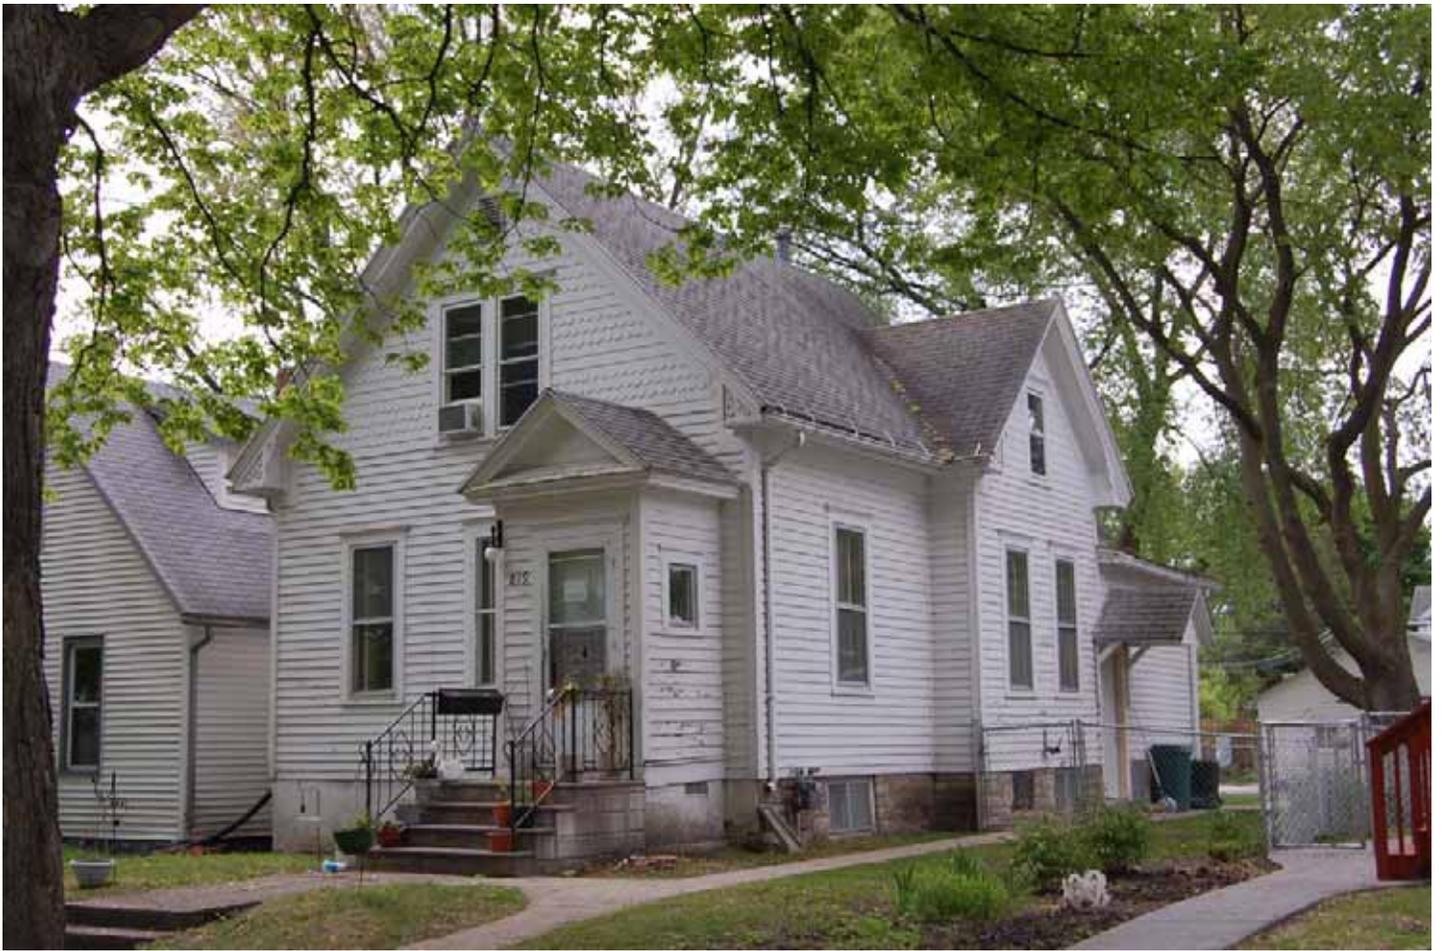
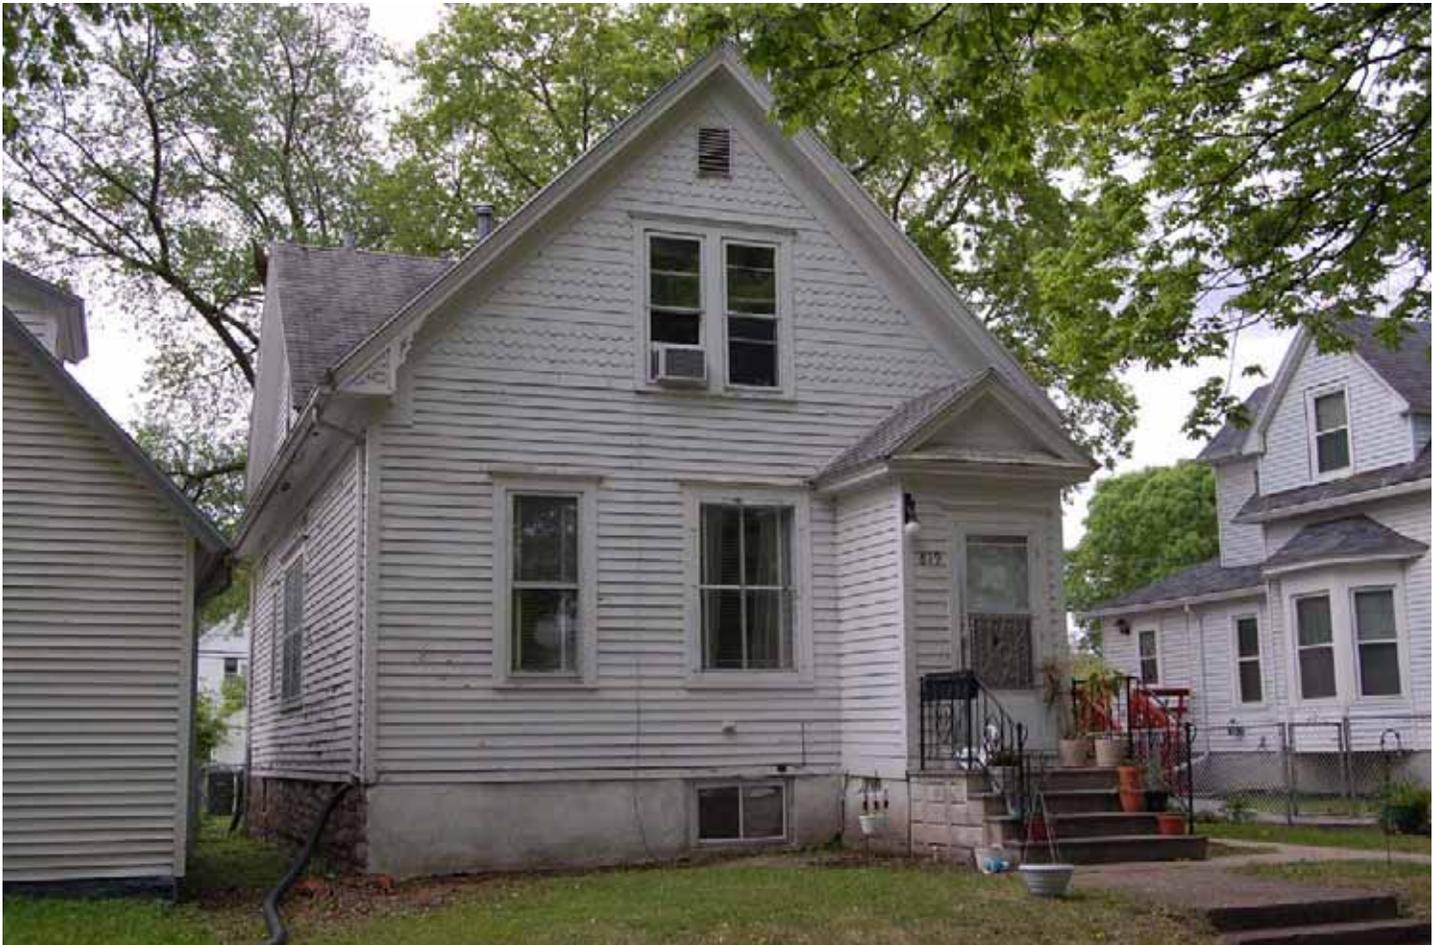
819 D Ave NW_View NW.JPG

819 D Avenue NW (1885) – This 1 ½-story, gable-front dwelling is clad with weatherboards and shaped wooden shingles and is set on a limestone foundation. A one-story projecting gable wing is located on the west side and a gable-roofed dormer is located on the east side. The gable ends feature enclosed corner eaves with some decorative carving. The three-bay front (north) features an enclosed, projecting, gable-roofed entrance bay that is flanked by two 1/1 wood-sash windows. While the gable-front dwelling is a common house form in Cedar Rapids neighborhoods, this example appears to be particularly intact and retains a high level of architectural integrity. The 2000 MPD *Architectural and Historical Resources of Cedar Rapids Residential Neighborhoods, 1870 - 1940* identifies the gable-front dwelling as a house form that dated from the 1870s -1910 with extant examples especially common in ethnic neighborhoods where such housing was affordable for newly arrived Bohemian immigrants. “This house form was typified by a narrow, rectangular plan with a gabled roof oriented toward the street. The front facade contained an attic window centered beneath the gable and two double-hung windows on the lower level or one double-hung window and an entrance door” (Svendsen 200: Section E, Page 25). This dwelling is eligible for listing in the National Register under Criterion C as an important example of an intact, late-nineteenth-century example of a gable-front house.
