**Architectural Reconnaissance Survey
for St. Patrick's Neighborhood
in Cedar Rapids
(57-086)**

Linn County, Iowa

June 8, 2009

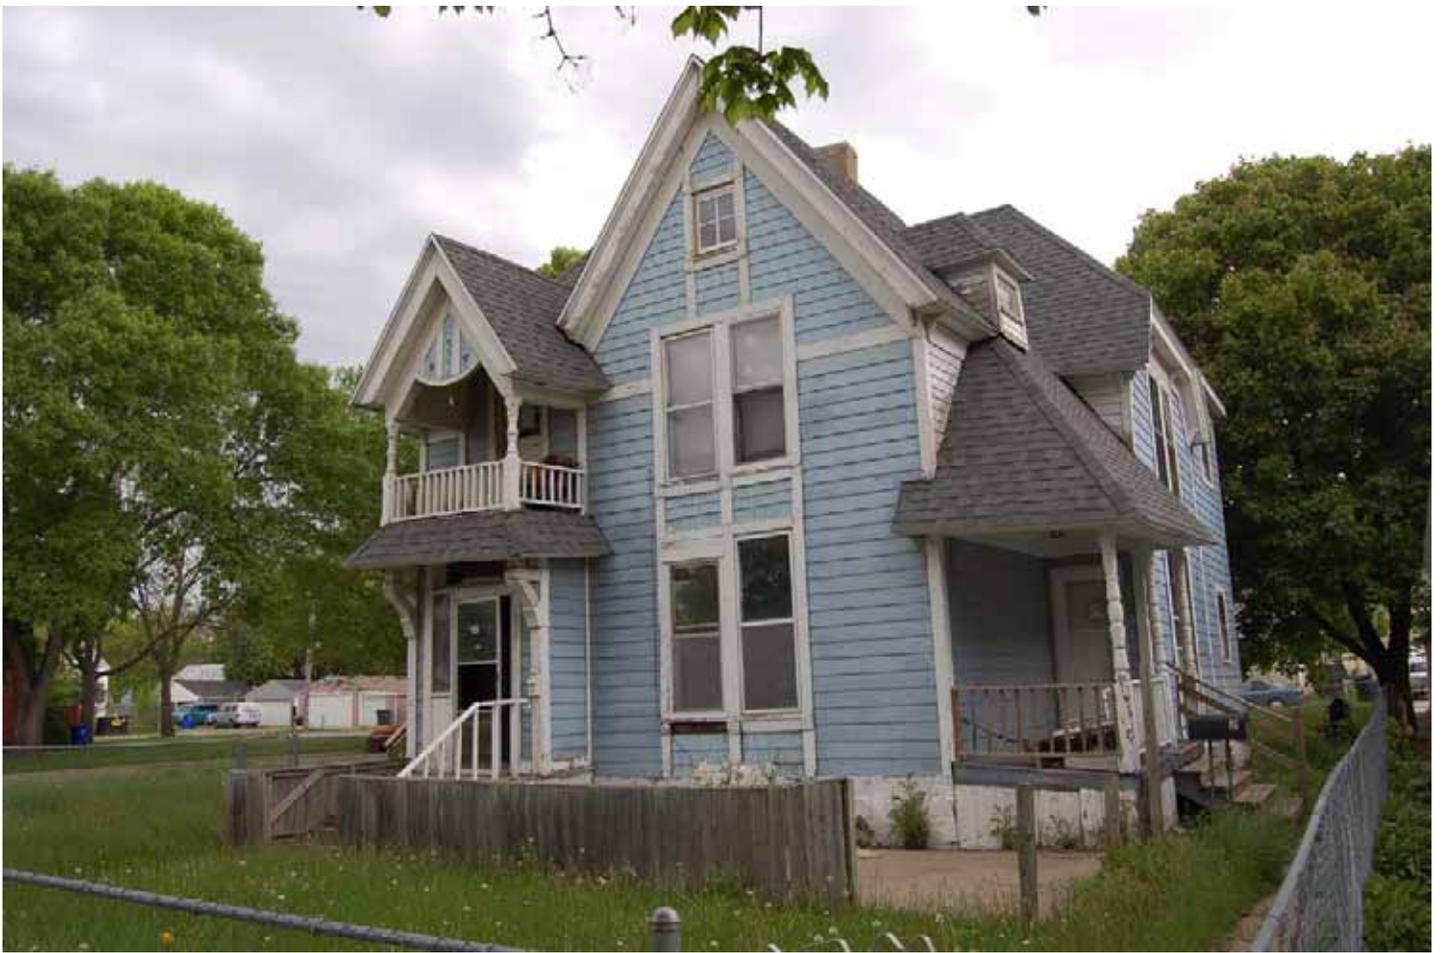
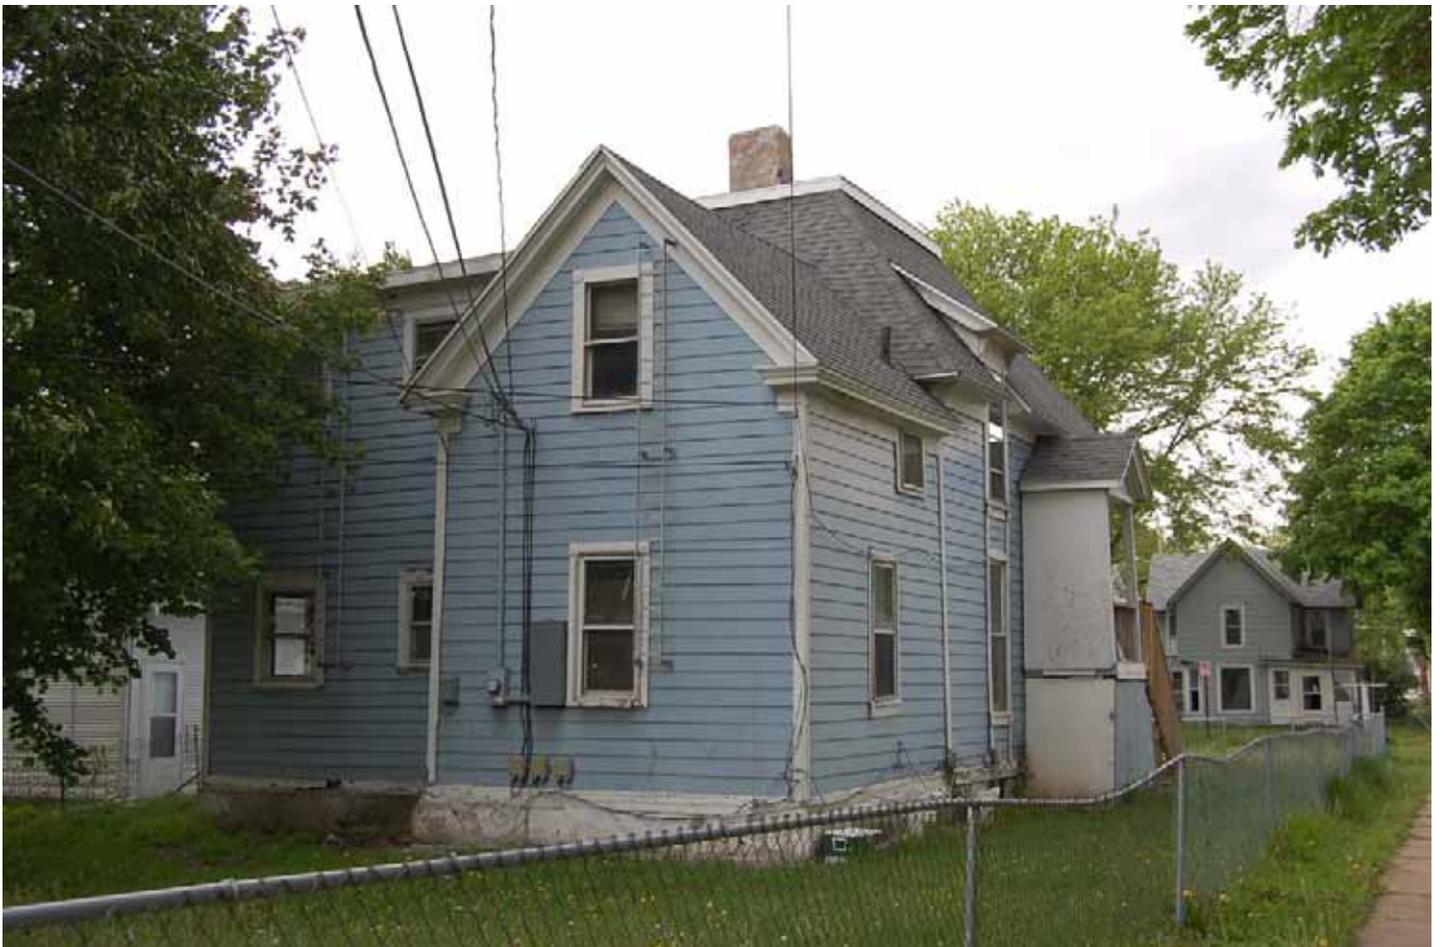
828 C Ave NW_View NW.JPG

828 C Avenue NW (1890) – This 2 ½-story frame dwelling is covered by a complex roofline of gable, hip, and clipped gable sections. The house is clad with weatherboard and wooden shingles and is set on a stone foundation. The front (south) consists of a front-gable wing with a two-story gable-roofed porch on the west side and a one-story, hip-roofed porch on the east side. The paired 1/1 windows on the front are detailed with framed panels of wooden shingles beneath each opening. Wooden shingles are also present in the front gable end of the house. Porch details include turned posts, wooden knee braces, applied decoration in the gable ends, and sawn pilasters. Other details on the house include wooden corner boards and belt courses, hip-roofed and shed-roofed dormers, and gable end returns. This dwelling is identified in the 2000 MPD *Architectural and Historical Resources of Cedar Rapids Residential Neighborhoods 1870 – 1940* as an individually eligible resource and is labeled as the Curry House. The house is eligible for listing in the National Register under Criterion C as a late-nineteenth-century example of a modest Stick style dwelling. Stylistic elements include the varied wooden wall cladding and decorative porch features. The building currently retains a good level of architectural integrity and possesses sufficient material to reflect its historical appearance.

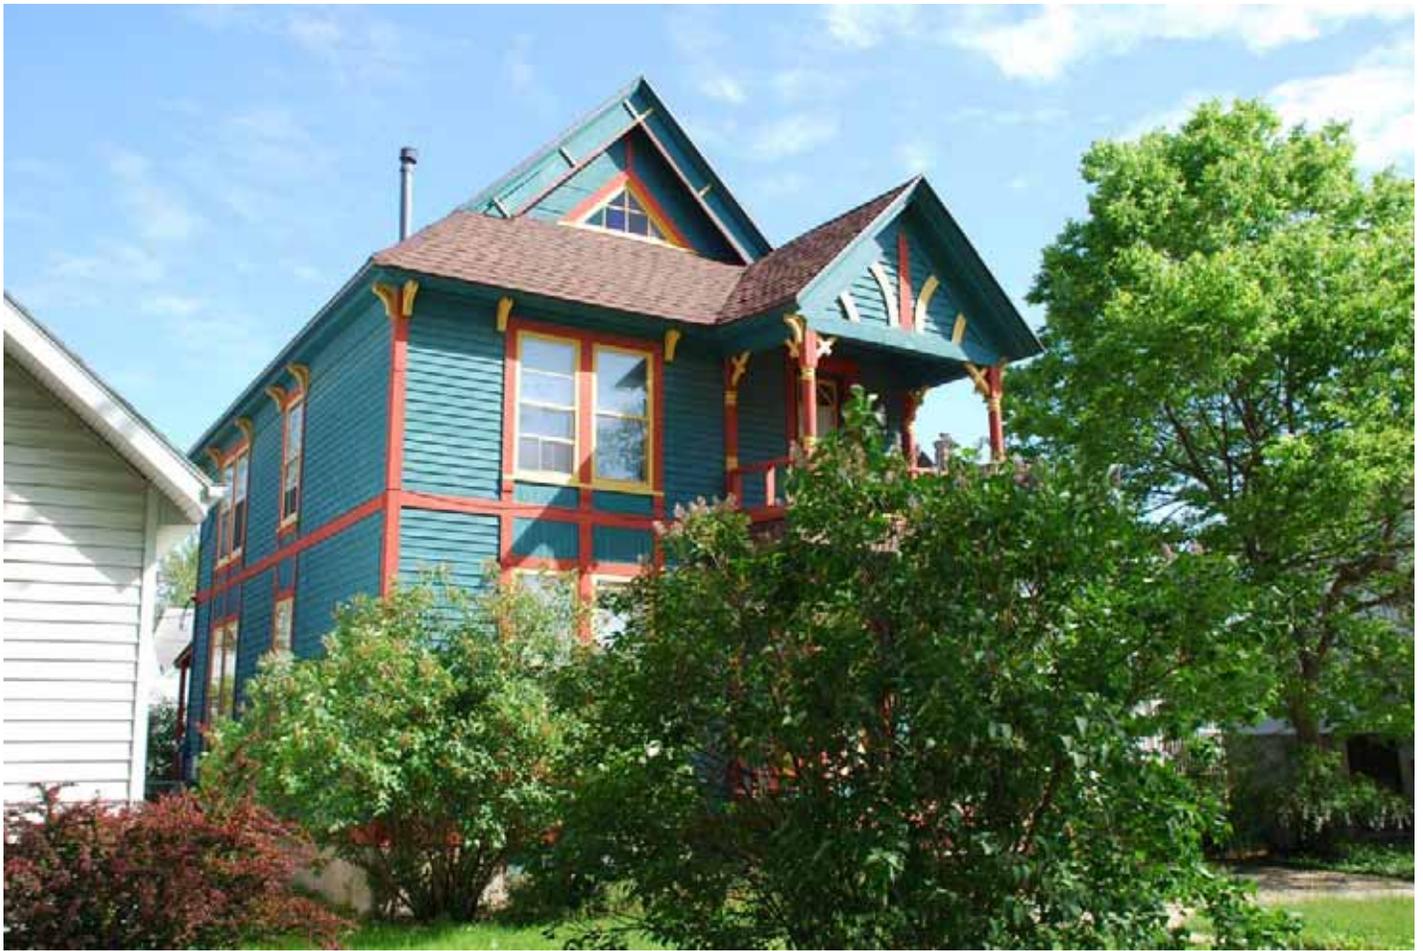
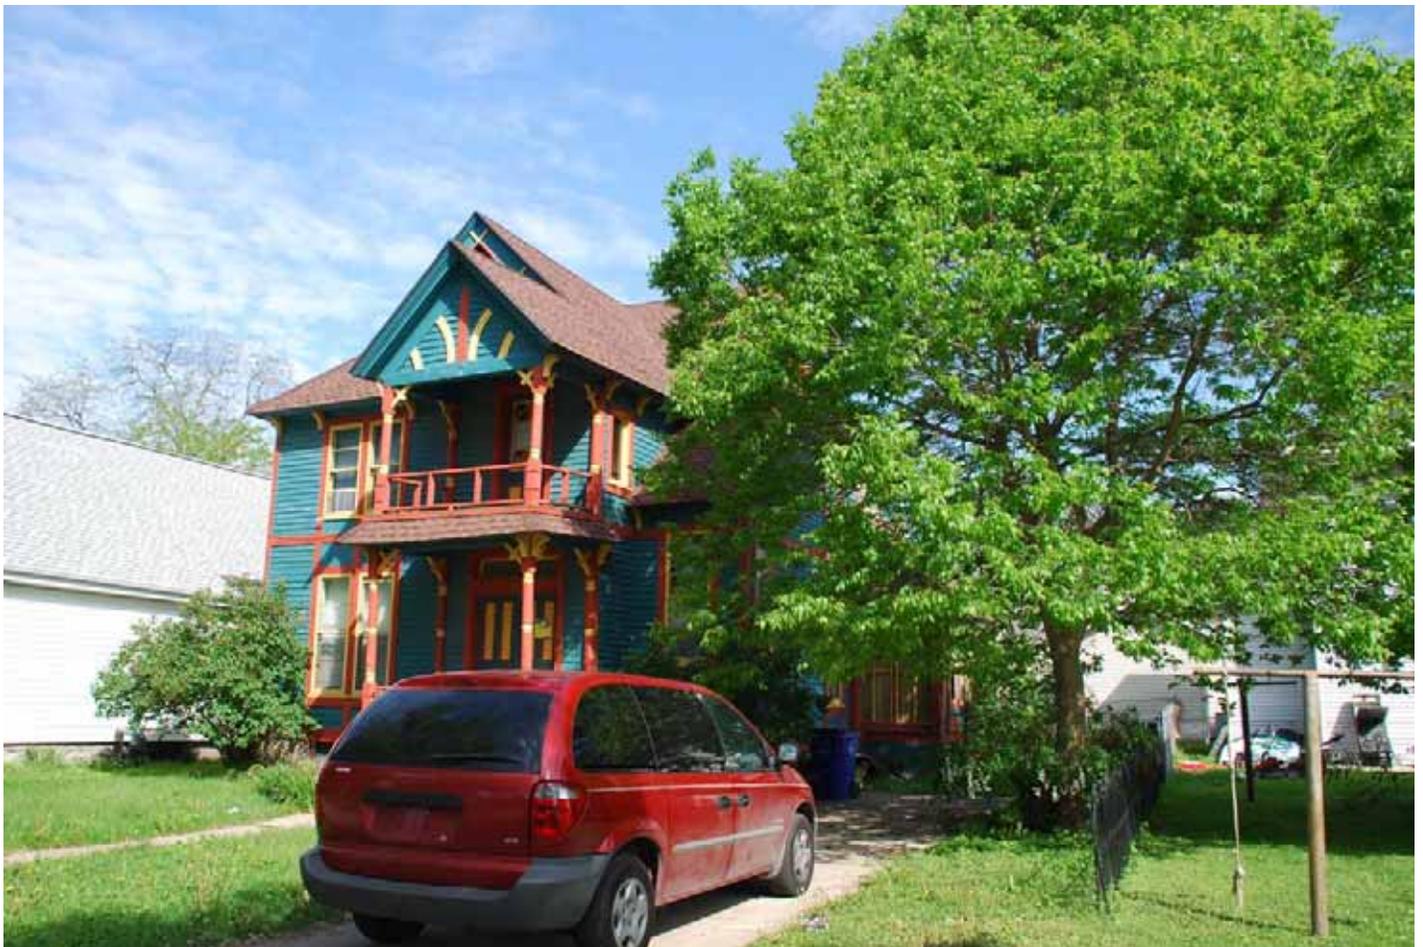
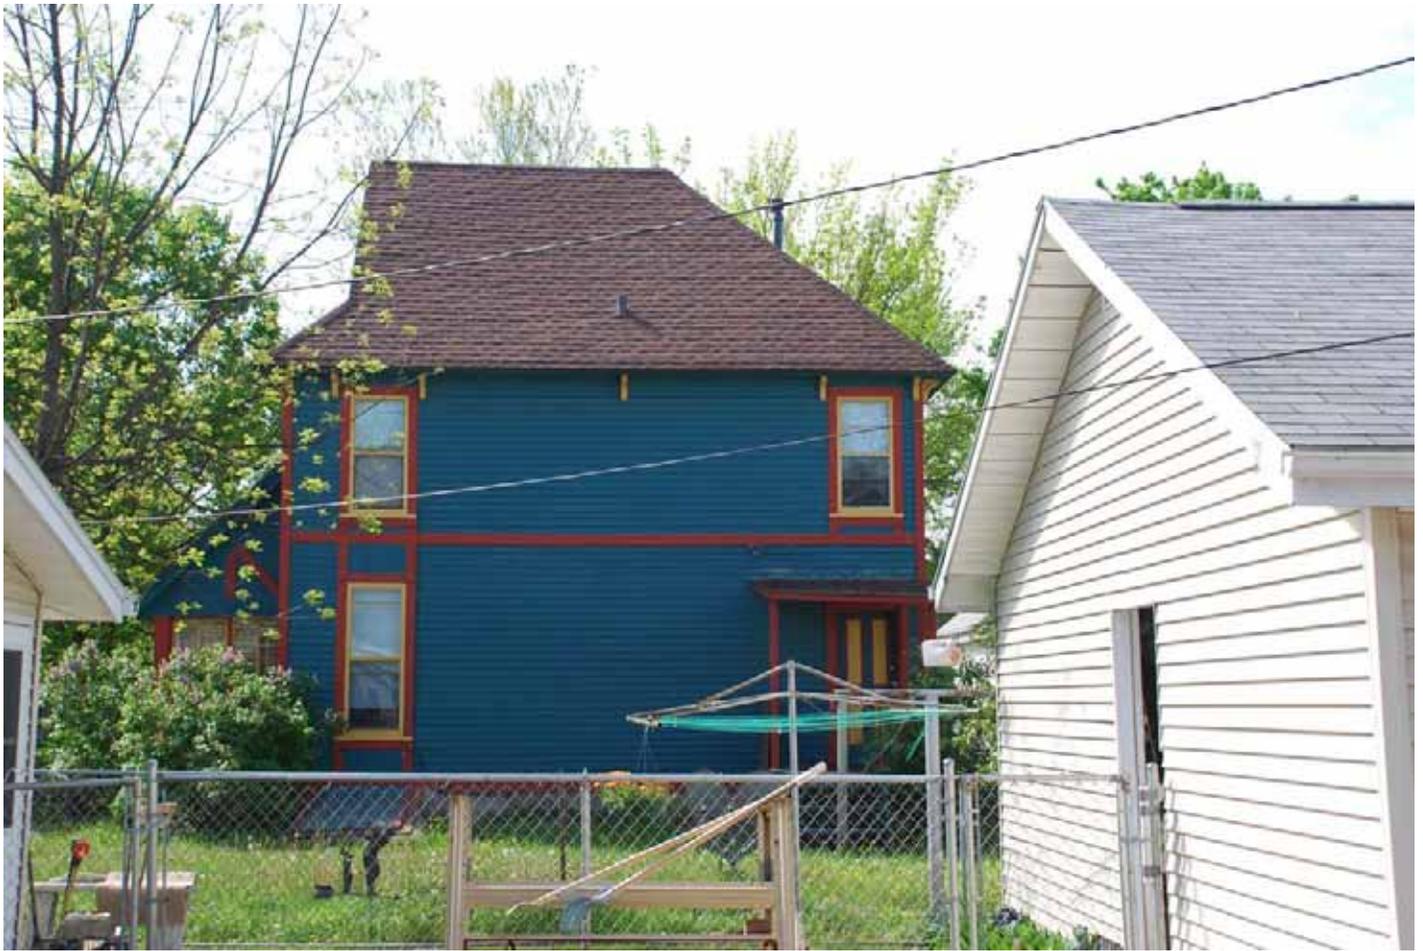
906 A Ave NW_View NE.jpg

906 A Avenue NW (ca. 1880) – This 2 ½-story, frame dwelling is covered by a complex roofline of a hipped roof with a front-facing cross gable. The two-bay front (southeast) features a double-leaf entrance with transom above flanked to the west by paired 1/1 wood-sash windows. Wide wooden trim surrounds are present at all window openings. The two-story front porch is covered by a gable roof that is contiguous from the centrally located, steeply pitched cross gable at the front of the house. The cross gable holds a triangular-shaped window of multiple panes, and the eave is detailed with stick supports. The exuberant porch detailing includes turned wooden posts on both floor levels that are set on square wooden piers and that feature both curved and straight wooden brackets. Other details on the house include weatherboard siding, wide wooden corner boards and string courses, and curved wooden brackets beneath the roof eave. The window bays are further enhanced by framed panels of vertical wooden sheathing located between the first and second-floor openings. This dwelling was identified in the 2000 MPD *Architectural and Historical Resources of Cedar Rapids Residential Neighborhoods, 1870 – 1940* as an individually eligible resource located outside of existing historic districts (Svendsen 2000: Section F, Page 76) and was labeled as the Finn House. This dwelling is eligible for listing in the National Register under Criterion C for its local significance as an intact example of late-nineteenth-century Stick style architecture. As an example of a transitional style, the house also reflects decorative detailing often attributed to the Queen Anne style. This is an unusual example of a style most commonly seen in the Northeastern United States. The house is also unusual for its use of a hipped roof with front gable, rather than a gable roof as the primary roof. The house retains excellent integrity of materials and retains its polychrome appearance, which highlights the patterned wood wall surfaces.

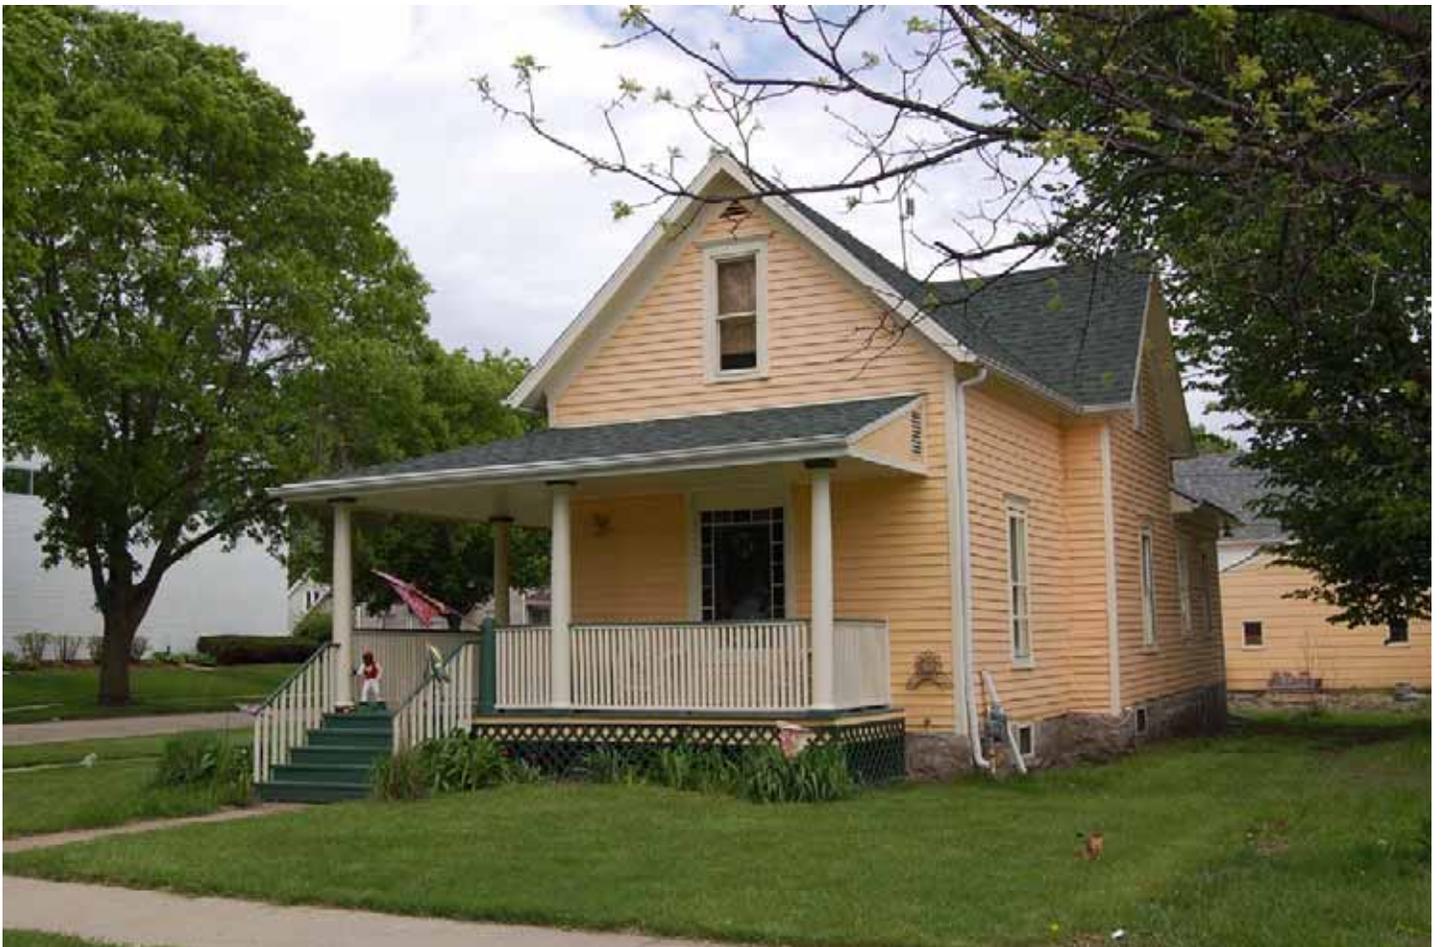
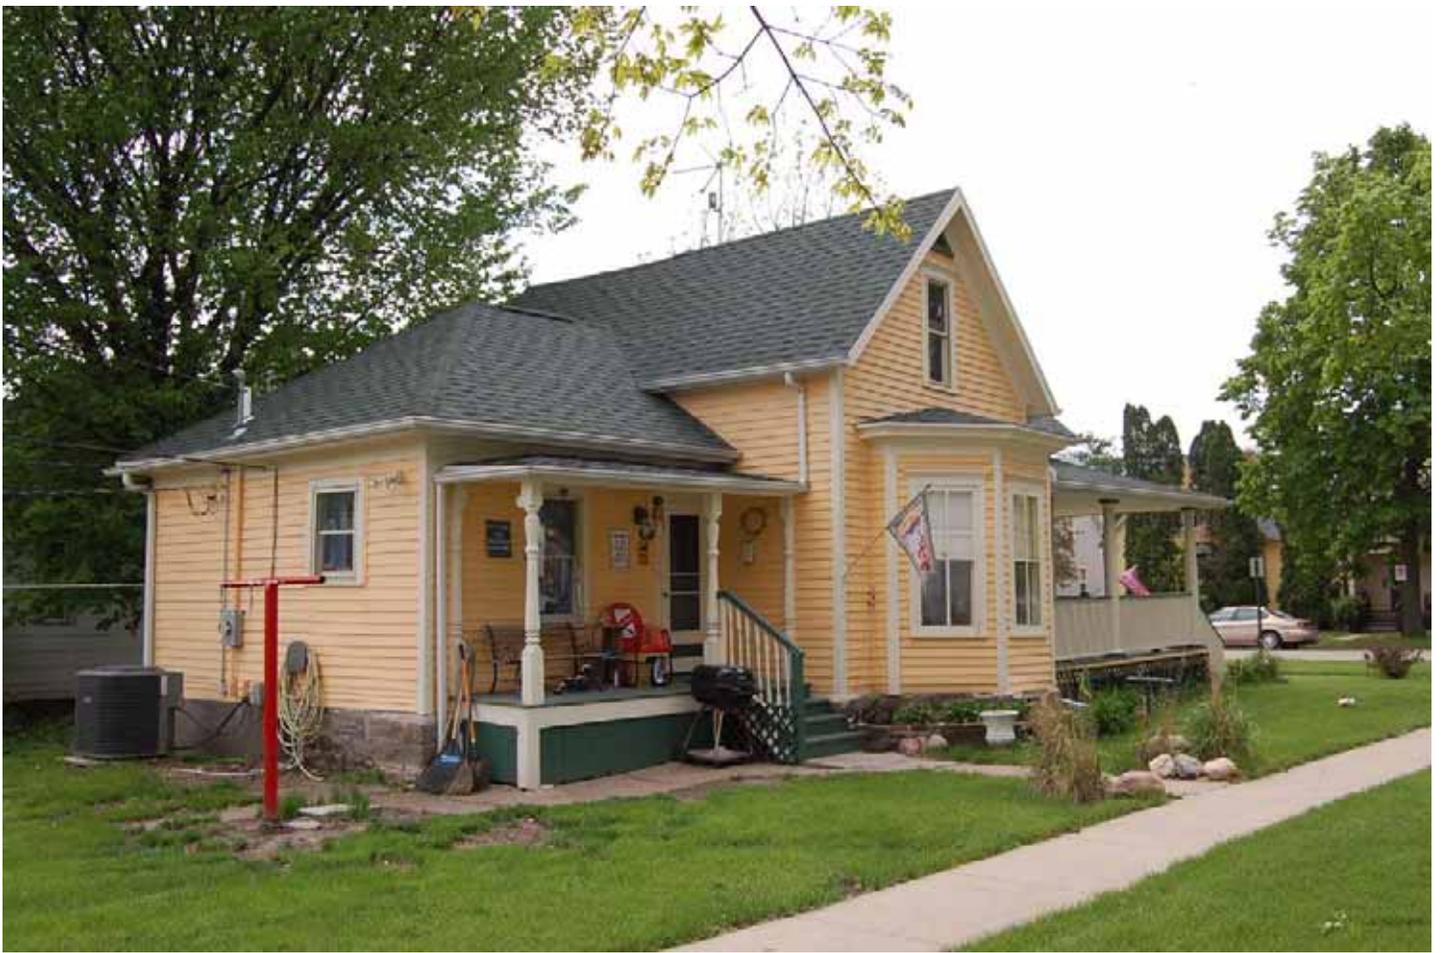
922 C Ave NW_View NW.JPG

922 C Avenue NW (ca. 1890) – This 1 ½ story, frame dwelling is covered by a side-facing gable roof with a projecting front gable wing, is clad with weatherboard siding, and is set on a limestone foundation. The one-story, four-bay porch wraps around the front and west side of the house. Porch details include round columns and slender wooden balusters. The small, two-bay side porch, located on the west side of the rear hip-roofed ell, features turned wooden posts. Windows on the house are 1/1 and 2/2 wood-sash; a fixed pane surrounded by small rectangular panes is located on the front projecting wing. Other details on the house include a plain frieze board, corner boards, and a three-sided window bay on the west side. This house is eligible for listing in the National Register under Criterion C for its local significance as an intact example of a Victorian-era cottage with detailing that reflects influences of Queen Anne style, including the decorative window at the front and the projecting window bay on the side. The dwelling could be classified as a *Plains Cottage* as described in the 2000 MPD *Architectural and Historical Resources of Cedar Rapids Residential Neighborhoods, 1870 – 1940* as a “small house form dating from the 1870's – 1910...typified by intersecting or perpendicular gable sections forming an ell plan with a porch usually filling the ell” (Svendsen 2000: Section E, Page 25).

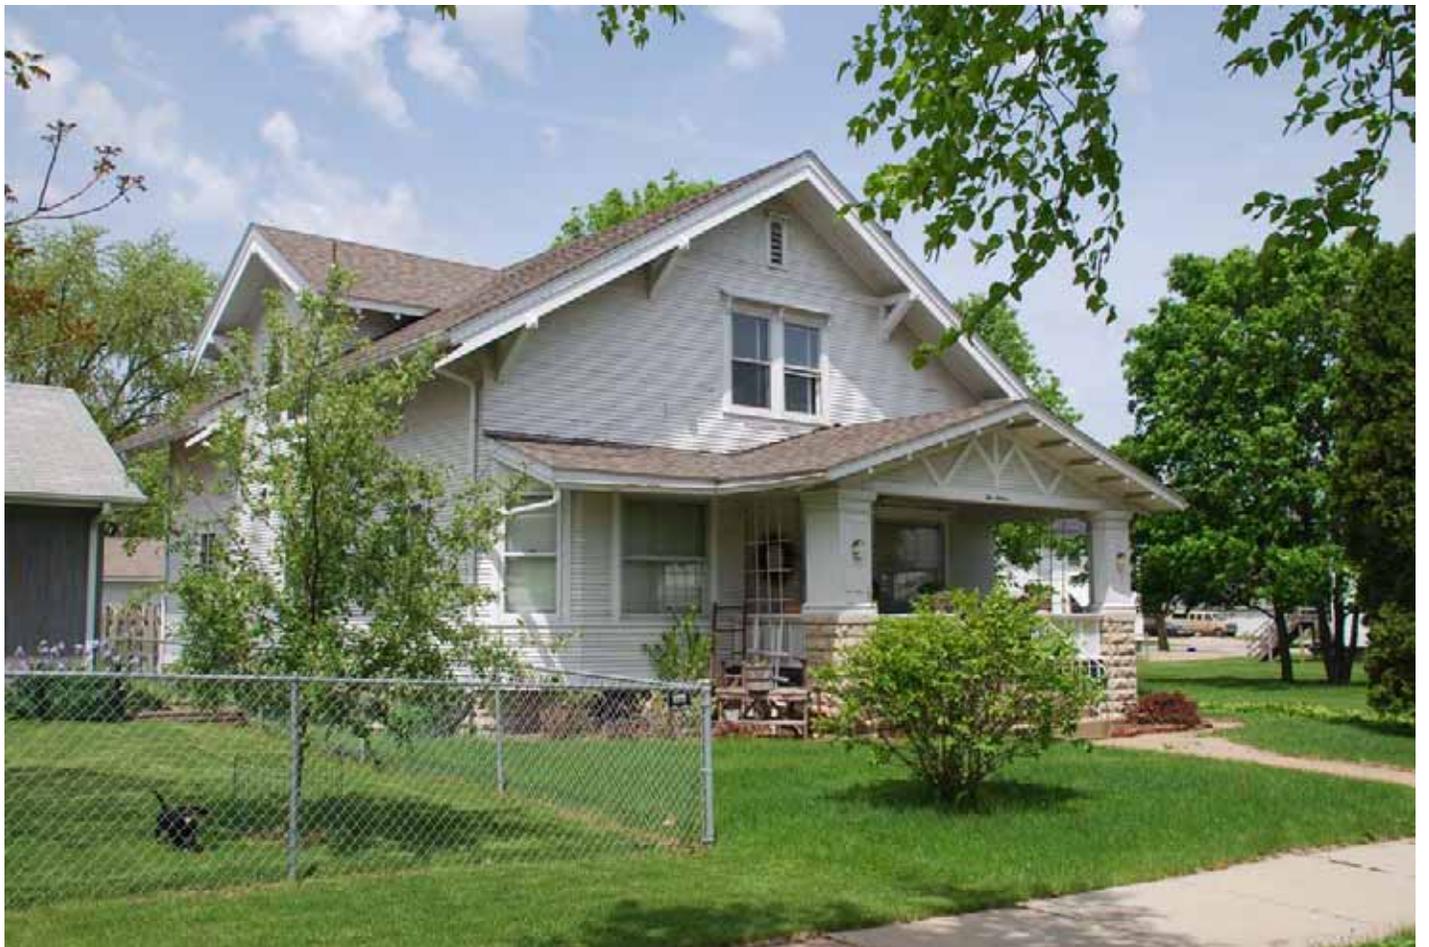
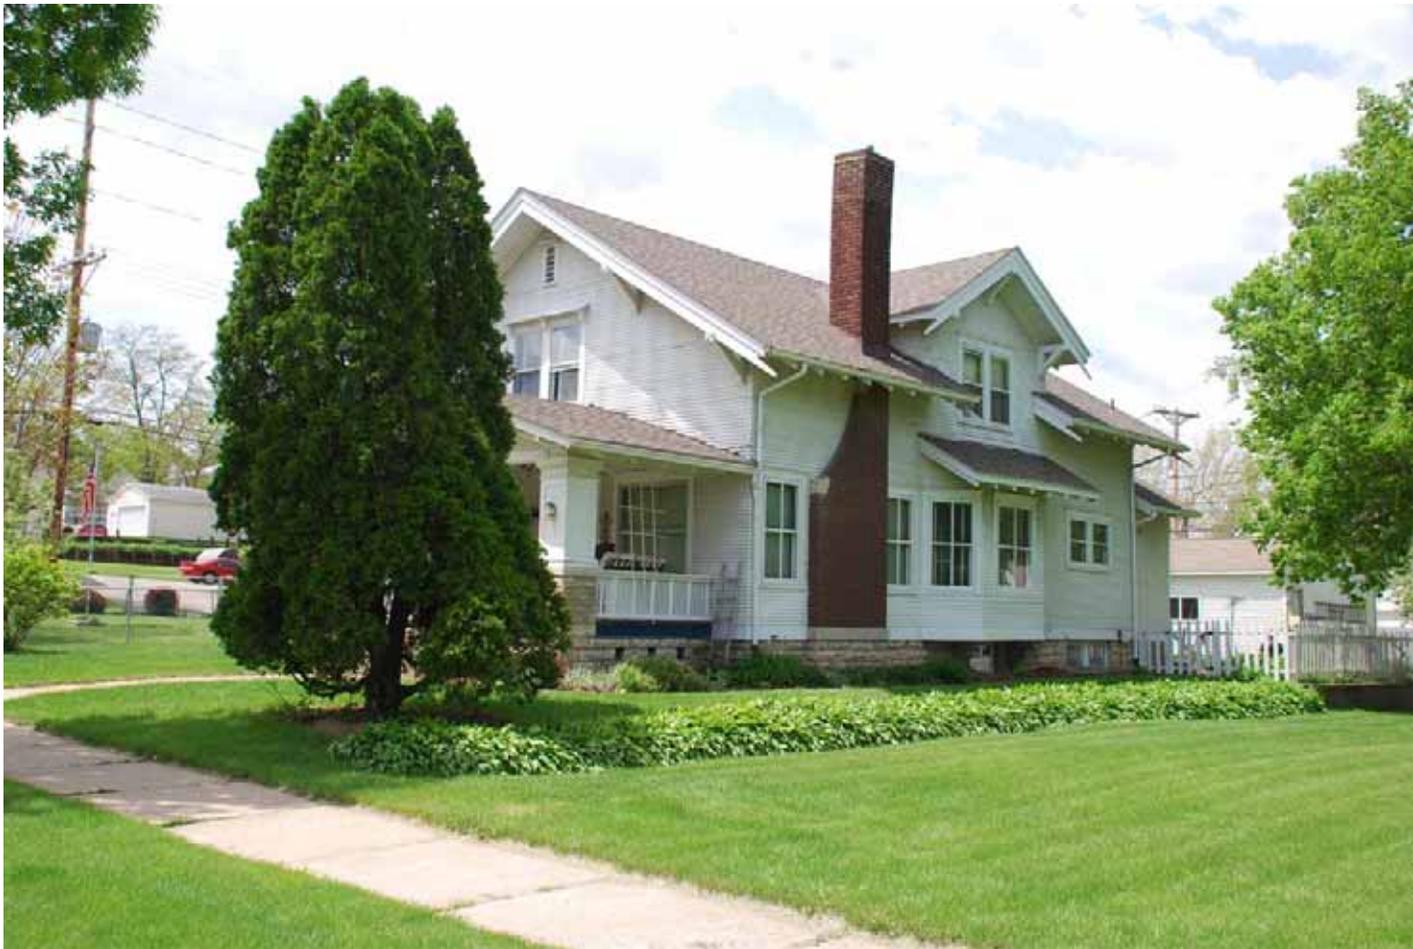
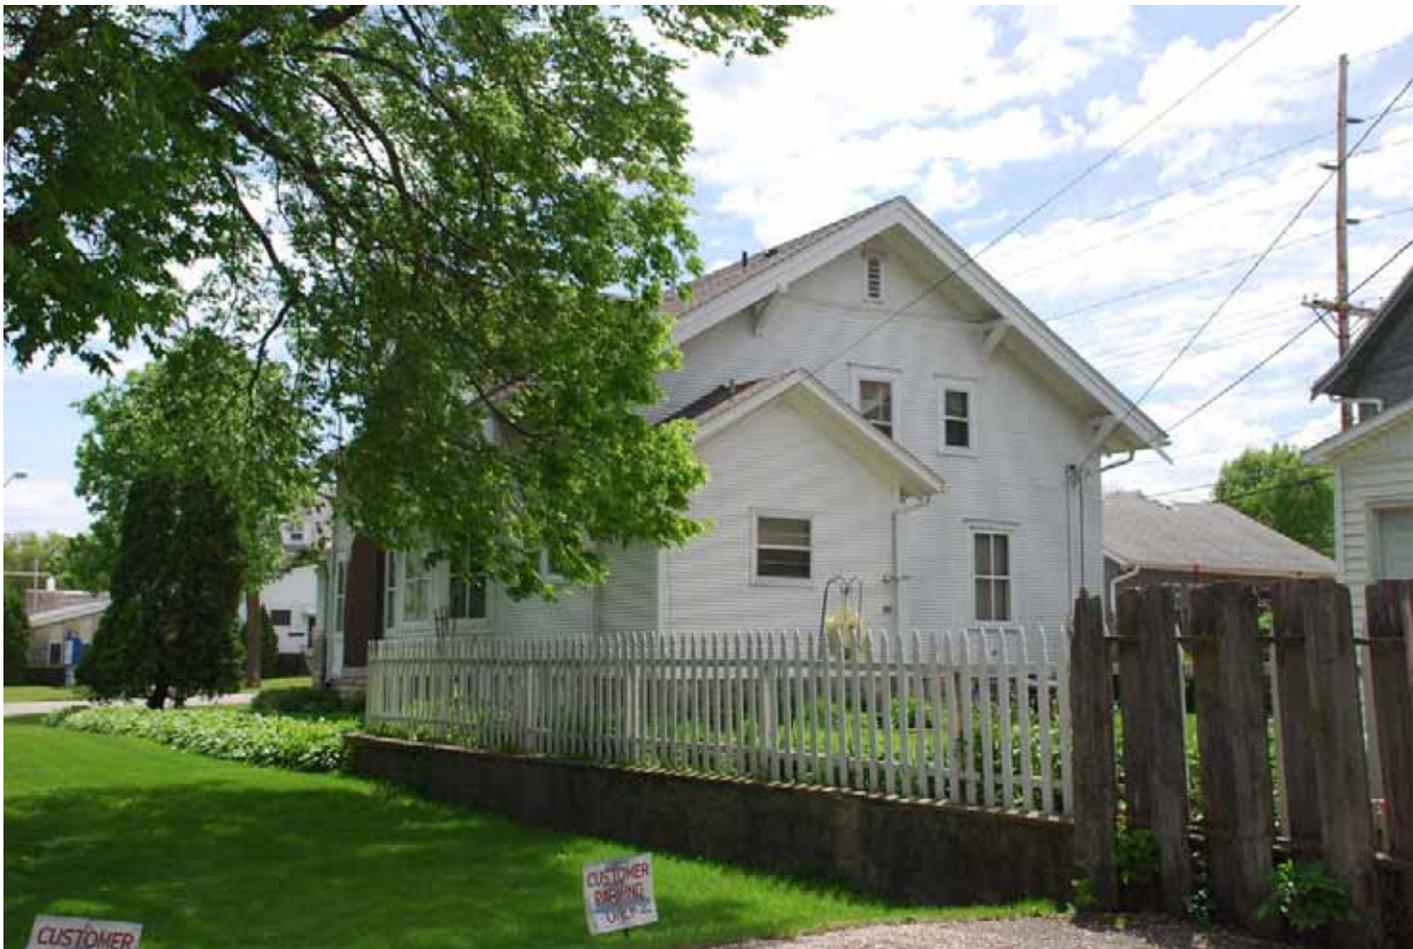
1016 1st Ave NW_View NE.jpg

1016 1st Avenue NW (1900) – This 1 ½-story, frame bungalow is covered by a front-facing gable roof with deep eaves that feature wooden knee braces in the gable ends and exposed rafter tails on the side eaves. The house is clad with weatherboards and is set on a stone foundation. The three-bay front consists of an off-center entrance that is flanked by wide 1/1 wood-sash windows. The façade also features a cutaway corner on the west end, which holds a 1/1 window. Paired 1/1 windows are featured in the gable end with a pent roof above. The one-bay entrance porch is covered by a projecting gable roof with exposed purlins beneath the eave and half-timbering in the gable end. The roof is supported by square, square, wooden paneled columns that are set on high stone piers. A small one-story, gable-roofed addition has been constructed at the rear of the house. This dwelling was identified in the 2000 MPD *Architectural and Historical Resources of Cedar Rapids Residential Neighborhoods, 1870 – 1940* as an individually eligible resource located outside of existing historic districts (Svendsen 2000: Section F, Page 76). The house was labeled as the Mary Stark House. This dwelling is eligible for listing in the National Register under Criterion C as a locally significant example of a turn-of-the-twentieth-century Craftsman-style Bungalow. The house retains very good overall integrity and possesses significant design elements that identify it as a bungalow such as the gable roofs with overhanging eaves, knee braces, and exposed rafter

tails, characteristic porch detailing, and cutaway window bays. Additional research may provide important information concerning the original owners and later residents.
