### ENVIRONMENTAL ASSESSMENT REPORT

City of Cedar Rapids 414 6th Ave SW Cedar Rapids, IA

Project Report Dated: November 21, 2017

City of Cedar Rapids 1124 6<sup>th</sup> Street NW Cedar Rapids, IA

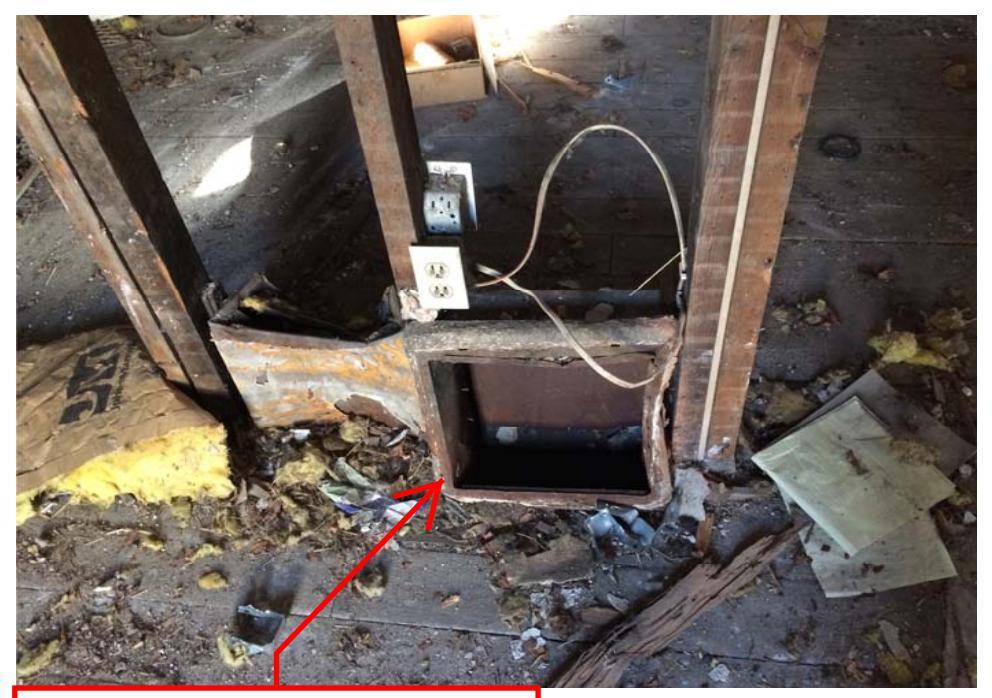
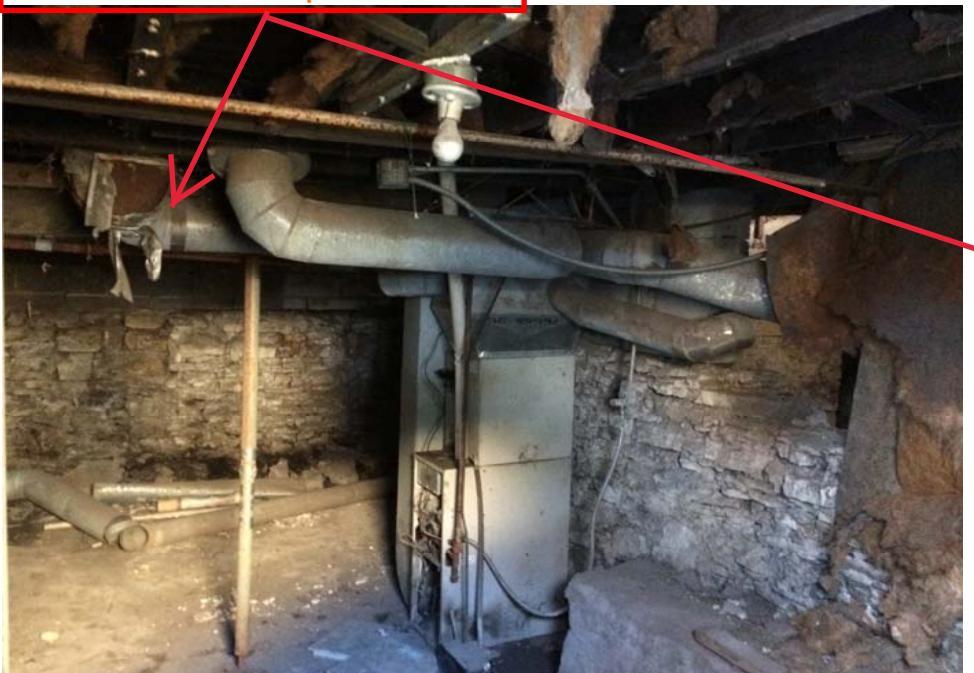
Material	Description	Location	Quantity
Duct Paper	Gray	Furnace Ducts	< 40 LF
Electrical Insulation Paper	Gray	Electrical Junction (1 <sup>st</sup> Floor)	< 3 SF

Asbestos Duct Paper

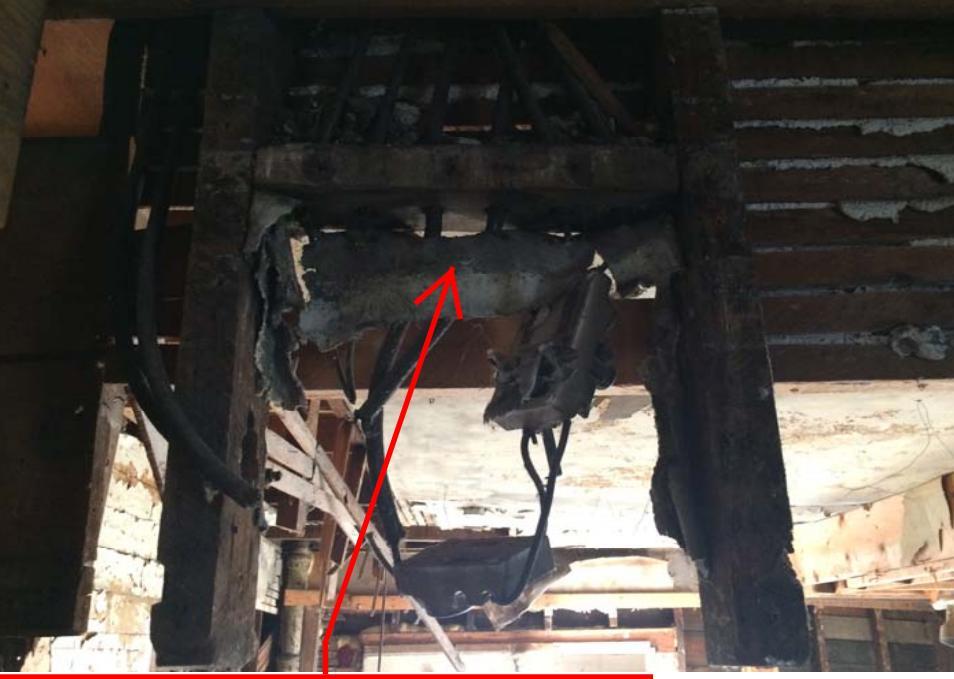
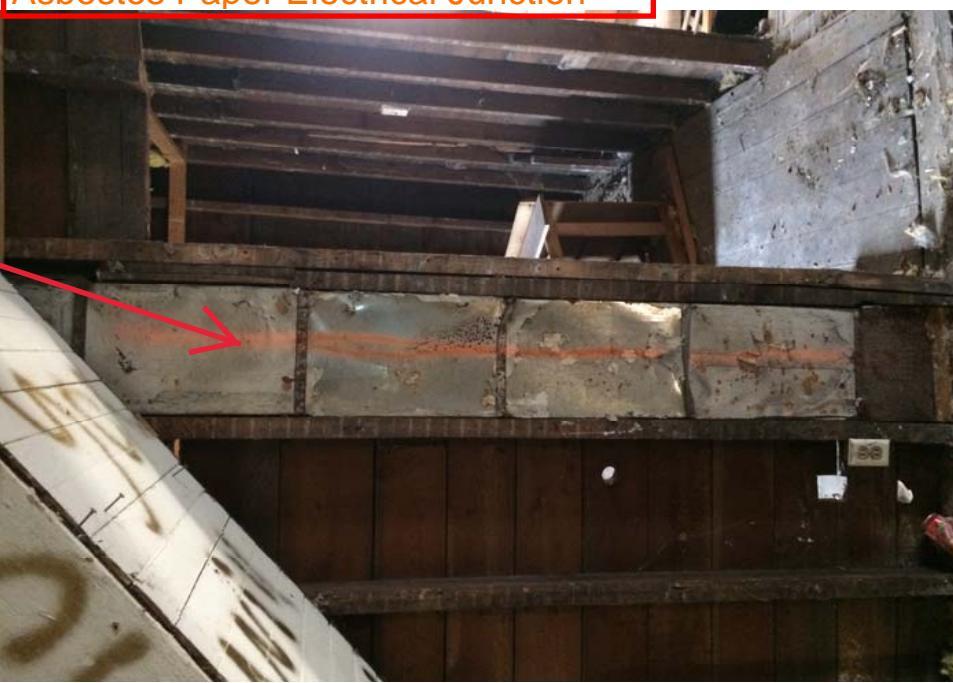
Asbestos Paper Electrical Junction
